All-Home Inspections

Harry Mills
1123 Linden Ave

Table of Contents

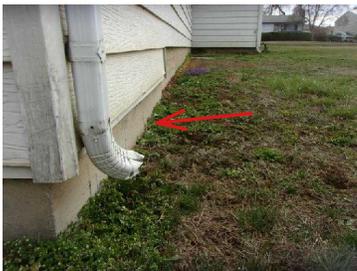
1. Driveway: Asphalt
2. Walks: Pavers
3. Steps/Stoops:
4. Porch: Concrete
5. Patio:
6. Deck:
7. Balcony:
8. Grading: Flat - / The grading has a negative slope, causing water to drain towards the foundation. This can cause water penetration into the basement or crawlspace. There should be a positive slope away from the foundation for at least 6 feet. Repairs are recommended to prevent moisture related concerns.

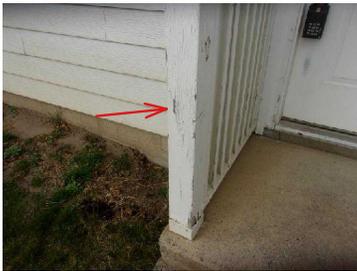
1. Type: Steel siding
2. Trim: Metal and painted wood - / Cracked and (or) peeling paint was noted. Preventative maintenance is recommended.

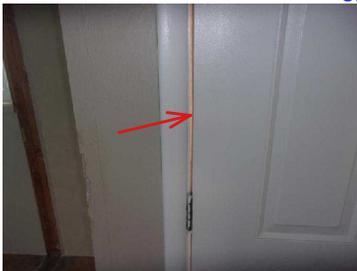
3. Fascia: Aluminum trim
4. Soffits: Painted Wood
5. Door Bell: Hard wired into the electrical system.
6. Entry Doors: Insulated metal entry door. / The weather stripping seal is damaged or missing. Repairs are recommended for energy efficiency.

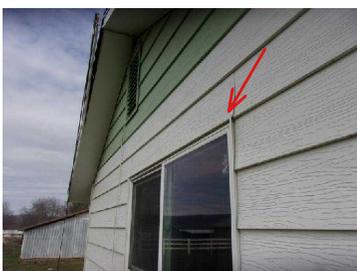
7. Patio Door: Insulated fiberglass entry door with tempered glass panel
8. Windows: Exterior concerns noted - / Windows and trim of this design do not contain a drip edge. No visual way to confirm if trim and water shields behind siding are intact. Monitoring recommended.

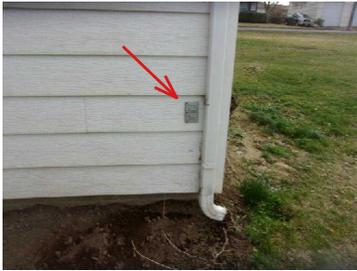
9. Storm Windows:
10. Window Screens: Fiberglass mesh screens
11. Basement Windows:
12. Exterior Lighting: Wall and soffit mounted
13. Exterior Electric Outlets: Standard electrical outlets. / The exterior outlets are not GFCI protected. Recommend evaluation and installation of GFCI protected outlets by a licensed electrician for safety.

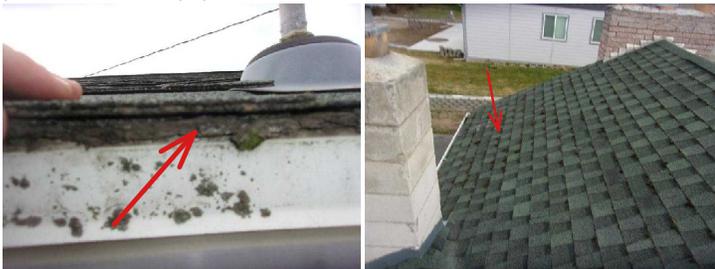
1. Method of Inspection: The roof was physically walked across and inspected from all corners.
2. Unable to Inspect: The roof was walked across and visually inspected from all sides.
3. Material: Fiberglass shingles - / Multiple layers of roofing were noted. This will decrease the life expectancy of the roofing material and may possibly void any warranty.

/Excessive moss growth should be removed by spraying and brooming the roof when weather permits to help protect the roof surface.

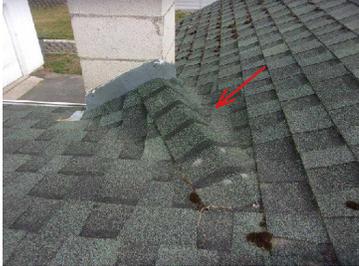
7. Valleys: Fiberglass shingle - / Some valleys are not adequately sloped for proper drainage. Water may pool and intrude into attic. Repairs recommended.

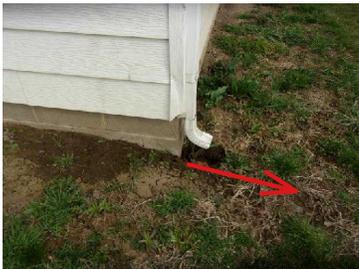
13. Leader/Extension: Missing - / Extension leaders should be installed to direct the water away from the foundation.

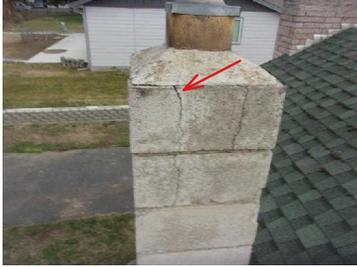
Center of structure Chimney

14. Chimney: Concrete block - / Cracks or damage noted in the chimney brick. Repairs recommended.

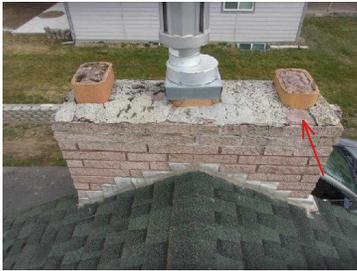
17. Chimney: Brick - / Small cracks in chimney should be monitored for increased size.
18. Flue/Flue Cap: Concrete - / Cracks in concrete cap should be repaired by a licensed contractor.

/ Unable to view interior of flue due to rain cap.

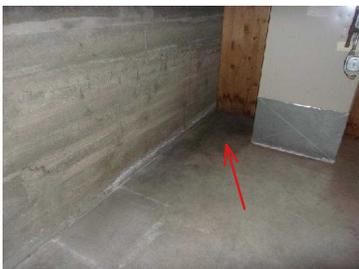
2. Foundation: Concrete - / **Water penetration is evident on the foundation walls. Monitoring recommended.**

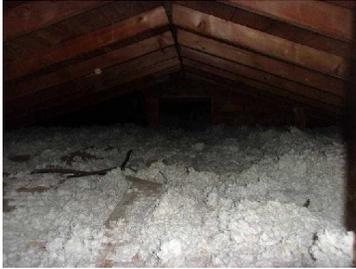
1. Method of Inspection: Inspected from the attic access entry
2. Unable to Inspect: Limited access for inspection - / There is insufficient space to safely access & visually inspect the entire attic.

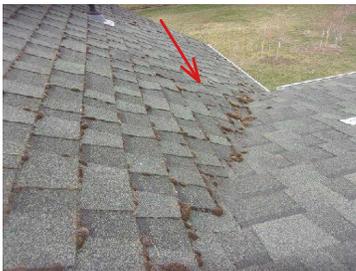
3. Roof Framing: Rafter framed construction
4. Sheathing: Dimensional wood - / Soft or heaving areas in sheathing may require replacement with the next roof surface is installed.

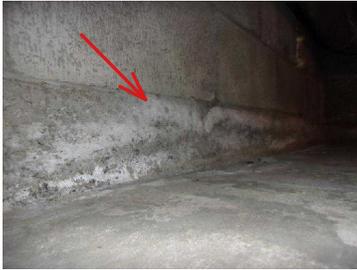
- 1. Unable to Inspect: All areas visible and accessible
- 2. Ceiling: Exposed framing with no finished ceiling.
- 3. Walls: Concrete and dimensional wood - / Efflorescence noted on basement wall areas.

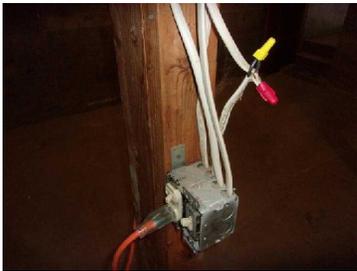
/ Open and exposed wire splices. Covers missing. A licensed electrician is recommended to evaluate and repair as needed.

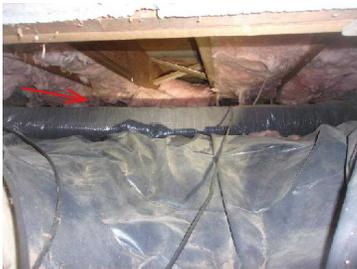
- 13. Method of Inspection: The crawlspace was entered and visually inspected
- 14. Unable to Inspect: Limited access for inspection - / Insufficient space between the floor and framing (18" minimum is required) prevented a complete visual inspection. There may be areas of concern that could not be accessed.

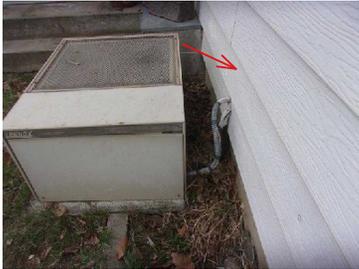
11. Electrical Disconnect: None - / Electrical disconnect on wall near unit should be installed by a licensed electrician for safety.

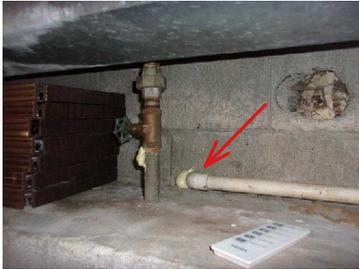
12. Draft Control: Automatic
13. Flue Pipe: Metal flue pipe
14. Controls: Service disconnect switch on the furnace
15. Devices: Condensate drain - / **Condensate drain pipe termination not visible as exits basement below ground level. Pipe could get plugged and water may back into furnace. Recommend evaluation and repairs by a licensed contractor.**

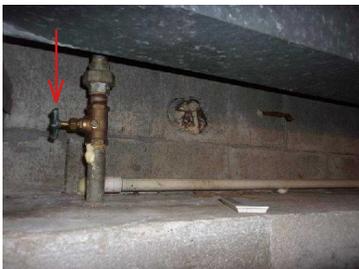
1. Service Line: Galvanized - / **Galvanized supply piping corrodes from inside causing decreased flow rates and will eventually require updating**
2. Main Water Shutoff: Basement

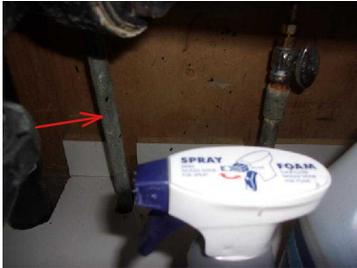
3. Water Lines: Galvanized and copper - / Galvanized supply piping corrodes from inside causing decreased flow-rates and will eventually require updating.

/ Galvanized to copper fittings will generate electrolysis, which will eventually corrode the galvanized pipe and result in leaks.

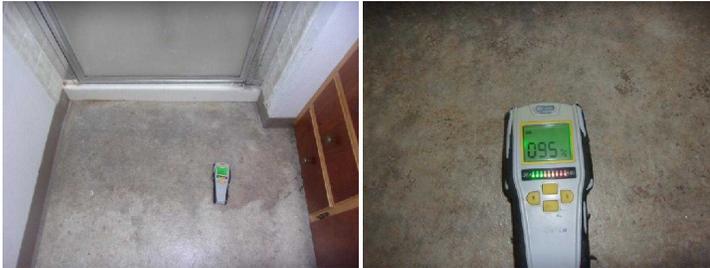
1. Closet:
2. Ceiling: Textured and painted drywall
3. Walls: Textured and painted drywall
4. Floor: Linoleum - / Excessively water damaged floor covering noted. High moisture readings noted in multiple locations. Due to concerns in the flooring, recommend a licensed contractor evaluate and repair as needed.

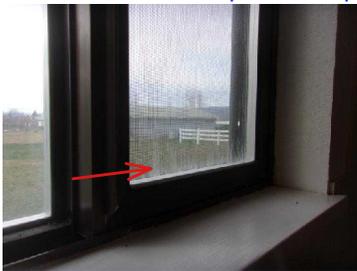
17. Closet:
18. Ceiling: Textured and painted drywall
19. Walls: Textured and painted drywall
20. Floor: Linoleum - / Moisture testing was done in several areas with no moisture noted.
21. Doors: Wood panel door
22. Windows: Aluminum framed - thermally insulated windows. / Moisture or water stains were noted between the panes of glass, indicating a damaged or broken thermal seal. Although this is mainly a cosmetic issue, repair or replacement should be considered.

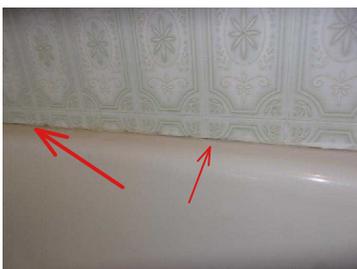
23. Electrical: Standard 110 volt electrical outlets and light fixtures. / Although not required when the home was built, current safety requirements recommend GFCI protected outlets in this room. Please consider having a licensed electrician install approved GFCI outlets where required.
24. Counter/Cabinet: Laminate countertop with a wood vanity cabinet
25. Sink/Basin: Pre-cast china vanity sink
26. Faucets/Traps: Plumbing fixtures were working as expected.
27. Tub/Surround: Cast iron bathtub
28. Shower/Surround: Laminate surround - / Recommend replacing the loose or missing caulk around tub and surround.

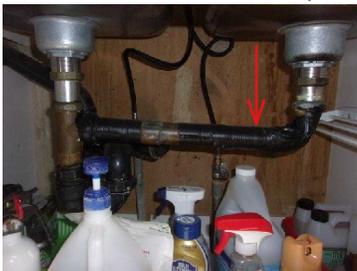
10. Plumbing/Fixtures: Plumbing concerns were noted - / **Drain lines have a negative slope. Recommend a licensed plumber evaluate and repair as needed.**

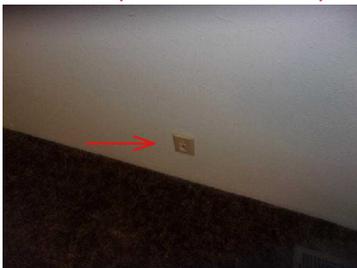
10. Closet: A large single closet - / Closet doors not installed.
11. Ceiling: Textured and painted drywall
12. Walls: Textured and painted drywall
13. Floor: Carpet
14. Doors: Wood panel doors
15. Windows: Aluminum framed - thermally insulated windows. / Operating windows opened, closed and locked as expected.
16. Electrical: Standard 110 volt electrical outlets and light fixtures. / **Some of the electrical outlets are loose. Replacement or repair by a licensed electrician is recommended.**

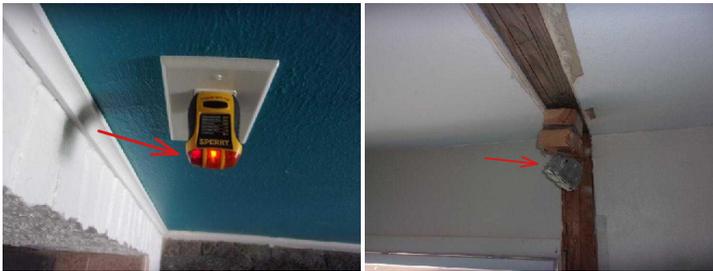
1. Closet:
2. Ceiling: Textured and painted drywall - / There are small settlement cracks noted.
3. Walls: Textured and painted drywall
4. Floor: Carpet
5. Doors: Entry door
6. Windows: Vinyl framed - thermally insulated windows.
7. Electrical: Standard 110 volt electrical outlets and light fixtures. / **Reversed polarity noted (hot & neutral wires are reversed) in some outlets. Evaluation and repair by a licensed electrician is recommended.**

Outlets not properly mounted.

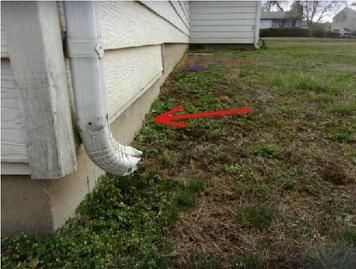
1. Grading: Flat - / The grading has a negative slope, causing water to drain towards the foundation. This can cause water penetration into the basement or crawlspace. There should be a positive slope away from the foundation for at least 6 feet. Repairs are recommended to prevent moisture related concerns.

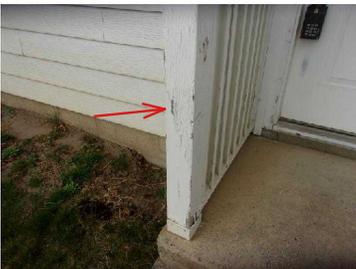
2. Trim: Metal and painted wood - / Cracked and (or) peeling paint was noted. Preventative maintenance is recommended.

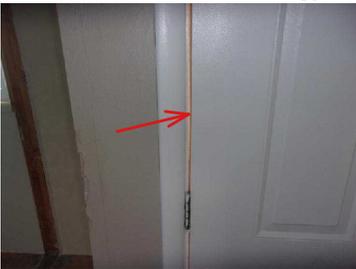
3. Entry Doors: Insulated metal entry door. / The weather stripping seal is damaged or missing. Repairs are recommended for energy efficiency.

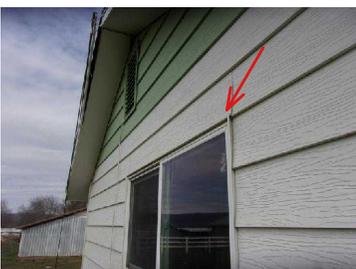
4. Windows: Exterior concerns noted - / Windows and trim of this design do not contain a drip edge. No visual way to confirm if trim and water shields behind siding are intact. Monitoring recommended.

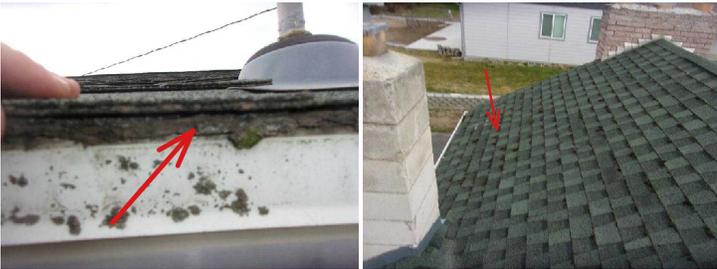
5. The same roofing material covers all roof areas. Roof Surface Material: Fiberglass shingles - / Multiple layers of roofing were noted. This will decrease the life expectancy of the roofing material and may possibly void any warranty.

/Excessive moss growth should be removed by spraying and brooming the roof when weather permits to help protect the roof surface.

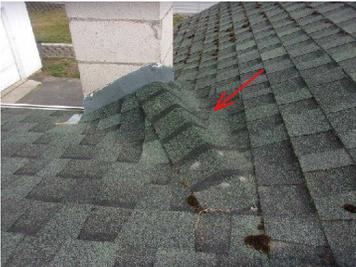
6. Valleys: Fiberglass shingle - / Some valleys are not adequately sloped for proper drainage. Water may pool and intrude into attic. Repairs recommended.

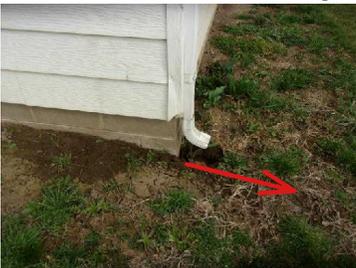
7. Leader/Extension: Missing - / Extension leaders should be installed to direct the water away from the foundation.

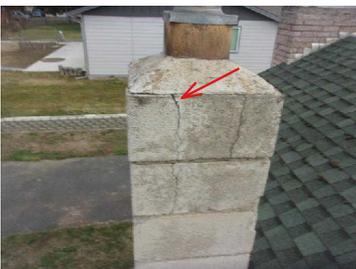
8. Center of structure Chimney Chimney: Concrete block - / Cracks or damage noted in the chimney brick. Repairs recommended.

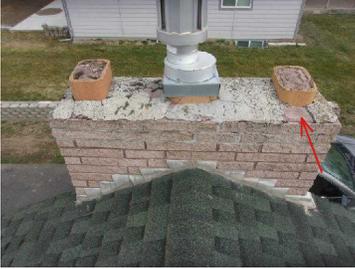
9. East side of the home Chimney Chimney: Brick - / Small cracks in chimney should be monitored for increased size.
10. East side of the home Chimney Flue/Flue Cap: Concrete - / Cracks in concrete cap should be repaired by a licensed contractor.

/ Unable to view interior of flue due to rain cap.

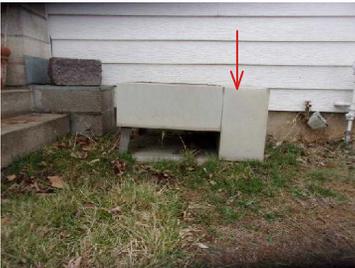
12. East side exterior AC System Exterior Unit: Pad mounted - / The exterior unit is not level, which may cause the oil to settle and possibly cause compressor damage. Recommend having the unit properly leveled and secured.

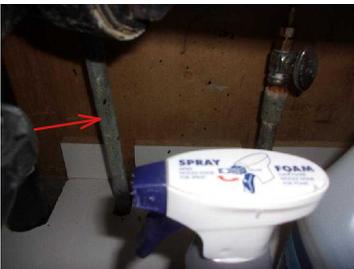
15. Service Line: Galvanized - /Galvanized supply piping corrodes from inside causing decreased flow rates and will eventually require updating
16. Water Lines: Galvanized and copper - / Galvanized supply piping corrodes from inside causing decreased flow-rates and will eventually require updating.

/ Galvanized to copper fittings will generate electrolysis, which will eventually corrode the galvanized pipe and result in leaks.

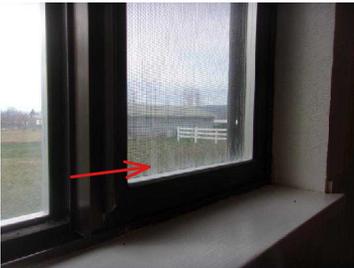
17. Hallway Bathroom Windows: Aluminum framed - thermally insulated windows. / Moisture or water stains were noted between the panes of glass, indicating a damaged or broken thermal seal. Although this is mainly a cosmetic issue, repair or replacement should be considered.

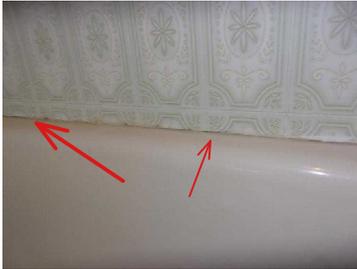
18. Hallway Bathroom Shower/Surround: Laminate surround - / Recommend replacing the loose or missing caulk around tub and surround.

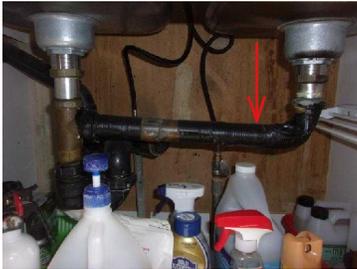
19. East side Kitchen Plumbing/Fixtures: Plumbing concerns were noted - / Drain lines have a negative slope. Recommend a licensed plumber evaluate and repair as needed.

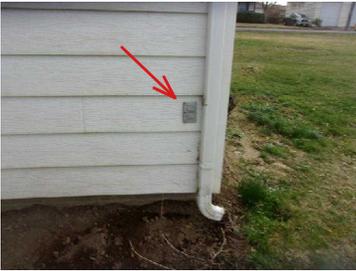
1. Exterior Electric Outlets: Standard electrical outlets. / The exterior outlets are not GFCI protected. Recommend evaluation and installation of GFCI protected outlets by a licensed electrician for safety.

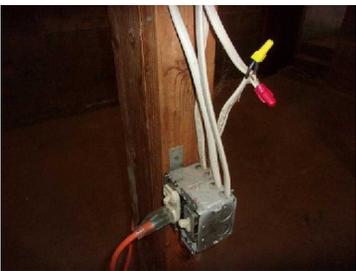
3. Under the center of home Basement Electrical: Standard 110 volt electrical outlets and light fixtures. / Although not required when the home was built, current safety requirements recommend GFCI protected outlets in this room. Please consider having a licensed electrician install approved GFCI outlets where required.

/ Open and exposed wire splices. Covers missing. A licensed electrician is recommended to evaluate and repair as needed.

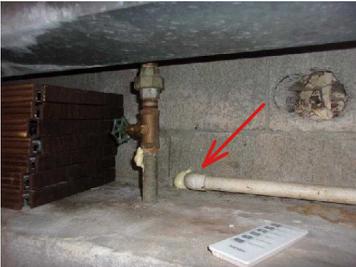
5. Basement Heating System Devices: Condensate drain - / Condensate drain pipe termination not visible as exits basement below ground level. Pipe could get plugged and water may back into furnace. Recommend evaluation and repairs by a licensed contractor.
