All-Home Inspections

Harry Mills
1123 Linden Ave

Property Address 1123 Linden Ave

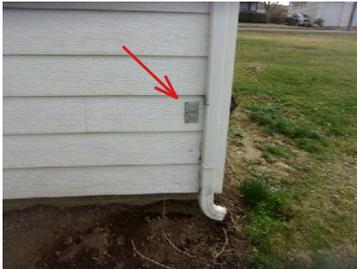
9. Storm Windows:
10. Window Screens: Fiberglass mesh screens
11. Basement Windows:
12. Exterior Lighting: Wall and soffit mounted
13. Exterior Electric Outlets: Standard electrical outlets. / The exterior outlets are not GFCI protected. Recommend evaluation and installation of GFCI protected outlets by a licensed electrician for safety.

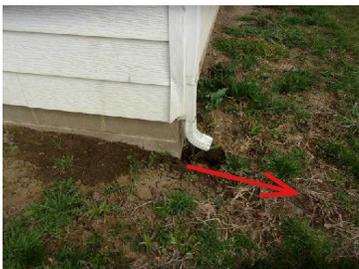
13. Leader/Extension: Missing - / Extension leaders should be installed to direct the water away from the foundation.

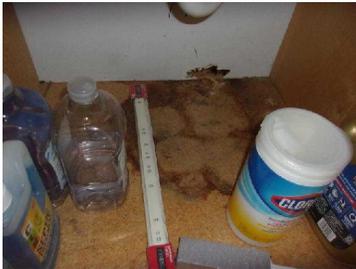
5. Doors: Interior hollow core door
6. Windows:
7. Electrical: Standard 110 volt electrical outlets and light fixtures. / Although not required when the home was built, current safety requirements recommend GFCI protected outlets in this room. Please consider having a licensed electrician install approved GFCI outlets where required.
8. Counter/Cabinet: Laminate countertop with a wood vanity cabinet - / Minor water damage noted under counter. No moisture detected at time of inspection.

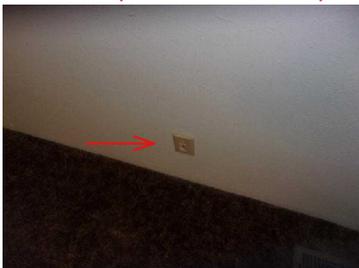
10. Closet: A large single closet - / Closet doors not installed.
11. Ceiling: Textured and painted drywall
12. Walls: Textured and painted drywall
13. Floor: Carpet
14. Doors: Wood panel doors
15. Windows: Aluminum framed - thermally insulated windows. / Operating windows opened, closed and locked as expected.
16. Electrical: Standard 110 volt electrical outlets and light fixtures. / **Some of the electrical outlets are loose. Replacement or repair by a licensed electrician is recommended.**

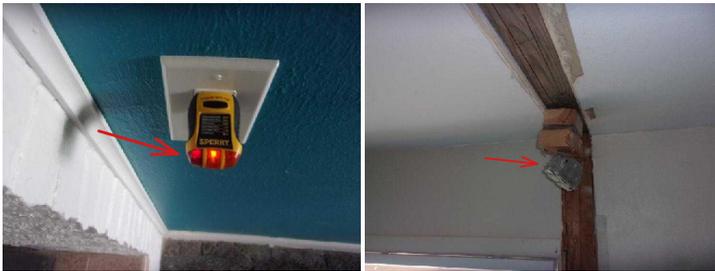
1. Closet:
2. Ceiling: Textured and painted drywall - / There are small settlement cracks noted.
3. Walls: Textured and painted drywall
4. Floor: Carpet
5. Doors: Entry door
6. Windows: Vinyl framed - thermally insulated windows.
7. Electrical: Standard 110 volt electrical outlets and light fixtures. / **Reversed polarity noted (hot & neutral wires are reversed) in some outlets. Evaluation and repair by a licensed electrician is recommended.**

Outlets not properly mounted.

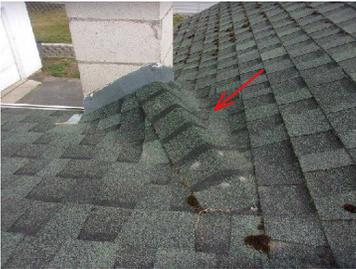
6. Valleys: Fiberglass shingle - / Some valleys are not adequately sloped for proper drainage. Water may pool and intrude into attic. Repairs recommended.

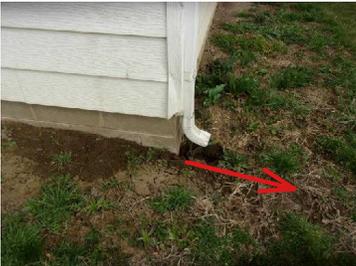
7. Leader/Extension: Missing - / Extension leaders should be installed to direct the water away from the foundation.

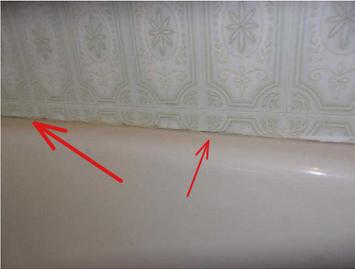
18. Hallway Bathroom Shower/Surround: Laminate surround - / Recommend replacing the loose or missing caulk around tub and surround.

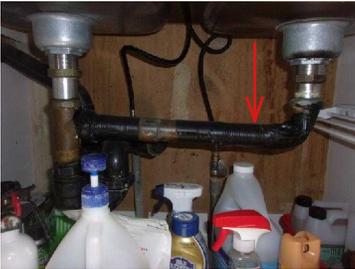
19. East side Kitchen Plumbing/Fixtures: Plumbing concerns were noted - / Drain lines have a negative slope. Recommend a licensed plumber evaluate and repair as needed.

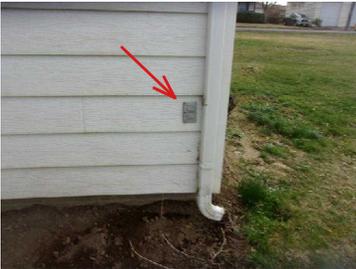
1. Exterior Electric Outlets: Standard electrical outlets. / The exterior outlets are not GFCI protected. Recommend evaluation and installation of GFCI protected outlets by a licensed electrician for safety.

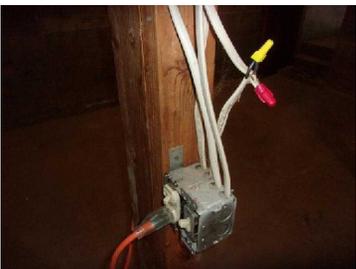
3. Under the center of home Basement Electrical: Standard 110 volt electrical outlets and light fixtures. / Although not required when the home was built, current safety requirements recommend GFCI protected outlets in this room. Please consider having a licensed electrician install approved GFCI outlets where required.

/ Open and exposed wire splices. Covers missing. A licensed electrician is recommended to evaluate and repair as needed.

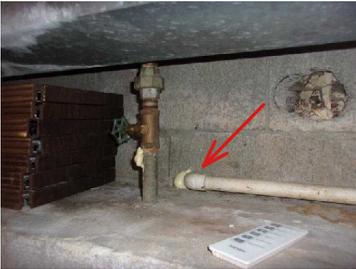
5. Basement Heating System Devices: Condensate drain - / Condensate drain pipe termination not visible as exits basement below ground level. Pipe could get plugged and water may back into furnace. Recommend evaluation and repairs by a licensed contractor.
