# Inspection Report

## Harry Mills

1123 Linden Ave  
Lewiston ID 83501

## Safe@Home Inspections, LLC

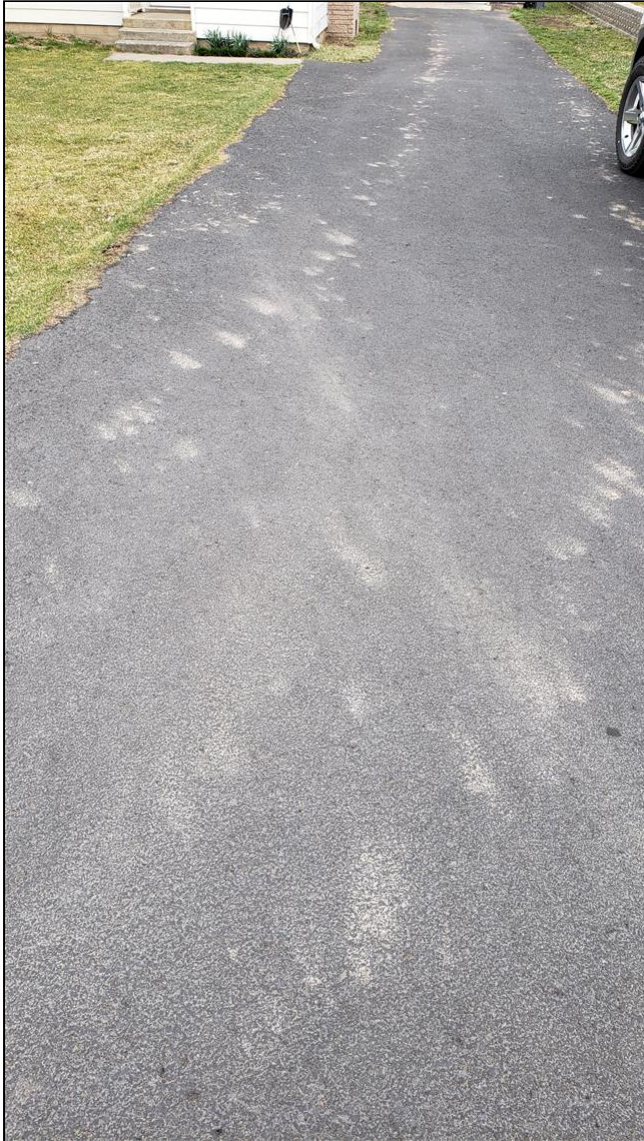
1.1 Item 1(Picture)

(1) The driveway appears in serviceable condition and appears to function as intended given the age and type of home unless otherwise specified in this report. Serviceable condition includes normal minor cracks.

(2) Within the next several years, the asphalt will need to be resealed.

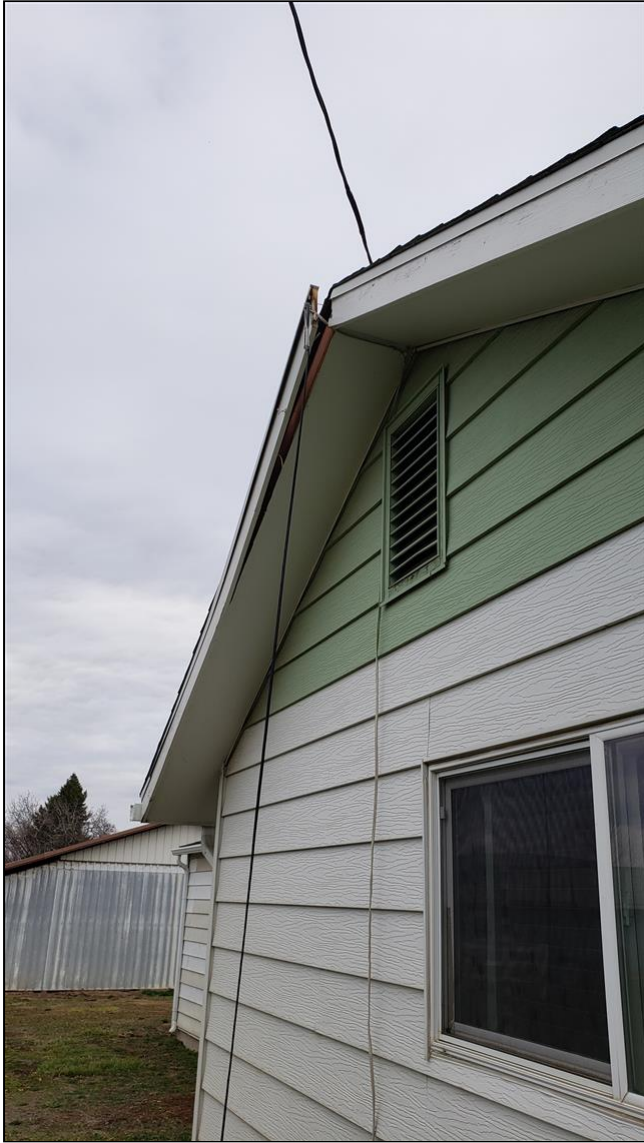
2.4 Item 1(Picture)

(1) The fascia board on the westside gable has detached from the home. This allows for water entry into structural components, has pulled the flashing free of the roof, and is a hazard to fall. Recommend reattachment by a licensed and qualified contractor.

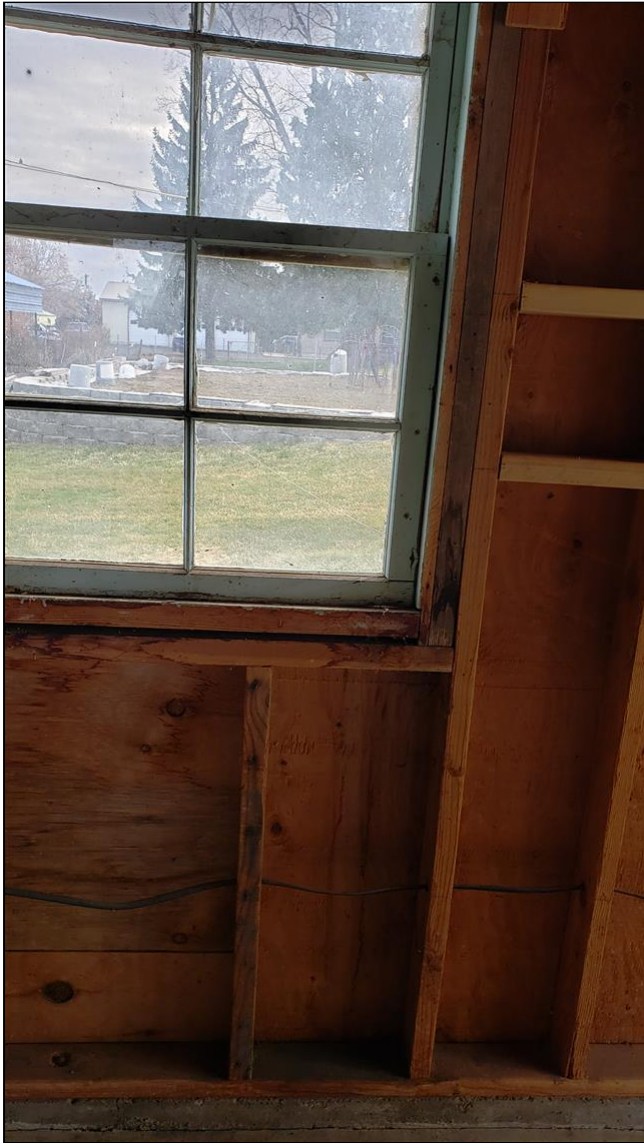
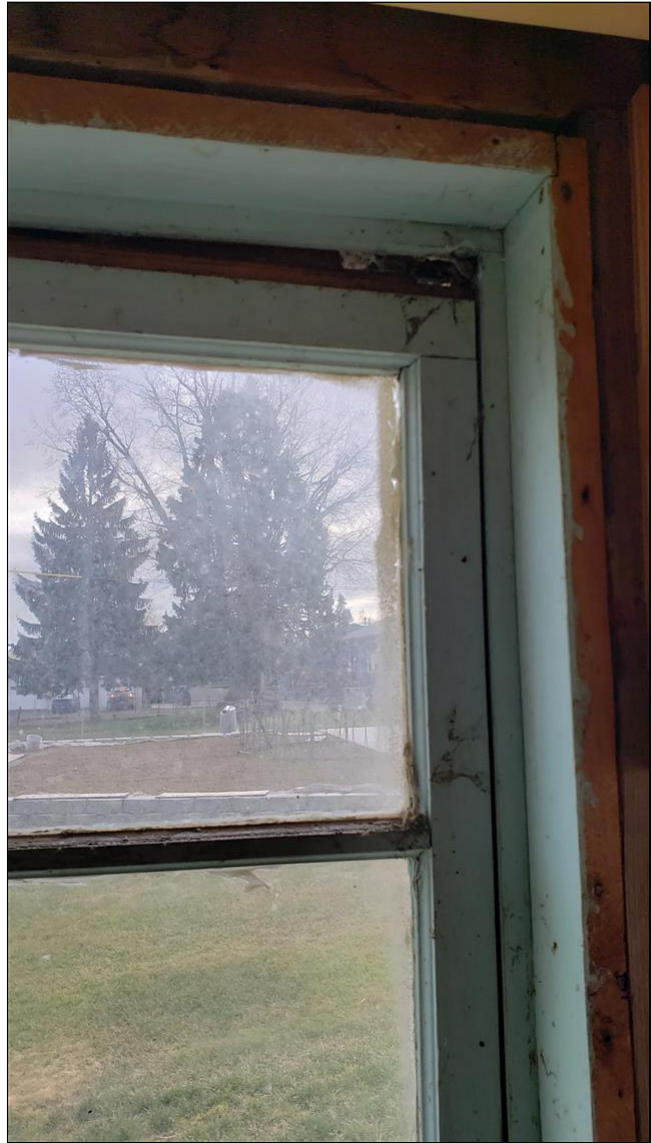
(1) One or more windows in the garage has one or more broken panes of glass and a damaged frame Recommend repair by a qualified and competent handyman/homeowner/window contractor.

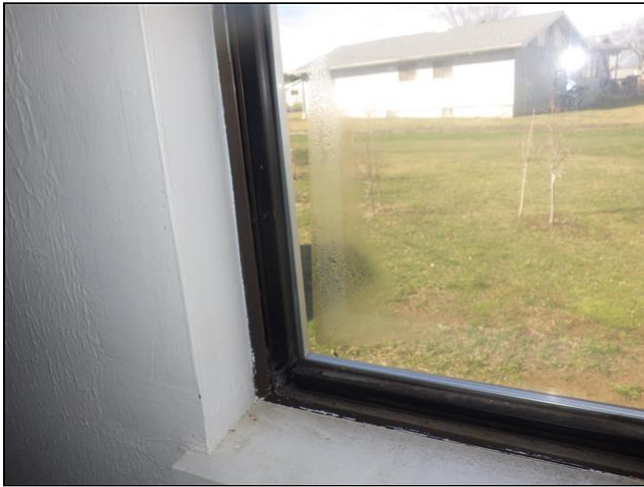
3.2 Item 3(Picture)

(3) One or more windows in the rear bedroom has considerable fogging. This does not substantially impact its weatherproofing capacity or insulative capacity, but does interfere with light transmittance. Recommend replacement of the affected window assembly.

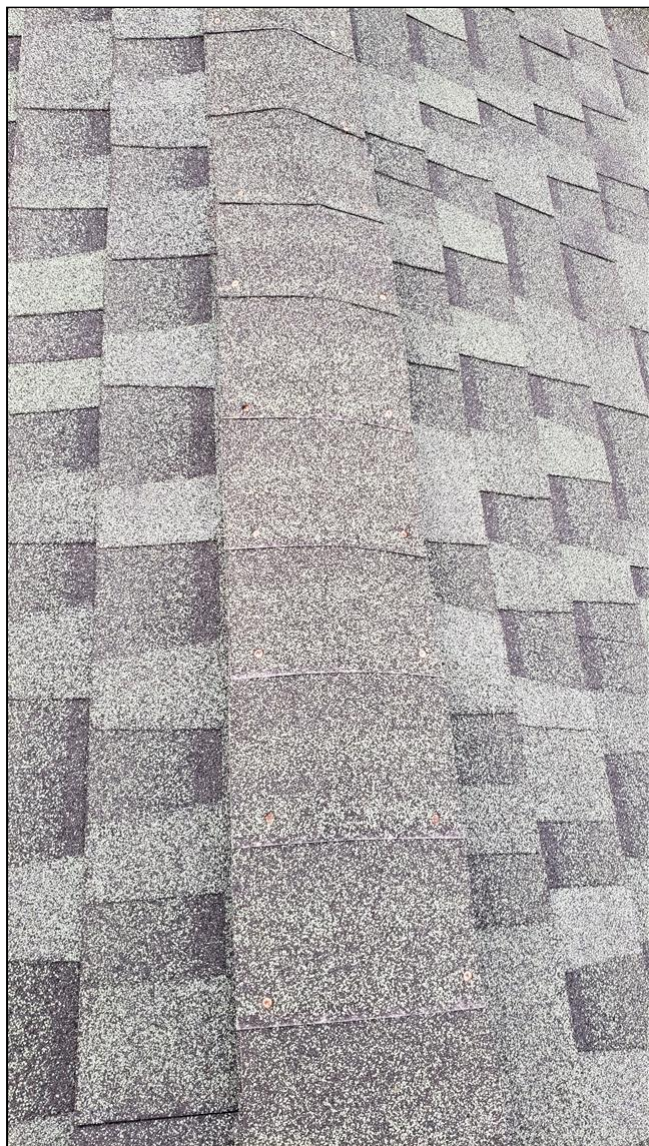
4.1 Item 3(Picture)

(5) Exposed nails present on the roof deck. These should be covered with caulk or roof sealant to prevent potential water intrusion to the rest of the home. Recommend correction of all such by a licensed and qualified roofing contractor.

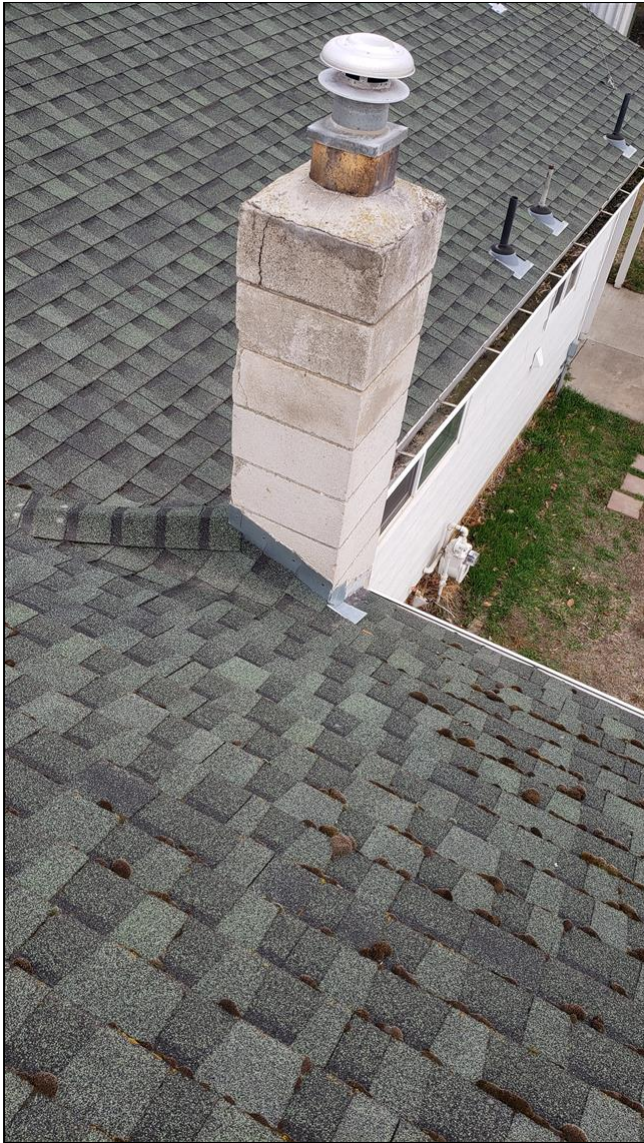
4.2 Item 1(Picture)

(2) Chimney counter flashing is missing, poorly installed or damaged: Counter flashing is integral to the flashing system and leak prevention. Recommend further evaluation and repair. Be aware that with used or older structures that hidden conditions may exist.

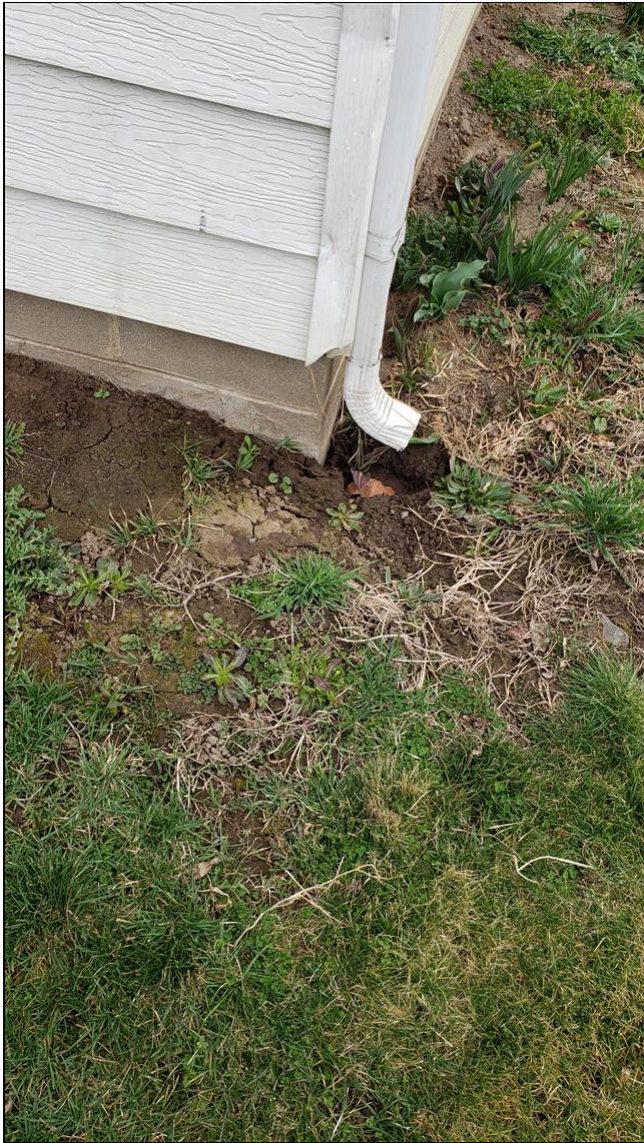
4.3 Item 1(Picture)

- (1) The roof drainage system consisted of conventional gutters hung from the roof edges feeding downspouts.
- (2) The downspouts and extensions/splashblocks gutters are not directing water sufficiently far from the foundation. They should direct all roof water run-off at least ten feet from the foundation walls. Recommend correcting all the existing discharge points to accomplish this by adding properly aligned splash blocks, extensions, or similar means.

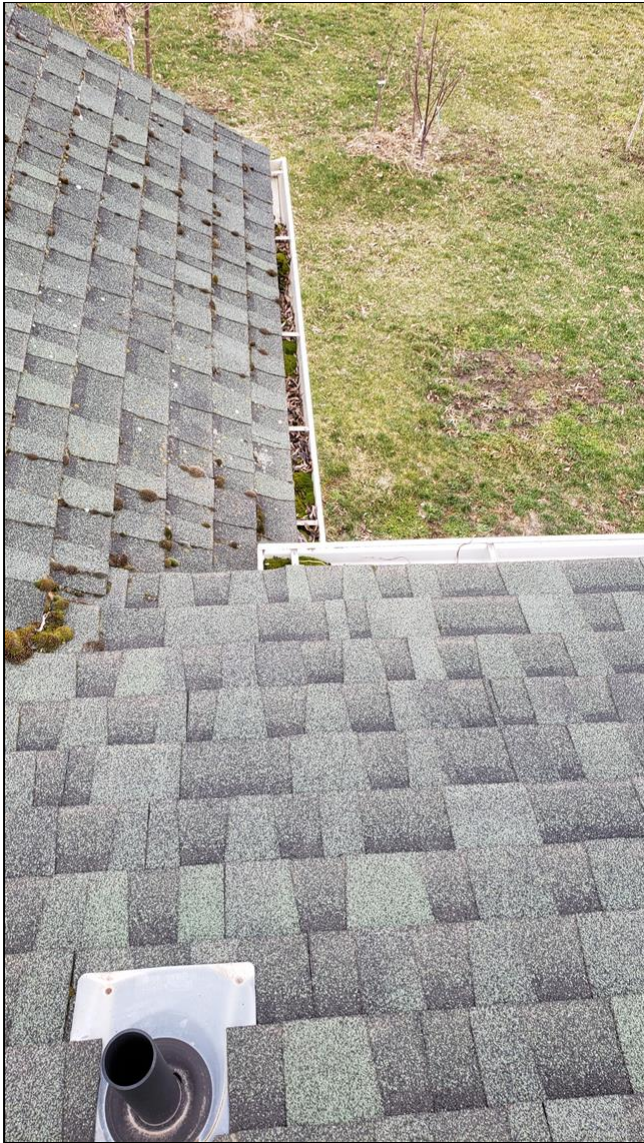
4.3 Item 2(Picture)

(4) The rear gutters are full of debris in areas and needs to be cleaned. The debris in gutters can also conceal rust, deterioration or leaks that are not visible until cleaned, and I am unable to determine if such conditions exist.

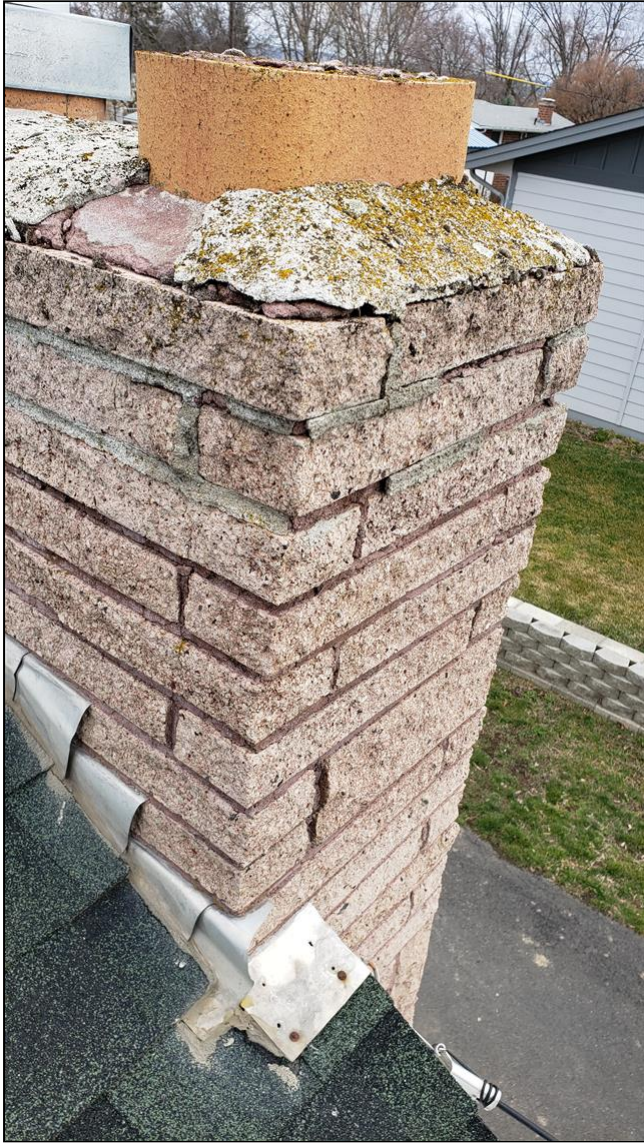
4.5 Item 1(Picture)

(1) The chimney had extensive deterioration at the mortar joints of the chimney and/or significant spalling of the brick/block. This will tend to make the chimney unstable over time. Recommend repair by a licensed and qualified masonry or fireplace contractor.

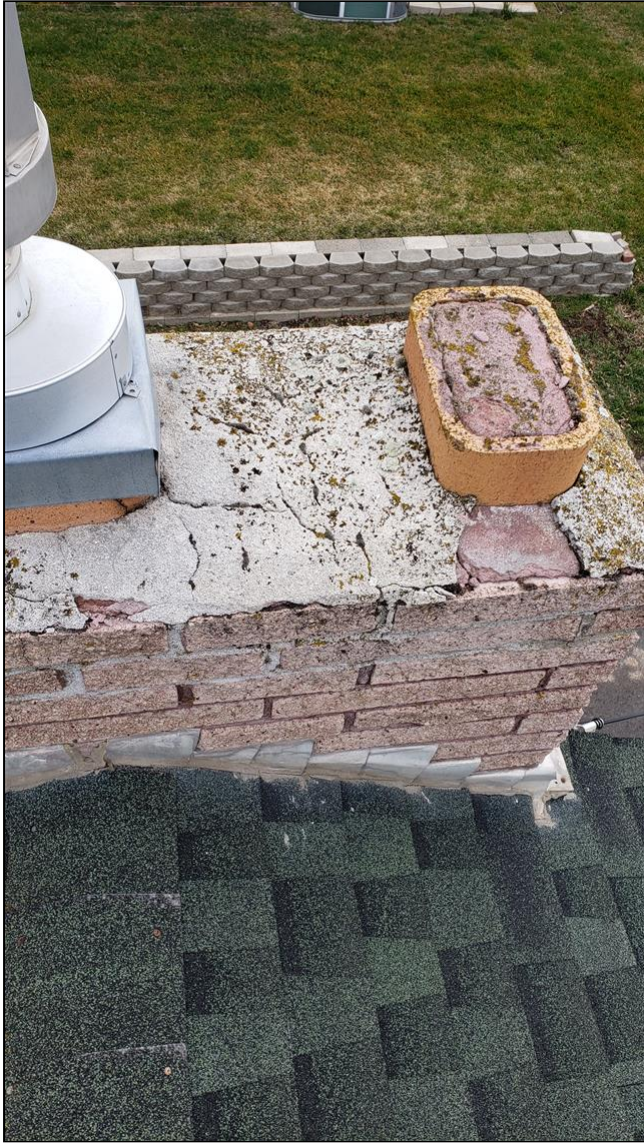
4.5 Item 3(Picture)

(2) The chimney cap had moderate to severe deterioration which should be repaired to avoid moisture intrusion of the chimney structure. Recommend repairs by a licensed and qualified contractor with experience performing work on chimneys.

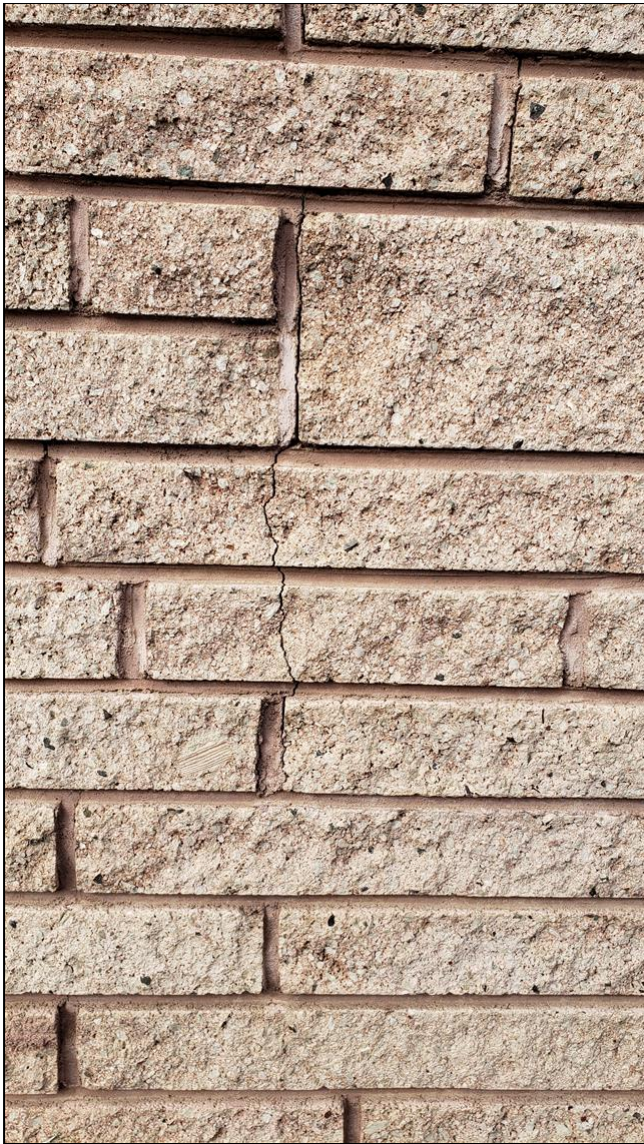
4.5 Item 6(Picture)

investigation by a licensed and qualified contractor to determine the full scope of necessary repairs.

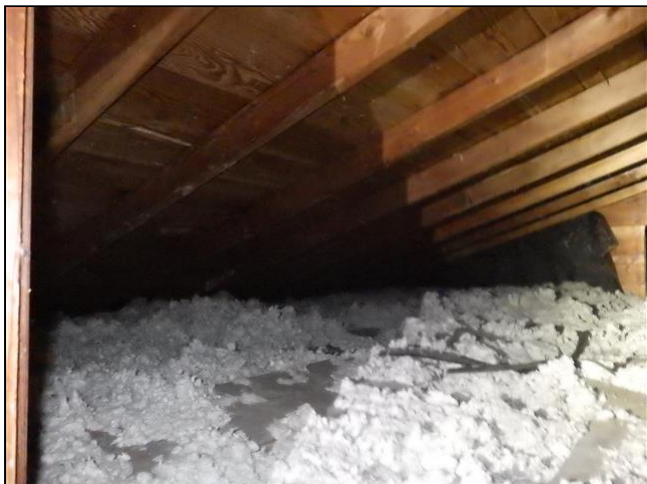
5.2 Item 3(Picture)

(2) Sagging visible in the roof rafters appeared to be caused by inadequate framing design of the roof structure typical of homes built in this area, during this time period, of this quality. Consider consulting with a qualified contractor to discuss options and costs for stabilization or correction.

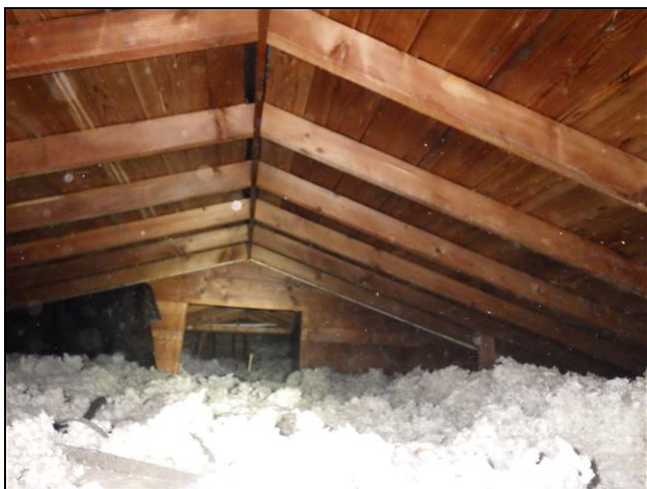
5.4 Item 1(Picture)

There were indications of previous leaks in the attic as evident by water marks on framing members and/or staining on the insulation. This is not unusual in older houses. These appeared dry at the time of inspection. However, even apparently dry areas can re-start under the right wind and rain conditions and there is no way to determine outside of those conditions. I recommend periodically checking the attic space during severe weather.

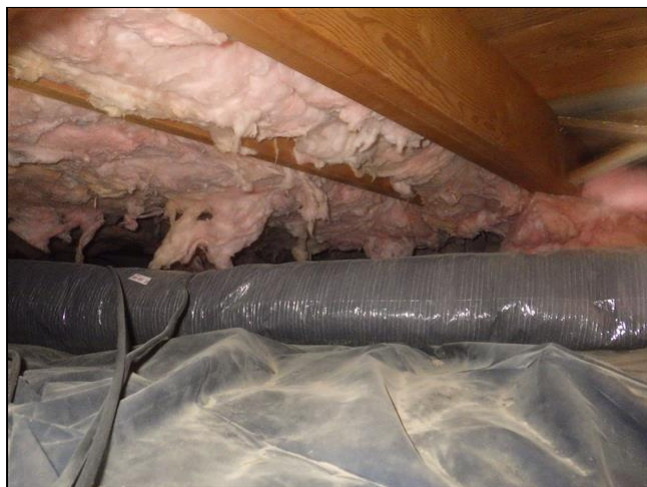
6.3 Item 1(Picture)

- (1) Current standards require one square foot of ventilation per 150 feet of area in the crawlspace with one ventilation opening located within three feet of corners. This appears to be present at this home.
- (2) The access appeared adequately sized. No significant deficiencies were noted.
- (3) Insulation is partially or completely blocking the vents. This may limit air flow and increase moisture levels in the crawlspace. Recommend adjusting/correcting to allow proper air flow.
- (4) The ductwork and plumbing prevented full access to approximately 30 percent of the crawlspace. The customer is advised that hidden conditions may be present. A second access should be created or a portion of the existing space should be dug out to allow for entry and inspection.

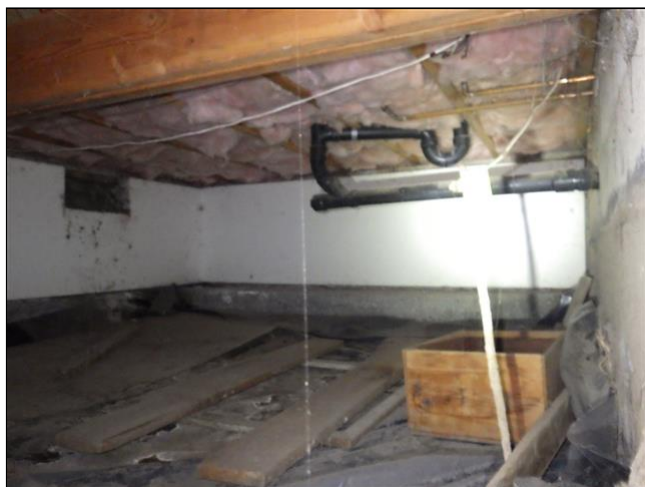
6.10 Item 1(Picture)

Left-over wood from construction is present in the crawlspace. This is considered a conducive condition for pest intrusion and wood-destroying fungus. Recommend removing all such materials.

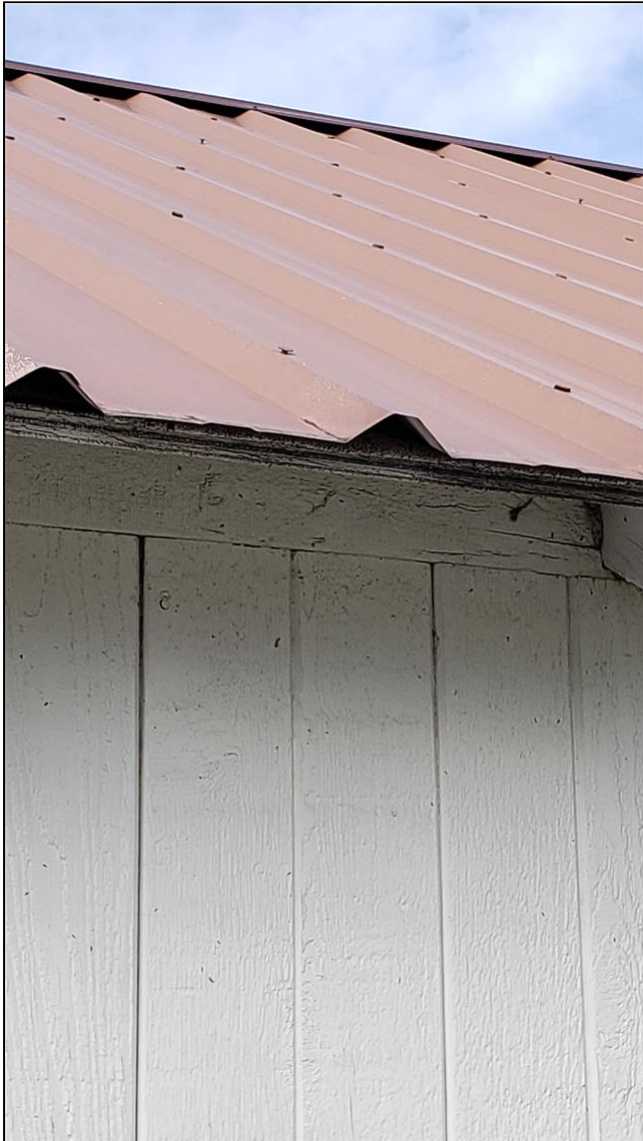
7.1 Item 1(Picture)

(2) Loose, protruding or missing fasteners visible at the time of the inspection. This condition should be corrected to avoid wind damage and/or damage from moisture intrusion. Recommend repair by a licensed and qualified roofing contractor.

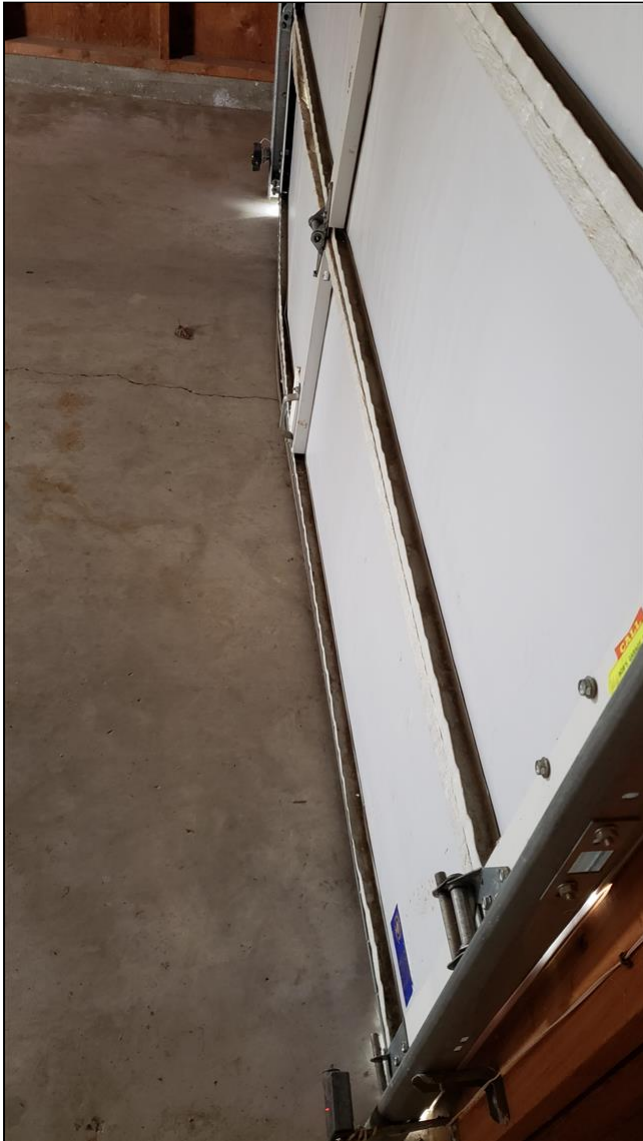
7.5 Item 1(Picture)

A garage vehicle door panel had severe damage visible which will require repair or replacement. Recommend consulting a garage door contractor to gain an idea of options and costs necessary to correct this condition.

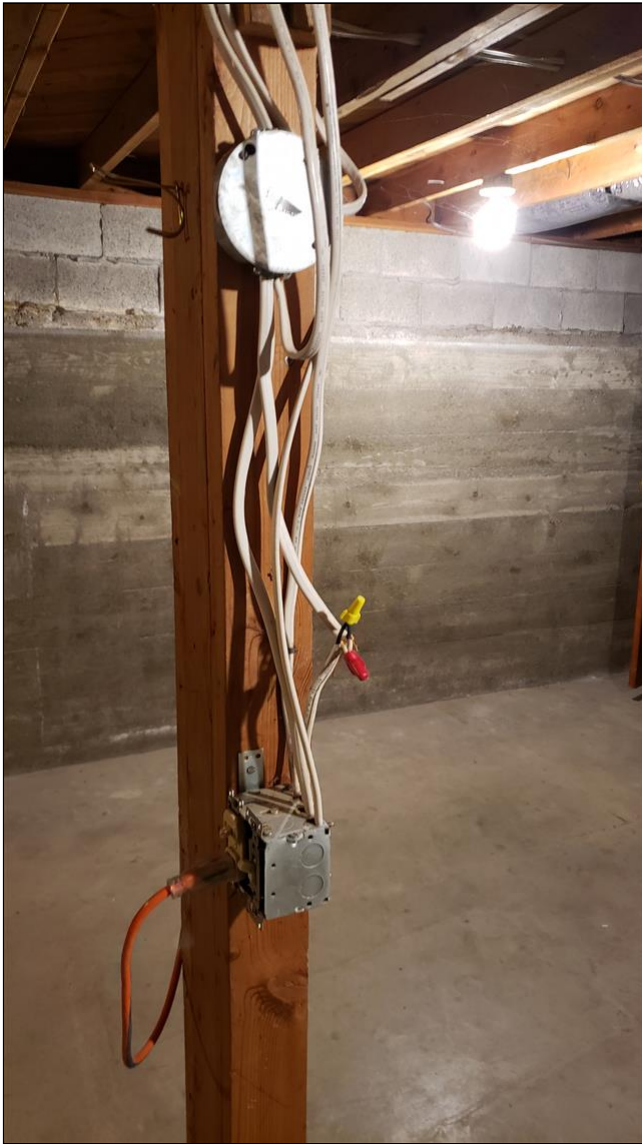
10.1 Item 1(Picture)

(2) The wiring in the basement appears to have been installed by a person unfamiliar with good electrical practices. Wiring is exposed to damage and the junction boxes are missing bushings. Recommend evaluation by a licensed and qualified electrical contractor.

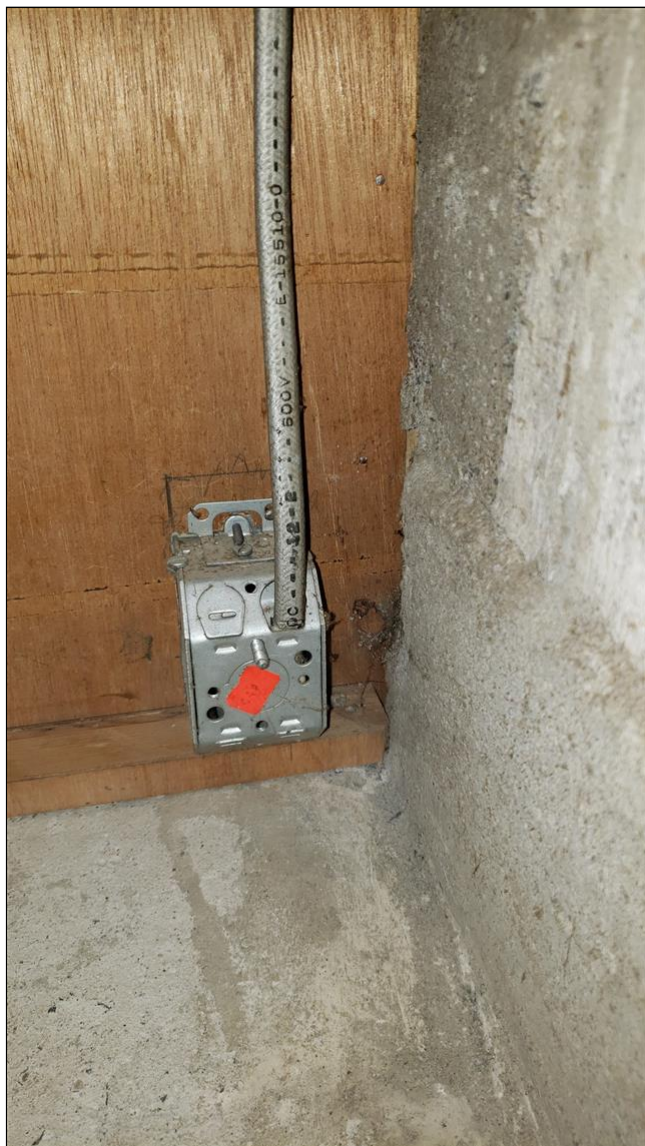
10.1 Item 2(Picture)

(3) The metal electrical receptacle boxes do not appear to have been properly grounded. Recommend correction by a licensed and qualified electrical contractor.

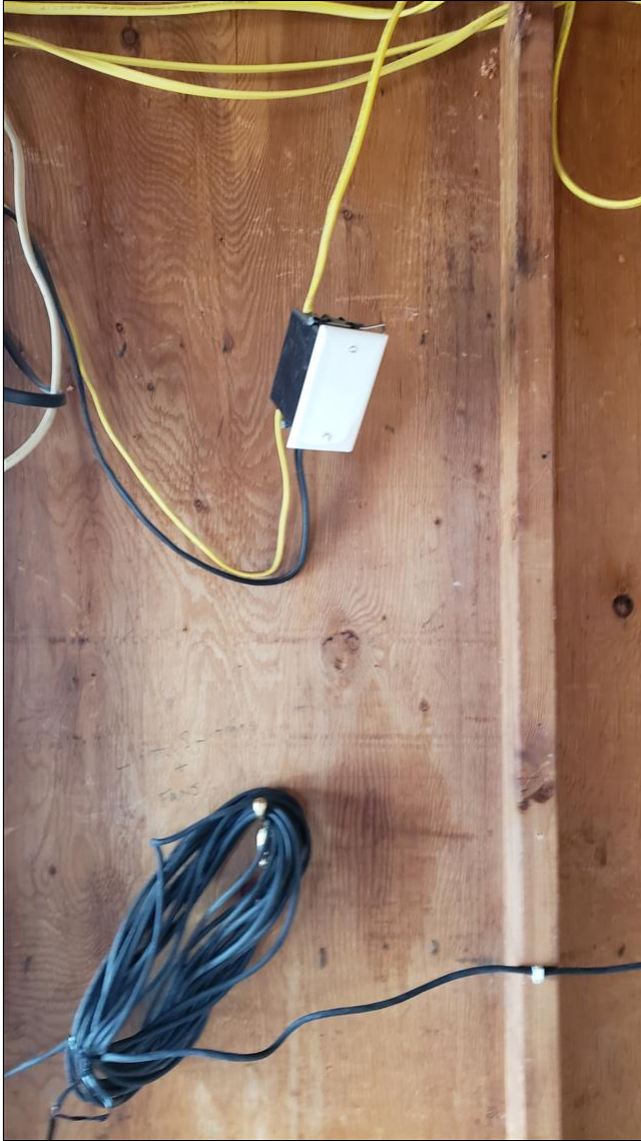
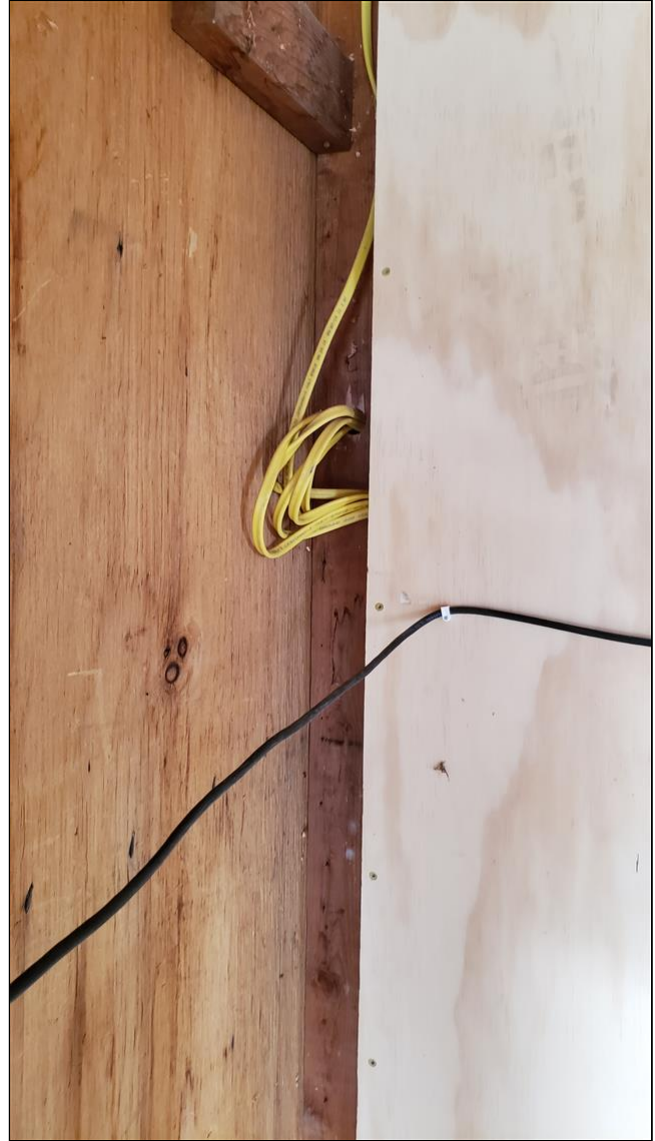
(5) Some of the wiring in the garage appears to have been installed by a person unfamiliar with good electrical practices. Wiring is exposed to damage and the junction boxes are missing bushings. Recommend evaluation by a licensed and qualified electrical contractor.

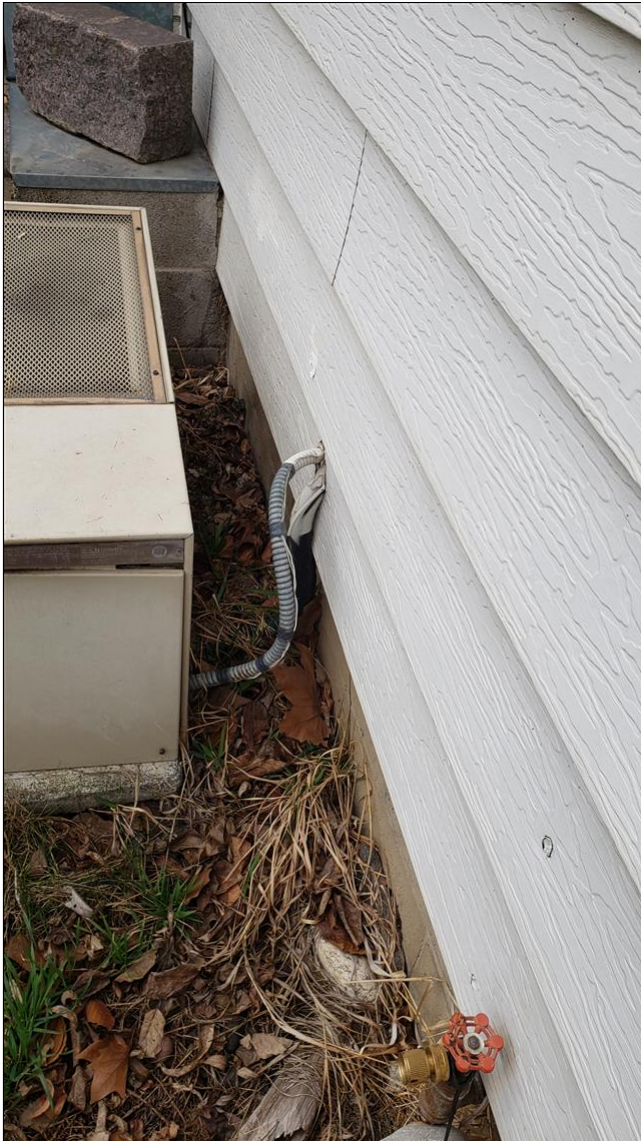
10.2 Item 1(Picture)

(2) The electrical service for the air conditioner is protected by conduit that is not weather tight. This can allow water into the service and cause damage to the wiring or create a shock hazard. Recommend repair by a licensed and qualified contractor.

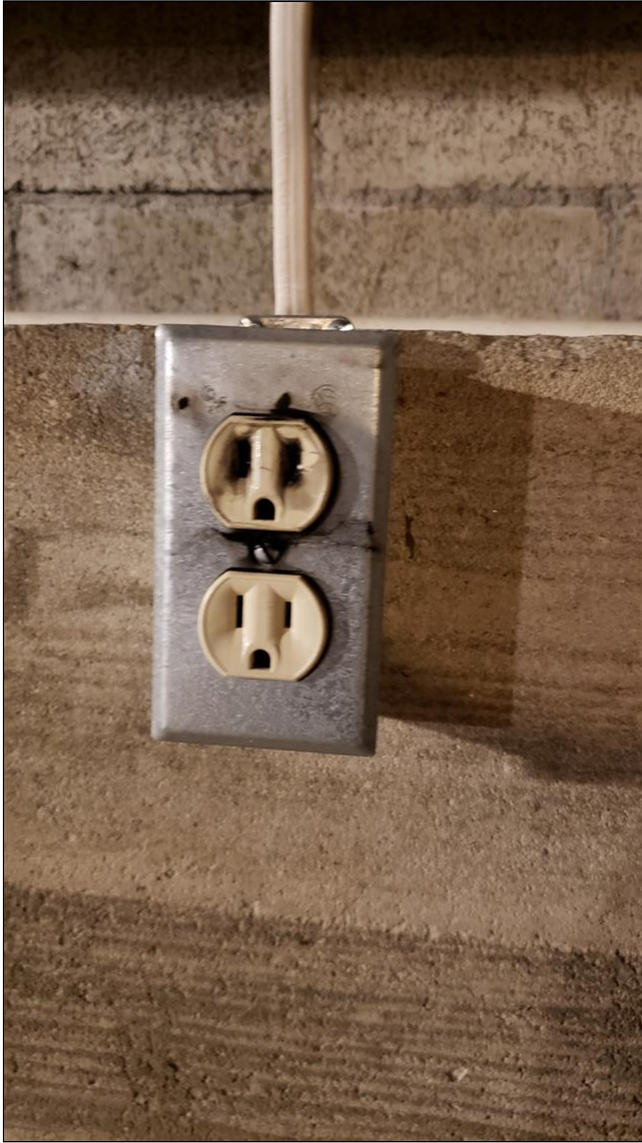
10.4 Item 1(Picture)

(2) One or more receptacles in the unfinished basement has scorch marks and is considered damaged This is a fire hazard. Recommend repairs by a competent, qualified, and licensed electrical contractor.

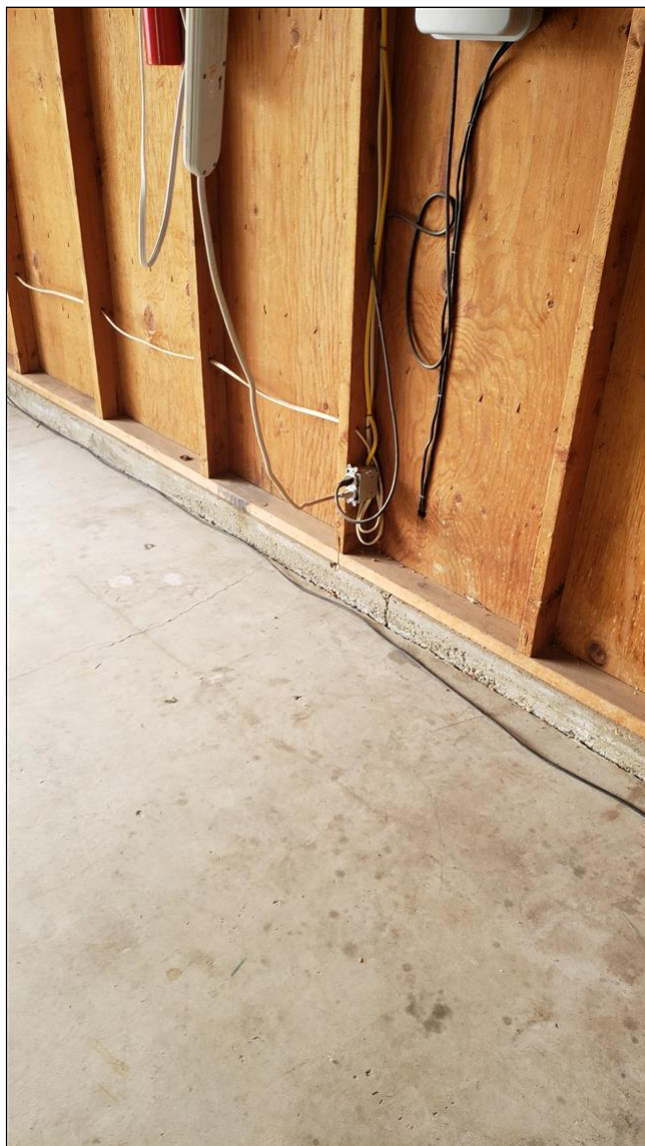
10.4 Item 2(Picture)

(3) Missing cover plates for electrical receptacles noted at garage. This is a shock hazard. Recommend installing appropriate covers on all uncovered receptacles and junctions boxes.

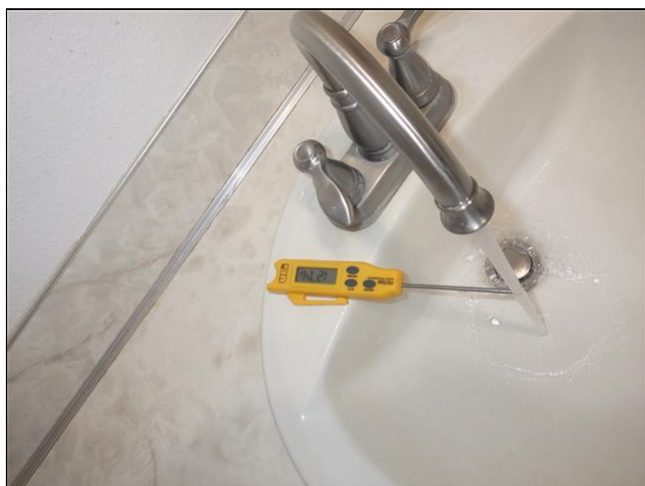
14.2 Item 1(Picture)

This water heater was generating water hotter (more than 130 degrees) than the generally accepted safe water temperature is 120 degrees Fahrenheit. This poses a scald or burn hazard, especially to the elderly and infants. Scald time for adults is approximately 30 seconds. Young children and the elderly scald faster. Recommend turning the water temperature down to the recommended level.

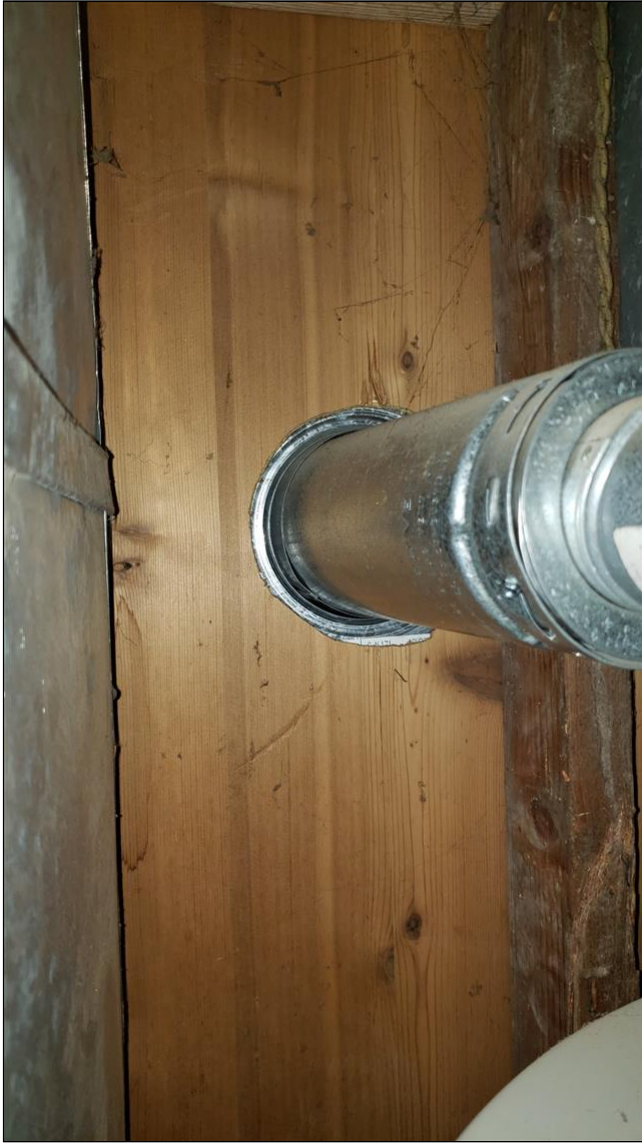
14.3 Item 1(Picture)

The gas-fired water heater exhaust flue had inadequate clearance from combustibles. This type of exhaust flue requires 1-inch clearance from combustible materials. This condition is a potential fire hazard and should be corrected by a qualified contractor.

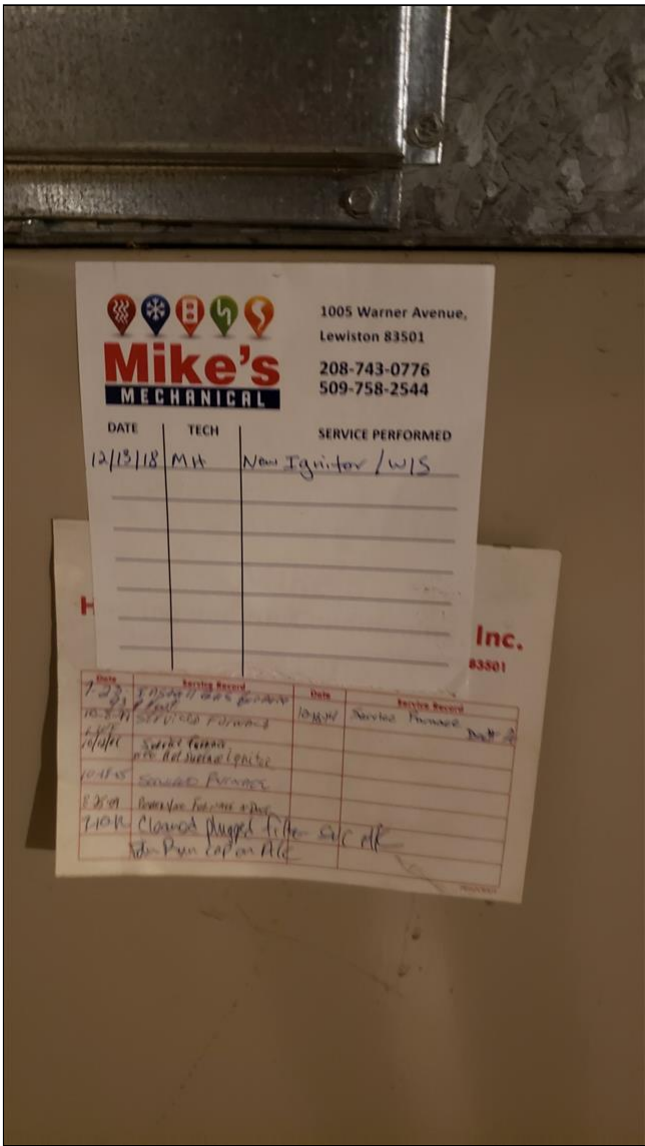
15.0 Item 5(Picture)

- (5) The furnace does not appear to have been recently serviced (no service sticker was observed/not current). Safe@Home recommends that furnace cleaning, service and certification be performed by a qualified contractor in accordance with manufacturer's instructions. If the current owner has had the unit serviced but the servicing company did not put on a sticker, he/she should have records and receipts that could be accepted in lieu of the new service.

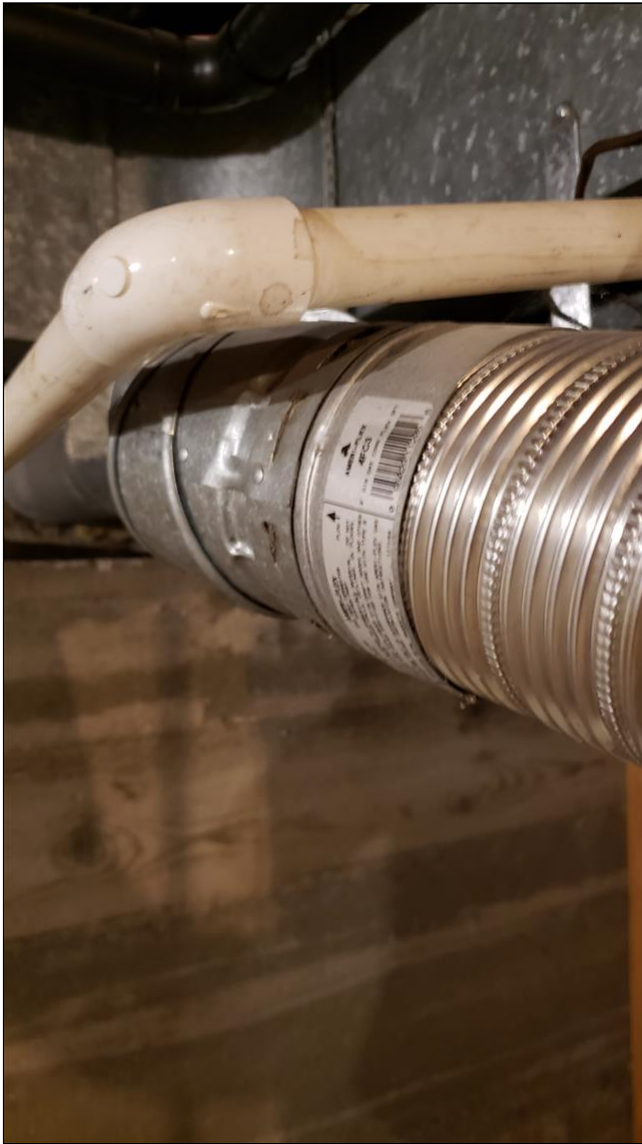
15.3 Item 2(Picture)

(3) The furnace exhaust flue pipe had improper clearance from combustibles materials. This type of vent requires 1-inch minimum clearance. This condition is a potential fire hazard. Recommend correction by a licensed and qualified HVAC contractor.

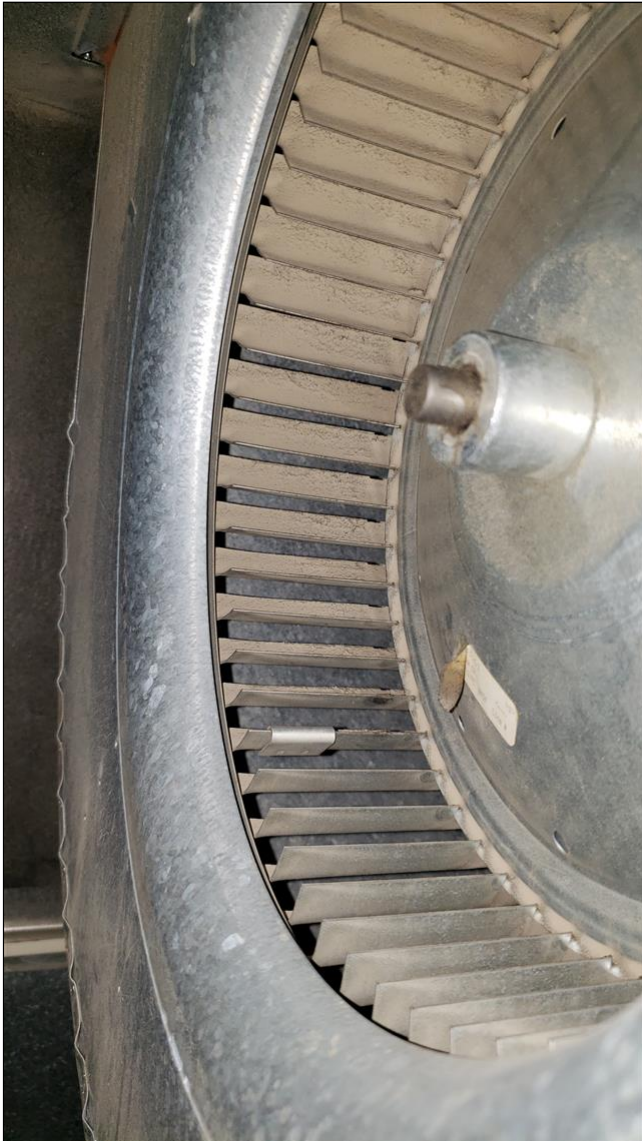
16.0 Item 1(Picture)

(1) The blower unit is dirty. Dirty blower components can lead to poor efficiency and potentially damage the blower system. Recommend maintenance by a licensed and qualified HVAC contractor.

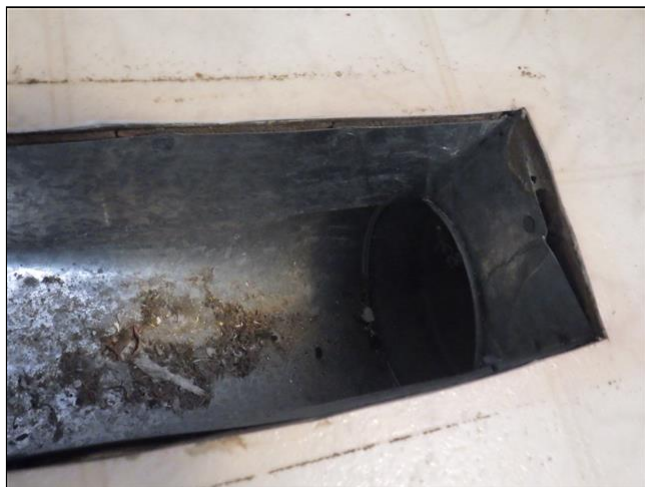
16.2 Item 1(Picture)

- (1) A source of heat was verified to be present in all the habitable spaces. It is outside the scope of inspection to determine whether each room is getting the proper amount of air flow. Those are considerations it take place when the system is designed for installation into the home.
- (2) Removal of room registers allowed observation of the ductwork leading into various rooms. The ductwork appears to need cleaning as evident by the level of materials visible. Recommend duct cleaning by a licensed and qualified specialist.

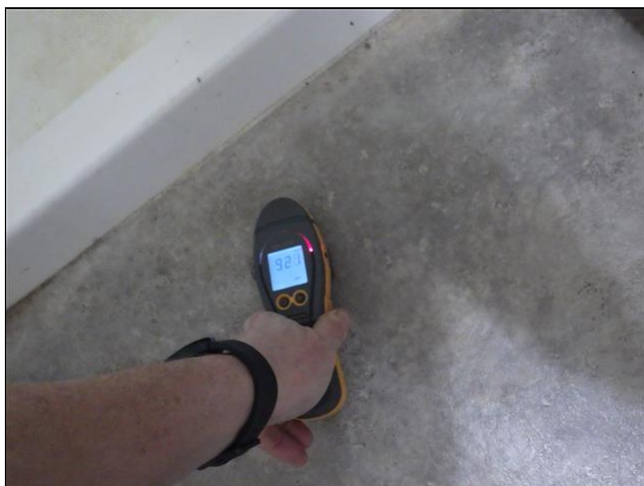
19.3 Item 1(Picture)

(2) The subflooring in the master bathroom was soft around the tub/shower indicating past or present damage due to water intrusion. Active water intrusion is present as measured with a moisture meter. Recommend repair of the sub-floor and shower enclosure by a competent and qualified contractor.
