# Inspection Report

## Harry Mills

1123 Linden Ave  
Lewiston ID 83501

## Safe@Home Inspections, LLC

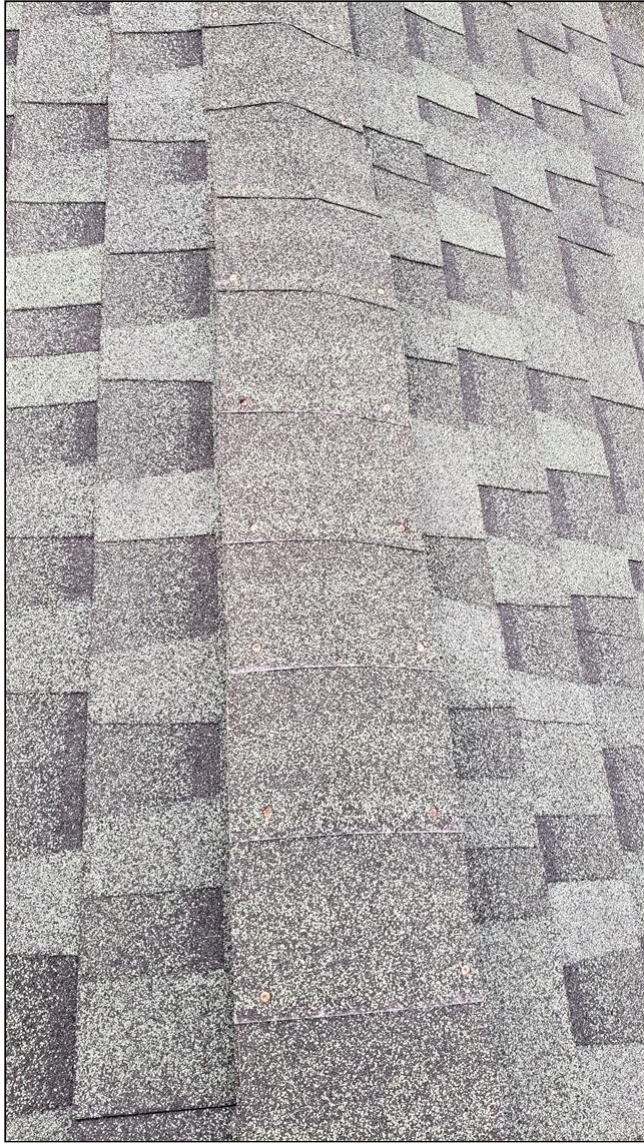
4.1 Item 3(Picture)

(5) Exposed nails present on the roof deck. These should be covered with caulk or roof sealant to prevent potential water intrusion to the rest of the home. Recommend correction of all such by a licensed and qualified roofing contractor.

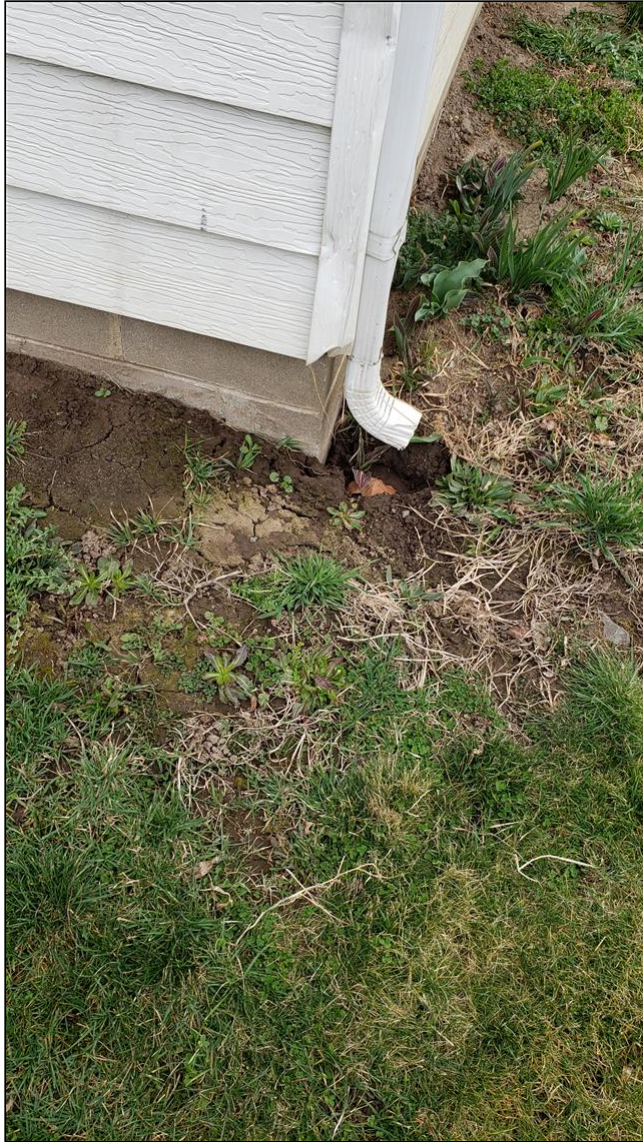
4.3 Item 1(Picture)

(2) The downspouts and extensions/splashblocks gutters are not directing water sufficiently far from the foundation. They should direct all roof water run-off at least ten feet from the foundation walls. Recommend correcting all the existing discharge points to accomplish this by adding properly aligned splash blocks, extensions, or similar means.

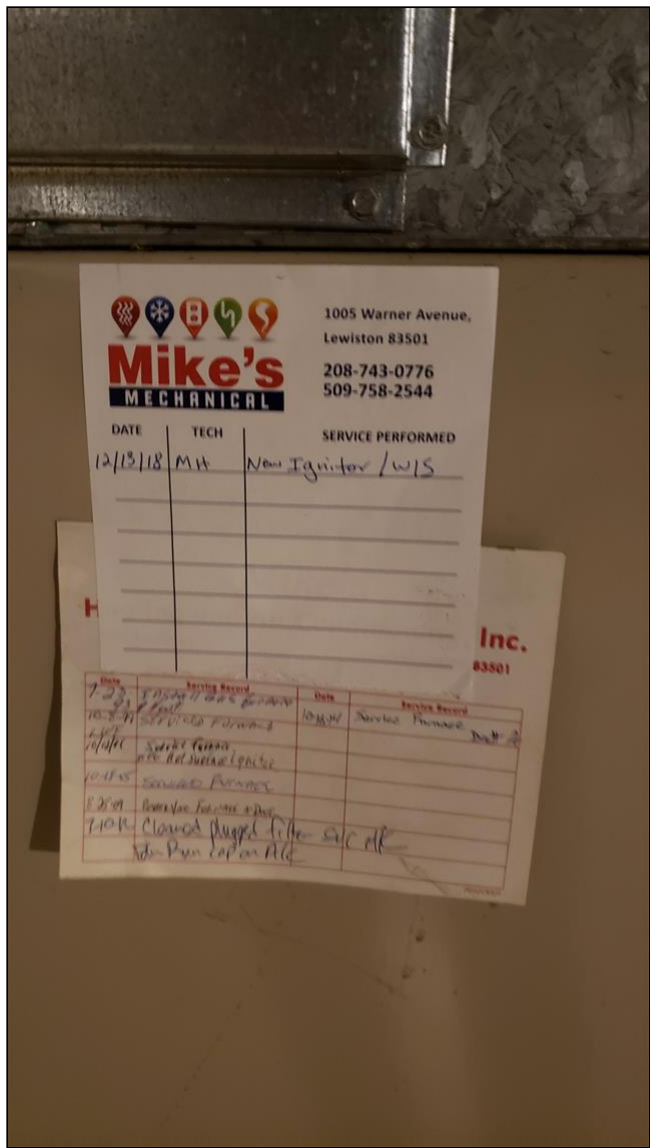
15.0 Item 5(Picture)

(5) The furnace does not appear to have been recently serviced (no service sticker was observed/not current). Safe@Home recommends that furnace cleaning, service and certification be performed by a qualified contractor in accordance with manufacturer's instructions. If the current owner has had the unit serviced but the servicing company did not put on a sticker, he/she should have records and receipts that could be accepted in lieu of the new service.

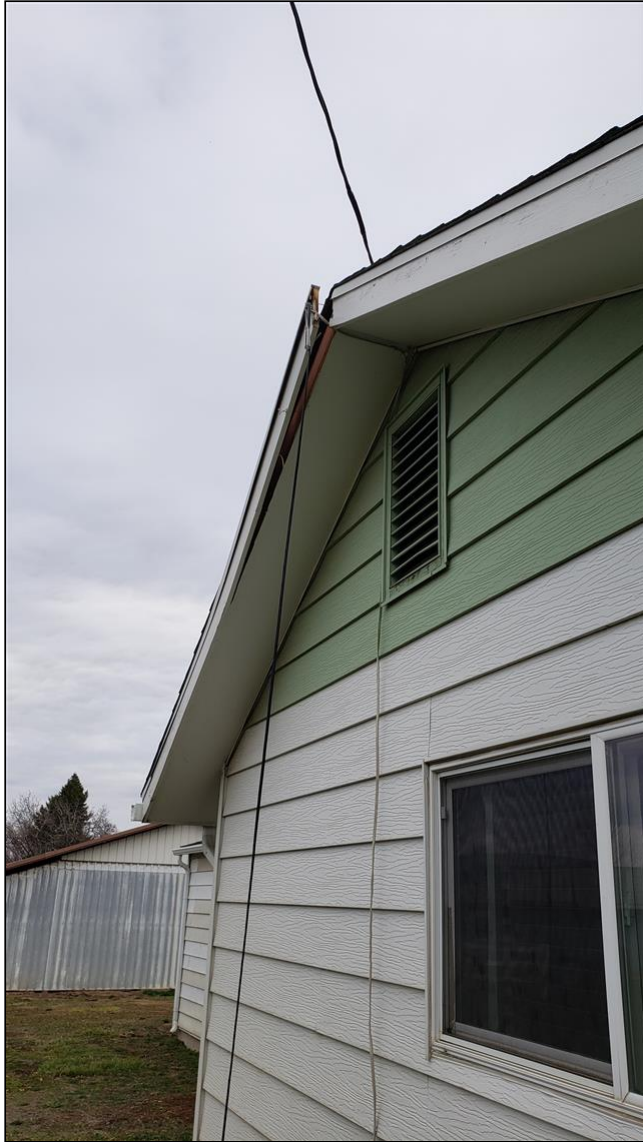
2.4 Item 1(Picture)

(1) The fascia board on the westside gable has detached from the home. This allows for water entry into structural components, has pulled the flashing free of the roof, and is a hazard to fall. Recommend reattachment by a licensed and qualified contractor.

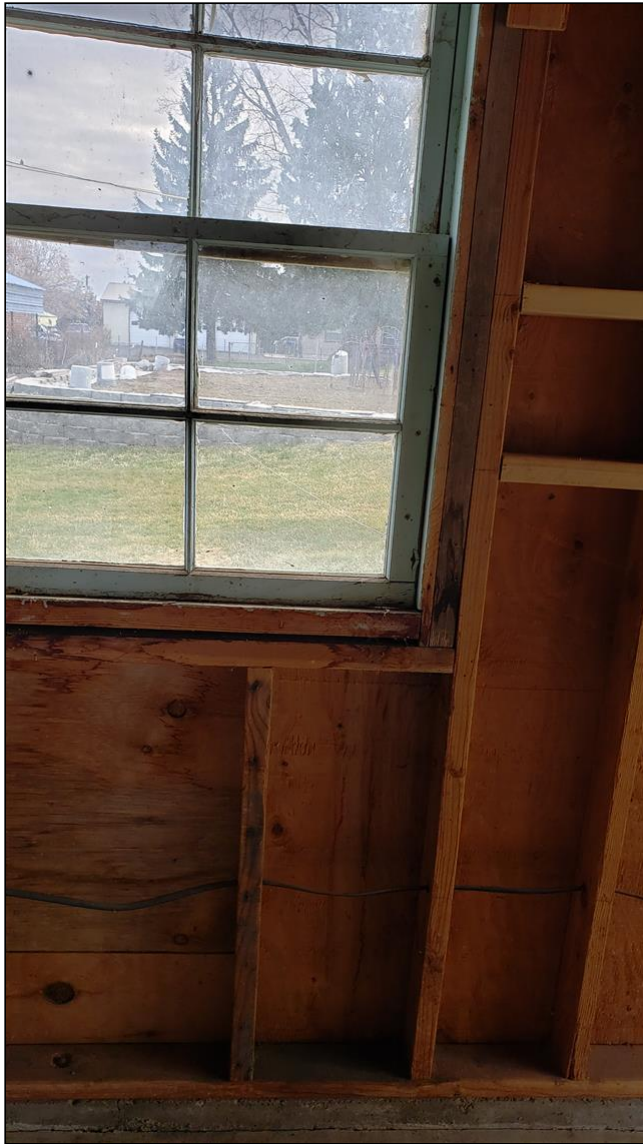
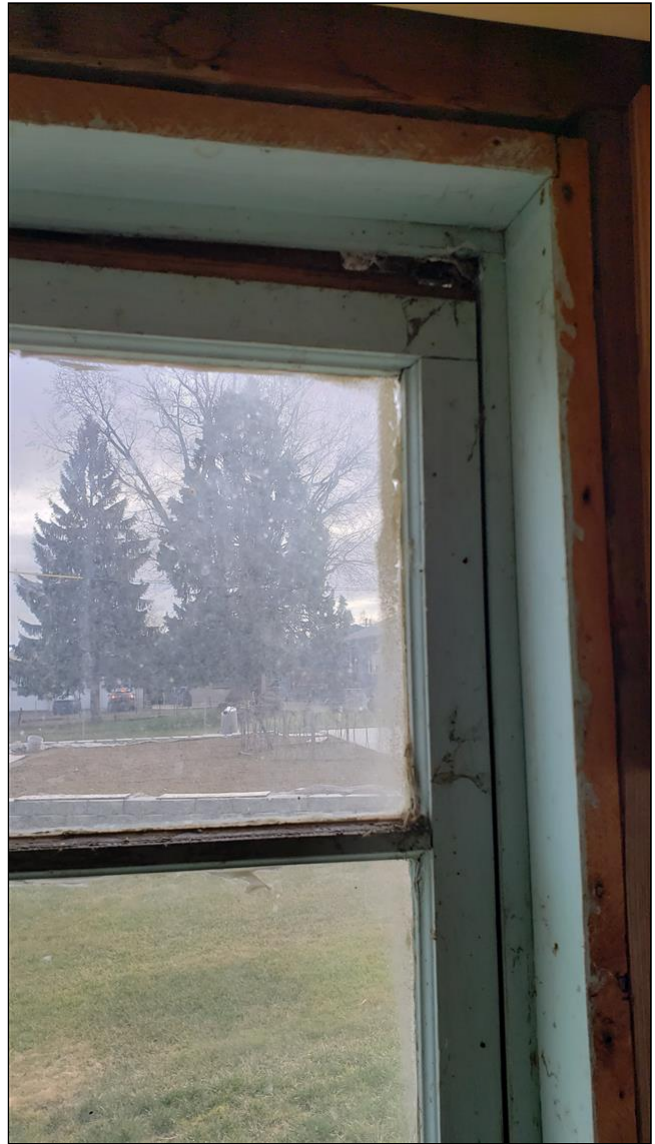
(1) One or more windows in the garage has one or more broken panes of glass and a damaged frame Recommend repair by a qualified and competent handyman/homeowner/window contractor.

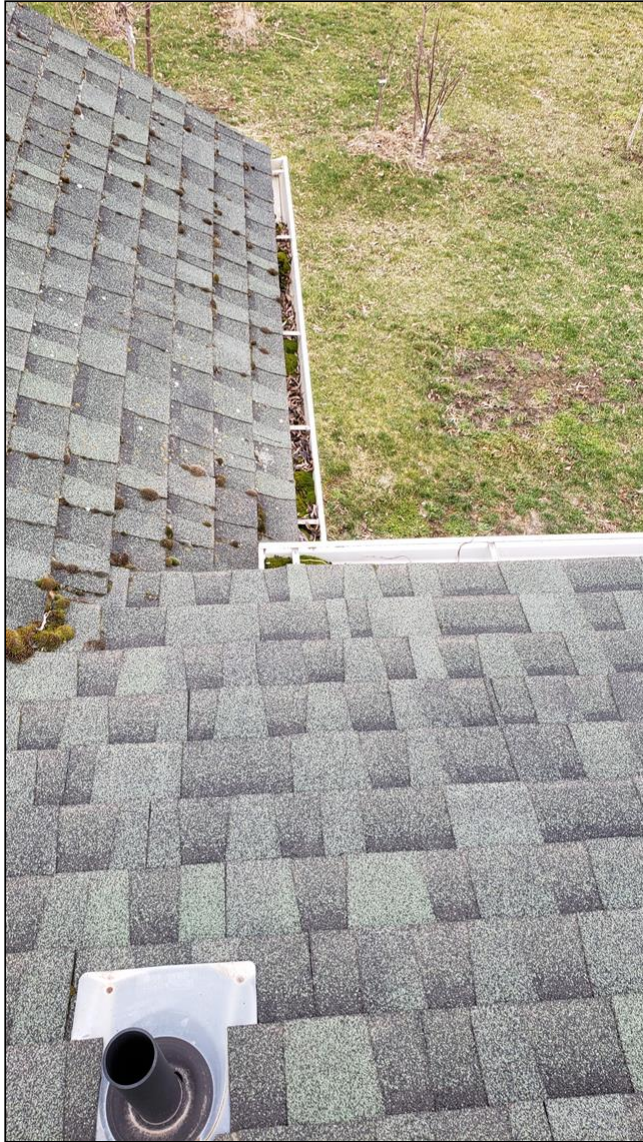
4.3 Item 2(Picture)

(4) The rear gutters are full of debris in areas and needs to be cleaned. The debris in gutters can also conceal rust, deterioration or leaks that are not visible until cleaned, and I am unable to determine if such conditions exist.

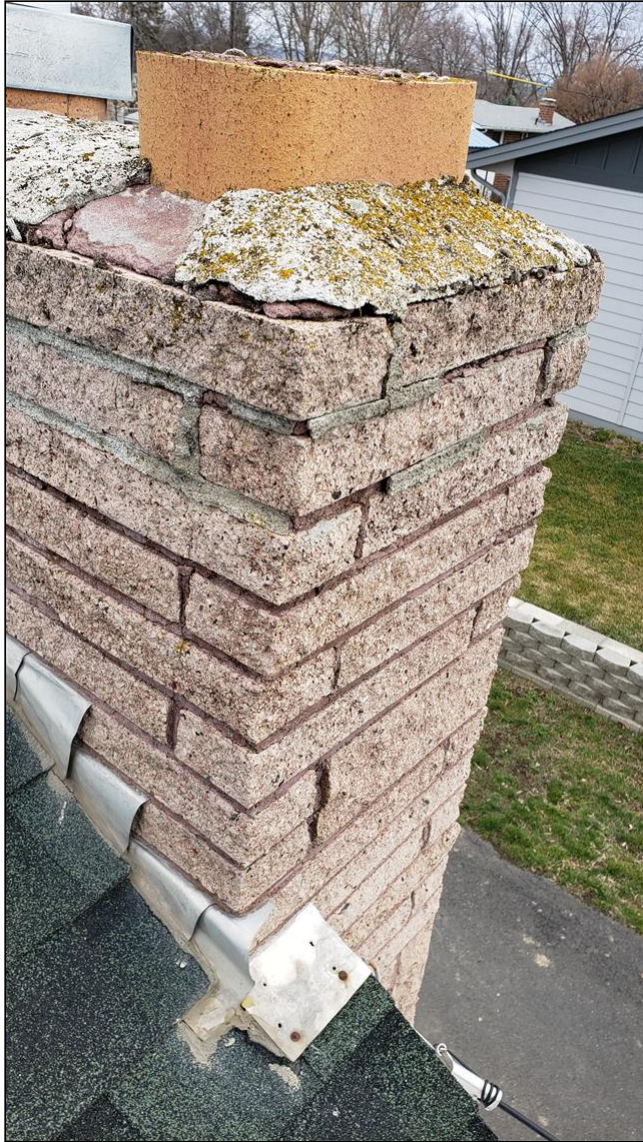
4.5 Item 1(Picture)

(1) The chimney had extensive deterioration at the mortar joints of the chimney and/or significant spalling of the brick/block. This will tend to make the chimney unstable over time. Recommend repair by a licensed and qualified masonry or fireplace contractor.

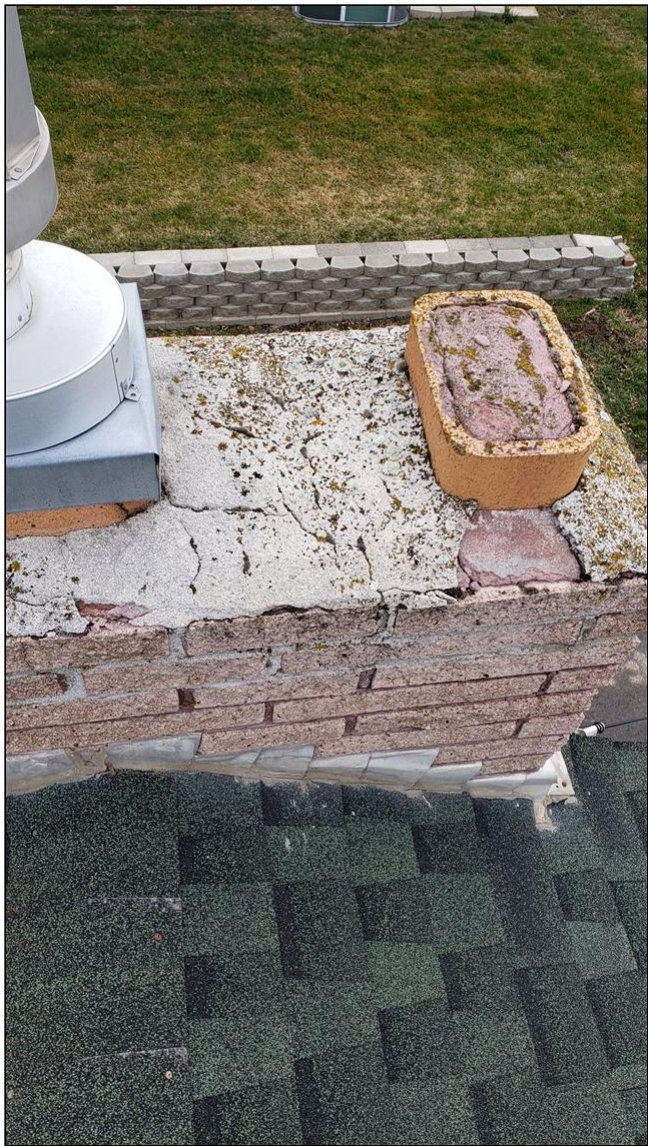
4.5 Item 3(Picture)

(2) The chimney cap had moderate to severe deterioration which should be repaired to avoid moisture intrusion of the chimney structure. Recommend repairs by a licensed and qualified contractor with experience performing work on chimneys.

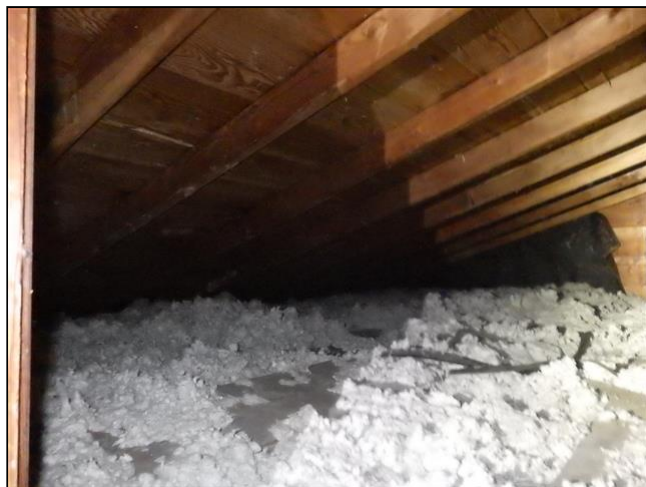
5.2 Item 3(Picture)

(2) Sagging visible in the roof rafters appeared to be caused by inadequate framing design of the roof structure typical of homes built in this area, during this time period, of this quality. Consider consulting with a qualified contractor to discuss options and costs for stabilization or correction.

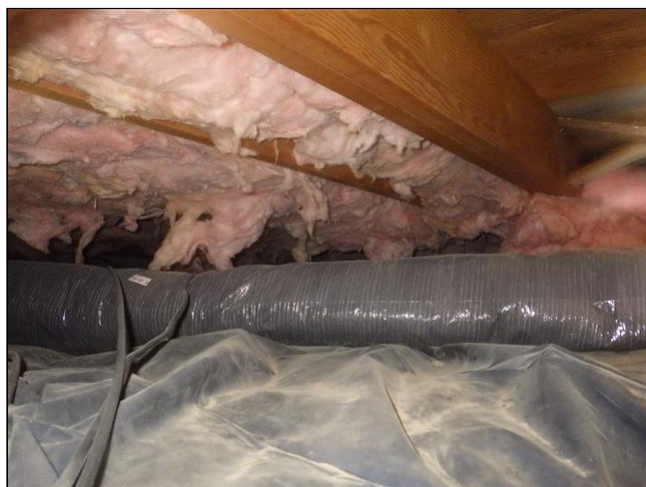
6.3 Item 1(Picture)

(4) The ductwork and plumbing prevented full access to approximately 30 percent of the crawlspace. The customer is advised that hidden conditions may be present. A second access should be created or a portion of the existing space should be dug out to allow for entry and inspection.

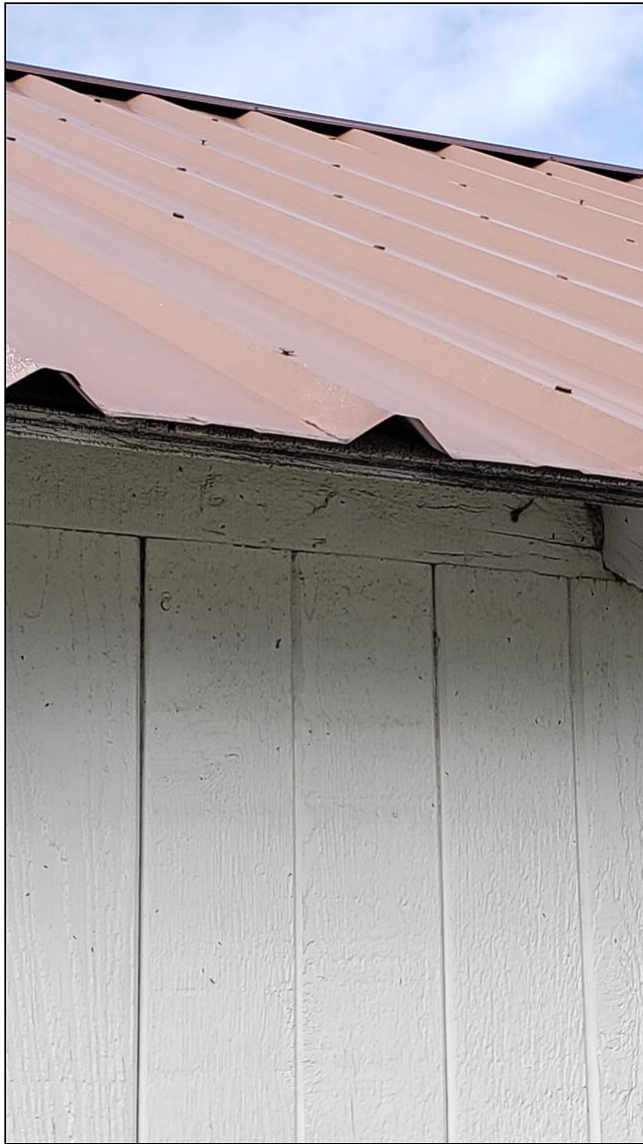
7.1 Item 1(Picture)

(2) Loose, protruding or missing fasteners visible at the time of the inspection. This condition should be corrected to avoid wind damage and/or damage from moisture intrusion. Recommend repair by a licensed and qualified roofing contractor.

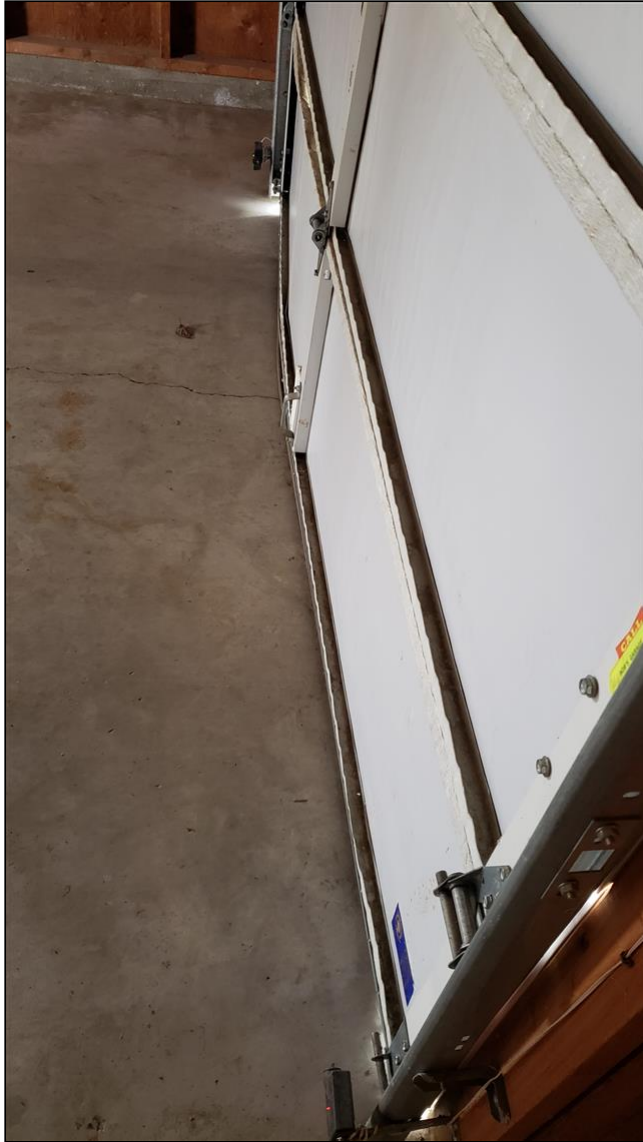
7.5 Item 1(Picture)

A garage vehicle door panel had severe damage visible which will require repair or replacement. Recommend consulting a garage door contractor to gain an idea of options and costs necessary to correct this condition.

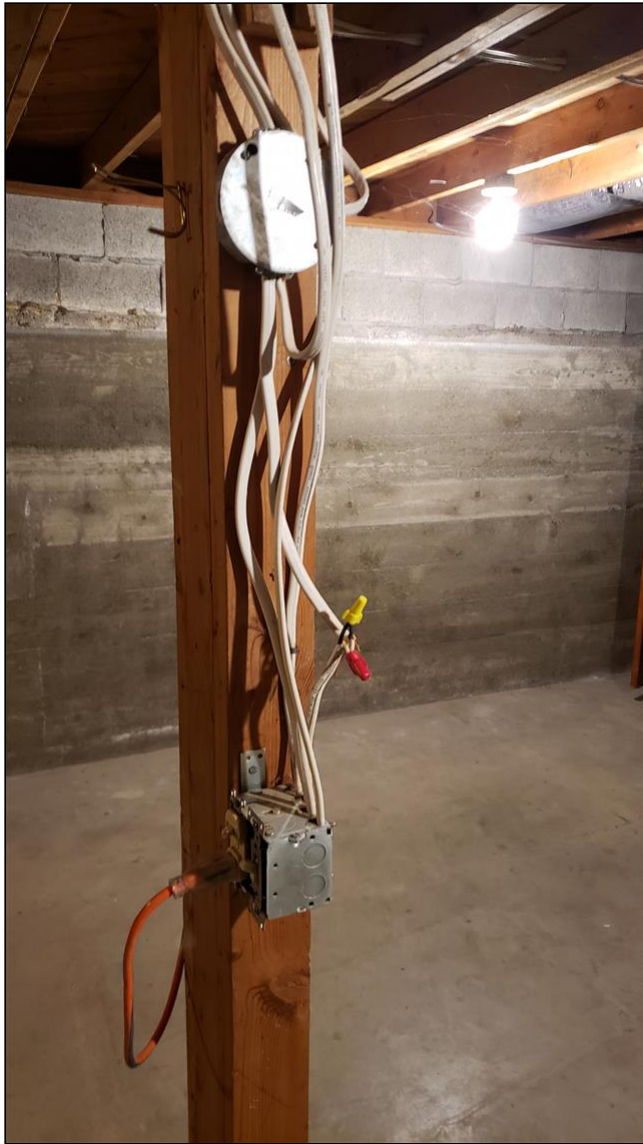
10.1 Item 1(Picture)

(2) The wiring in the basement appears to have been installed by a person unfamiliar with good electrical practices. Wiring is exposed to damage and the junction boxes are missing bushings. Recommend evaluation by a licensed and qualified electrical contractor.

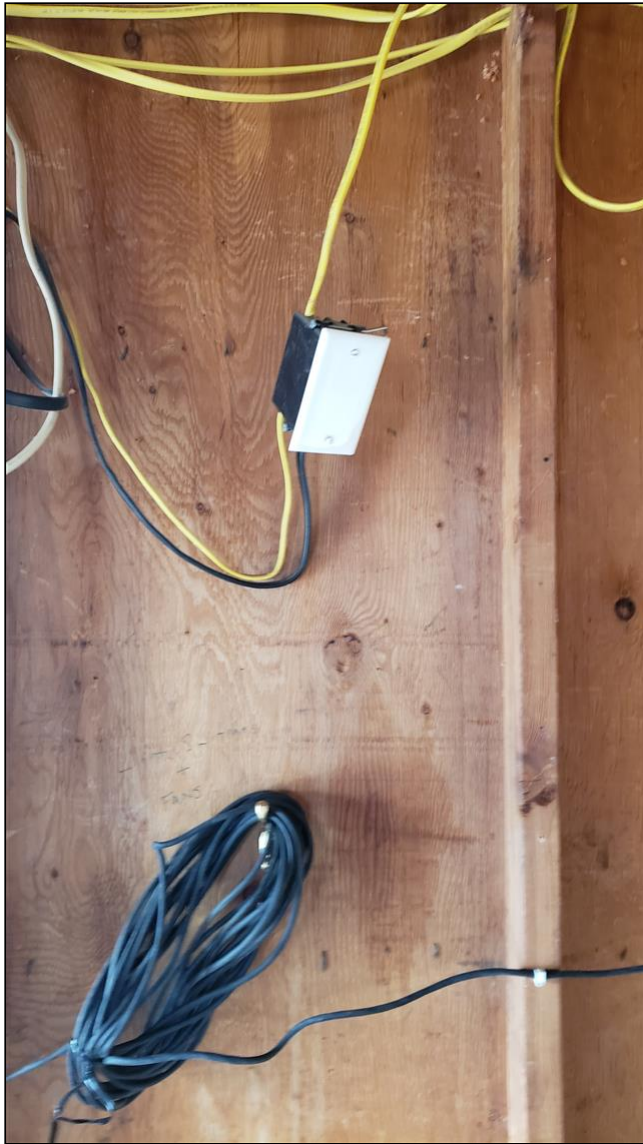
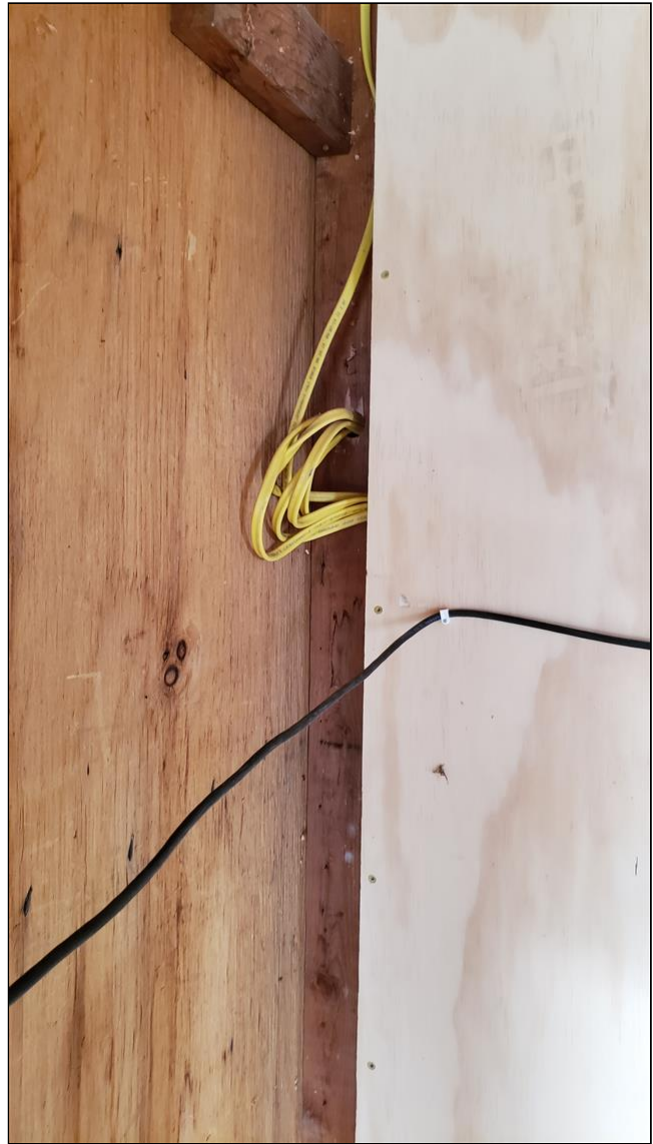
(5) Some of the wiring in the garage appears to have been installed by a person unfamiliar with good electrical practices. Wiring is exposed to damage and the junction boxes are missing bushings. Recommend evaluation by a licensed and qualified electrical contractor.

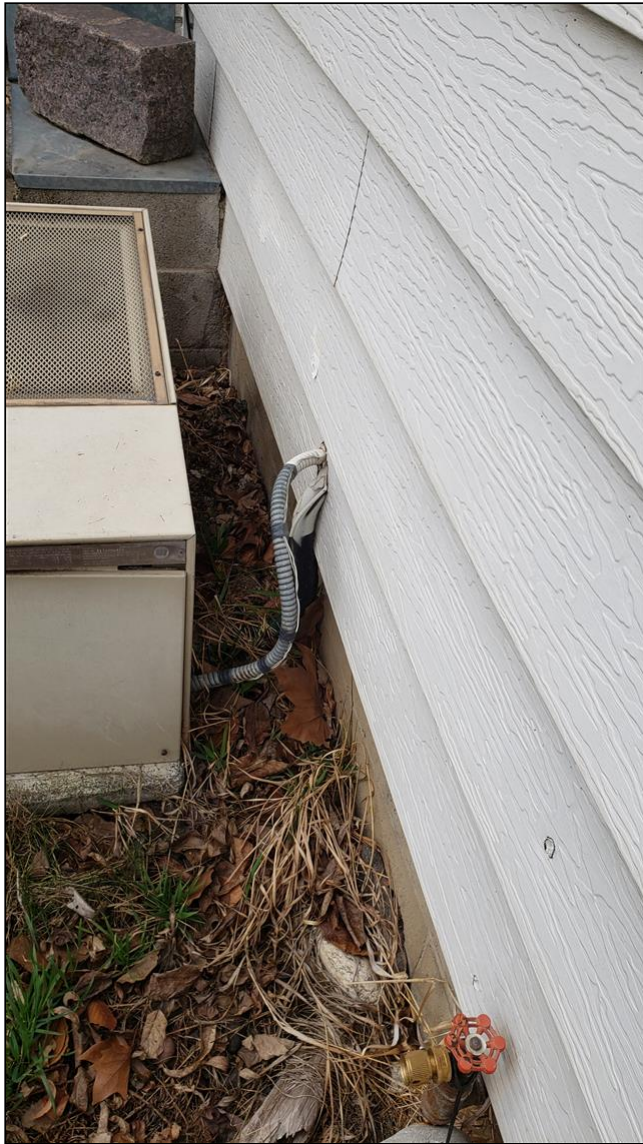
10.2 Item 1(Picture)

(2) The electrical service for the air conditioner is protected by conduit that is not weather tight. This can allow water into the service and cause damage to the wiring or create a shock hazard. Recommend repair by a licensed and qualified contractor.

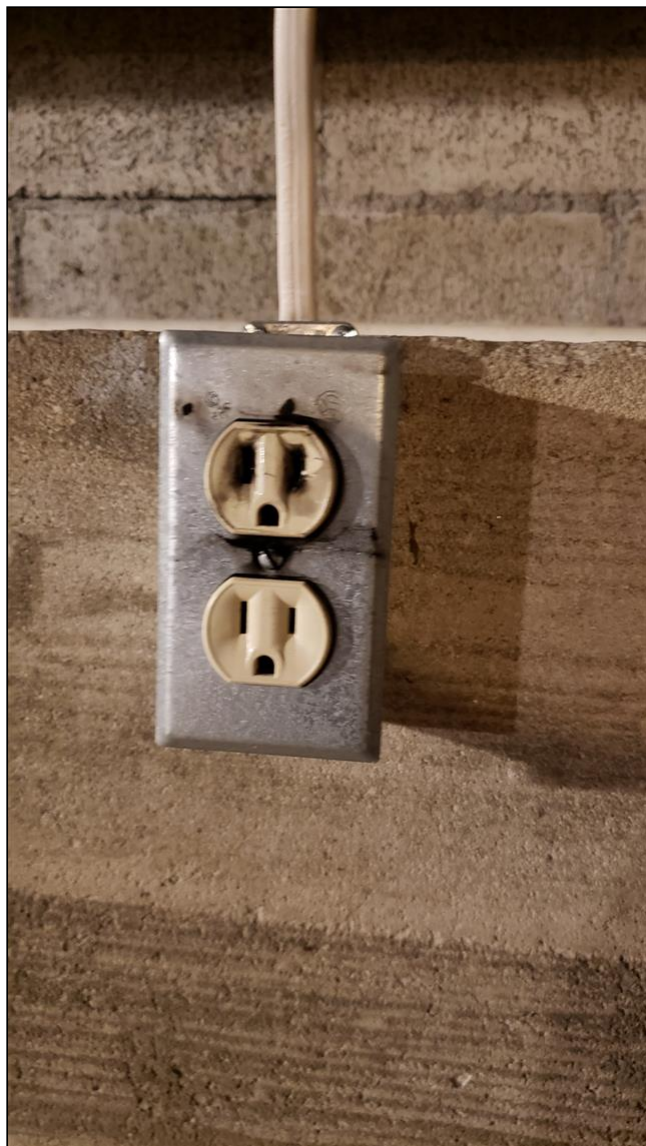
10.4 Item 1(Picture)

(2) One or more receptacles in the unfinished basement has scorch marks and is considered damaged This is a fire hazard. Recommend repairs by a competent, qualified, and licensed electrical contractor.

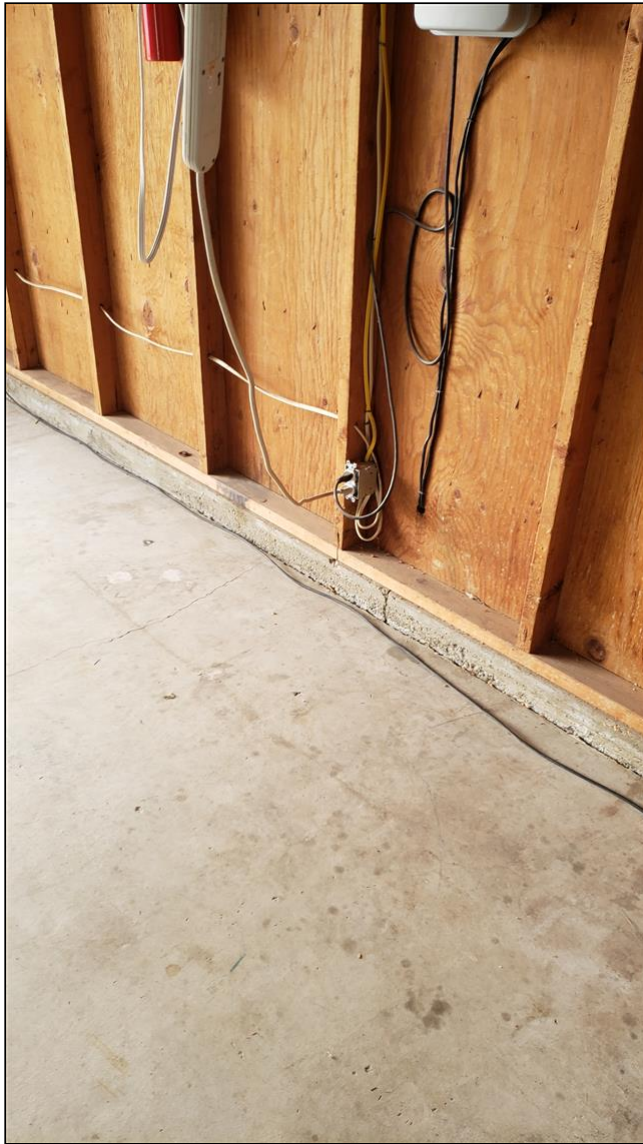
10.4 Item 2(Picture)

(3) Missing cover plates for electrical receptacles noted at garage. This is a shock hazard. Recommend installing appropriate covers on all uncovered receptacles and junctions boxes.

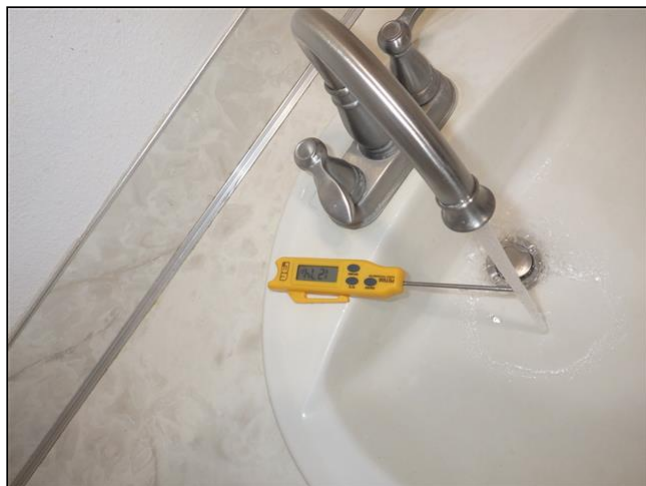
14.2 Item 1(Picture)

This water heater was generating water hotter (more than 130 degrees) than the generally accepted safe water temperature is 120 degrees Fahrenheit. This poses a scald or burn hazard, especially to the elderly and infants. Scald time for adults is approximately 30 seconds. Young children and the elderly scald faster. Recommend turning the water temperature down to the recommended level.

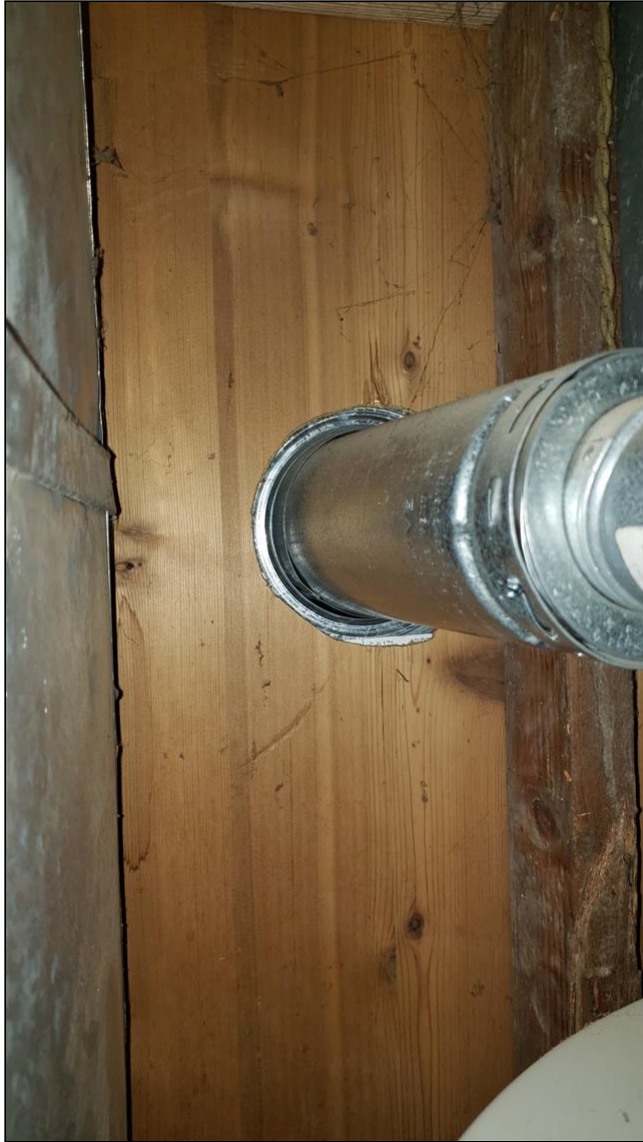
14.3 Item 1(Picture)

The gas-fired water heater exhaust flue had inadequate clearance from combustibles. This type of exhaust flue requires 1-inch clearance from combustible materials. This condition is a potential fire hazard and should be corrected by a qualified contractor.

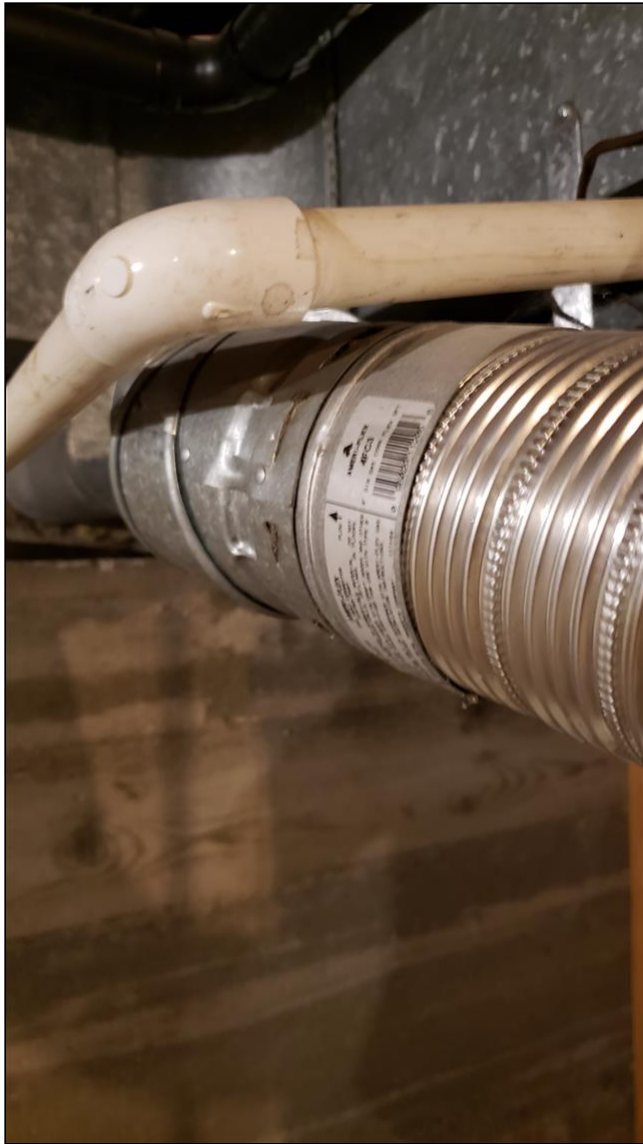
15.3 Item 2(Picture)

(3) The furnace exhaust flue pipe had improper clearance from combustibles materials. This type of vent requires 1-inch minimum clearance. This condition is a potential fire hazard. Recommend correction by a licensed and qualified HVAC contractor.

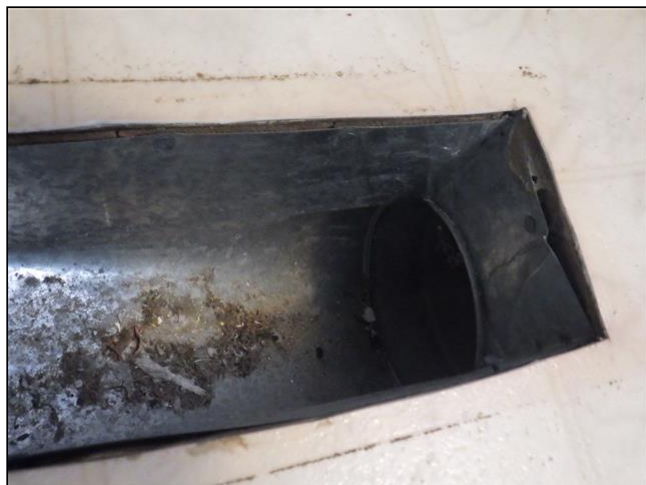
16.2 Item 1(Picture)

- (1) A source of heat was verified to be present in all the habitable spaces. It is outside the scope of inspection to determine whether each room is getting the proper amount of air flow. Those are considerations it take place when the system is designed for installation into the home.
- (2) Removal of room registers allowed observation of the ductwork leading into various rooms. The ductwork appears to need cleaning as evident by the level of materials visible. Recommend duct cleaning by a licensed and qualified specialist.
