## Inspection Report

**Property Address:**  
1123 Linden Avenue  
Lewiston ID 83501

| <b>Date:</b> 3/14/2022 | <b>Time:</b> 12:00 PM | <b>Report ID:</b><br>20220314-1123-Linden-Ave-OB |

| <b>Outbuilding Type:</b><br>SHOP, BARN | <b>Construction Type:</b><br>POLE BARN, STANDARD WOOD FRAMING ON | <b>Electricity:</b> |

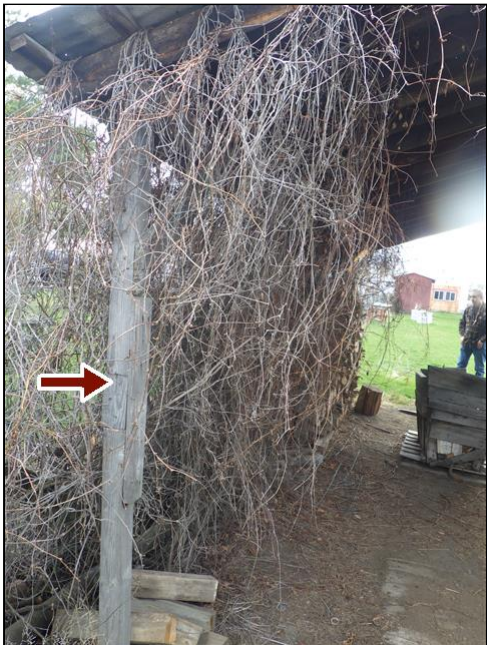
- 3.3 Item 1(Picture)
- 3.4 Foundation Anchorage (where accessible/visible)  
Comments: Not Present

- 3.0 Obstacles to Inspection  
Comments: Not Present
- 3.1 Foundation Walls and Footings (Where Visible)  
Comments: Not Present
- 3.2 Sub-structure Framing  
Comments: Not Present
- 3.3 Columns or Piers  
Comments: Inspected  
The columns for the lean-to portion of the barn are out of plumb and rotted. These need to be removed.

The columns for the lean-to portion of the barn are out of plumb and rotted. These need to be removed.

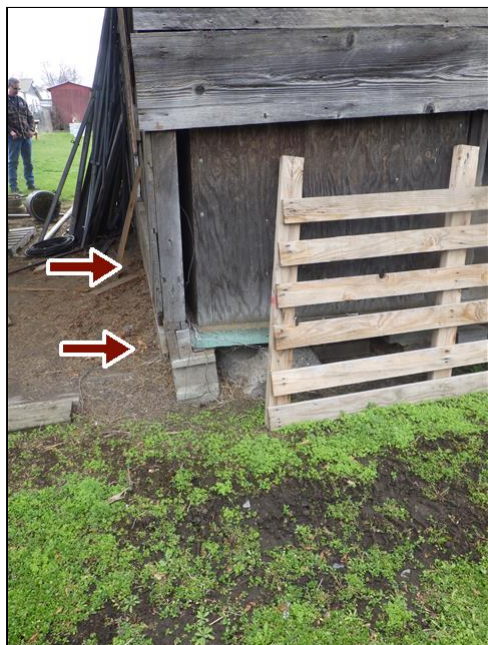
3.5 Item 1(Picture)

(1) The walls of the barn are rotted. Support for the lean-to roof does not meet safety standards. The rear wall is buckling at the base over the masonry unit that is there. This structure is unsound. Effort should be made to either upgrade it or remove it.

(1) The walls of the barn are rotted. Support for the lean-to roof does not meet safety standards. The rear wall is buckling at the base over the masonry unit that is there. This structure is unsound. Effort should be made to either

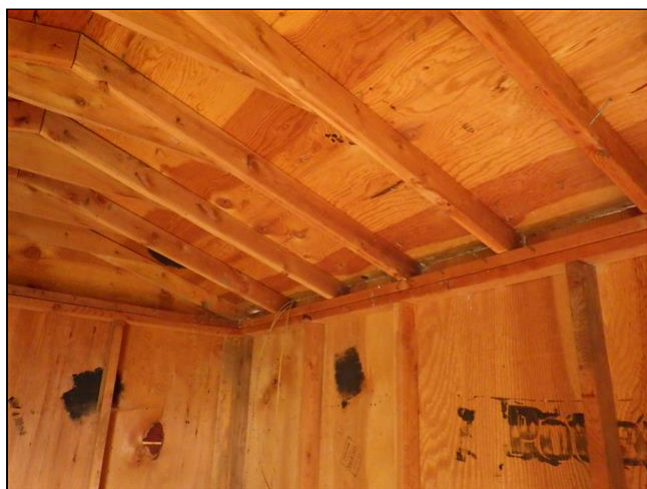
3.5 Item 3(Picture)

(2) Framing for the shed was better than average.

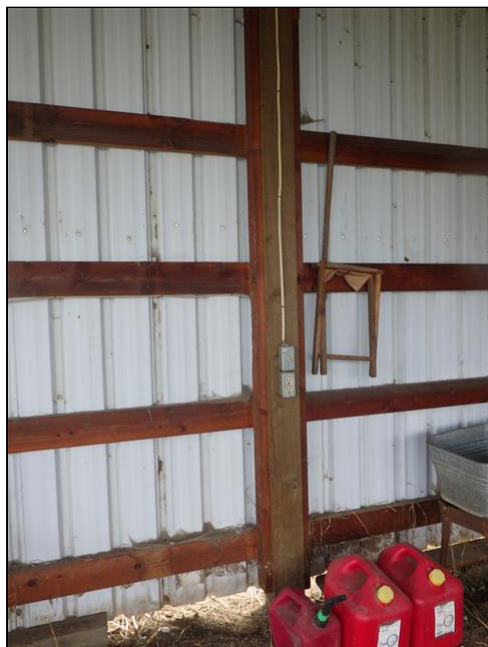
4.2 Item 1(Picture)

Electrical conductors not rated for exterior use were used for an exterior application at the outbuildings. This condition is a potential fire hazard. The SAFE@HOME recommends correction by a qualified electrical contractor.
