Inspection Report

Property Address:
1123 Linden Avenue
Lewiston ID 83501

Date: 3/14/2022	Time: 12:00 PM	Report ID: 20220314-1123-Linden-Ave-OB
Property: 1123 Linden Avenue Lewiston ID 83501	Customer: Harry Mills	Real Estate Professional: Tom Scher Windermere All-Star

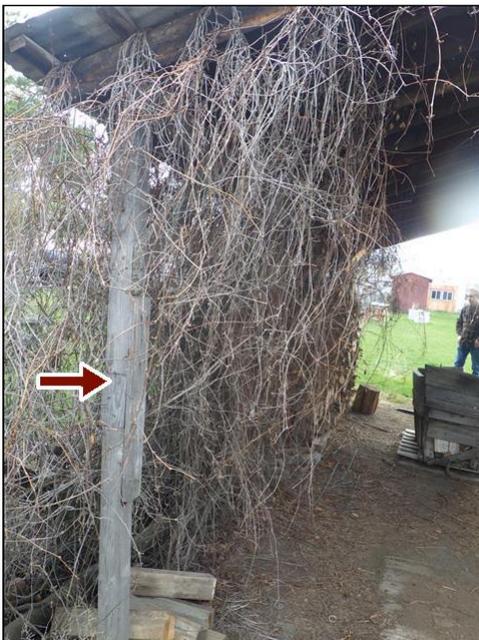
3.3 Item 1(Picture)

The columns for the lean-to portion of the barn are out of plumb and rotted. These need to be removed.

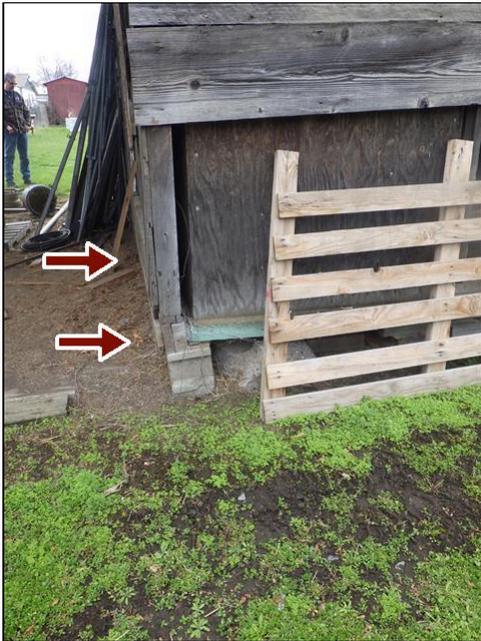
3.5 Item 1(Picture)

(1) The walls of the barn are rotted. Support for the lean-to roof does not meet safety standards. The rear wall is buckling at the base over the masonry unit that is there. This structure is unsound. Effort should be made to either upgrade it or remove it.

(1) The walls of the barn are rotted. Support for the lean-to roof does not meet safety standards. The rear wall is buckling at the base over the masonry unit that is there. This structure is unsound. Effort should be made to either

upgrade it or remove it.

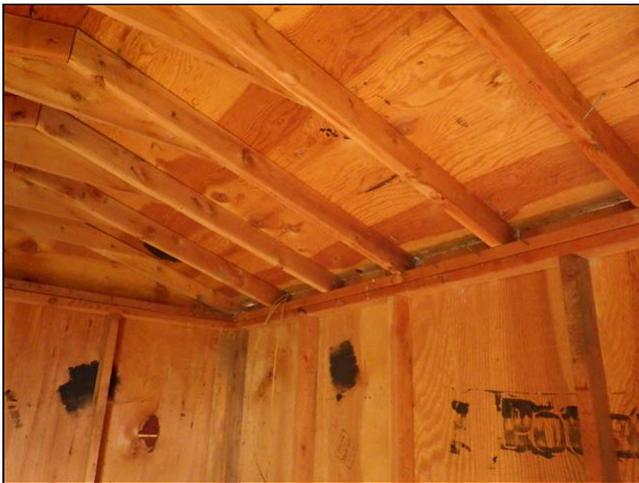
3.5 Item 3(Picture)

(2) Framing for the shed was better than average.

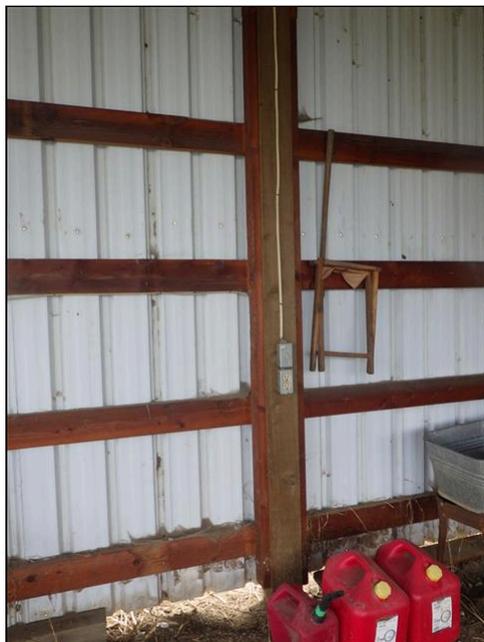
4.2 Item 1(Picture)

Electrical conductors not rated for exterior use were used for an exterior application at the outbuildings. This condition is a potential fire hazard. The SAFE@HOME recommends correction by a qualified electrical contractor.
