Inspection Report

Property Address:
1123 Linden Ave
Lewiston ID 83501

Safe@Home Inspections, LLC

Date: 3/14/2022	Time: 09:00 AM	Report ID: 20220314-1123-Linden-Ave
Property: 1123 Linden Ave Lewiston ID 83501	Customer: Harry Mills	Real Estate Professional: Tom Scher Windermere All-Star

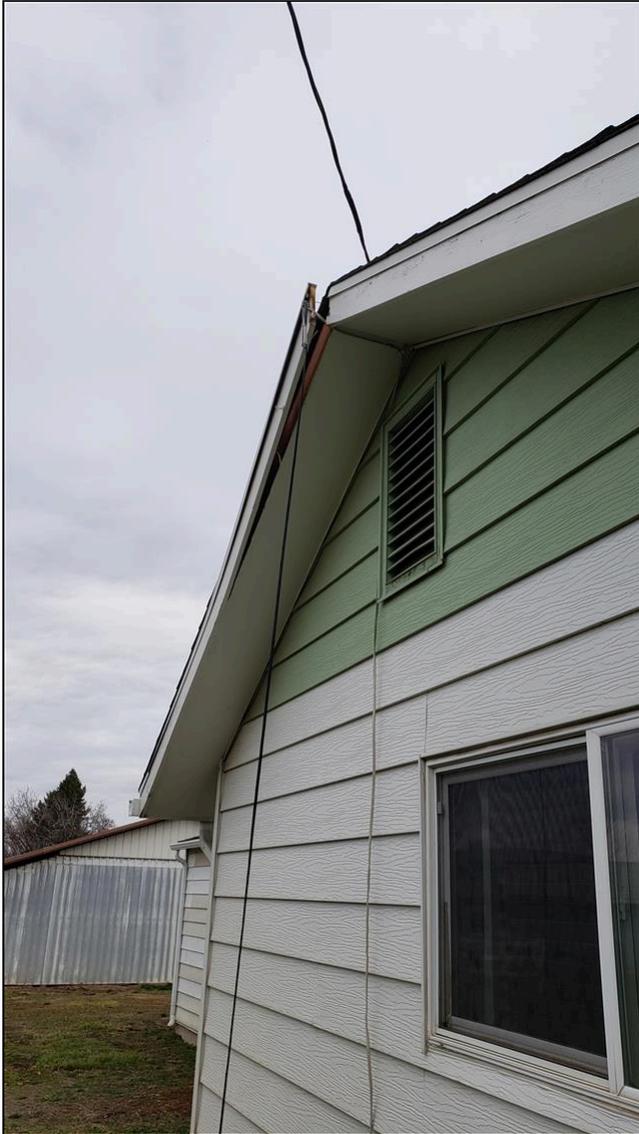
2.4 Item 1(Picture)

(1) The fascia board on the westside gable has detached from the home. This allows for water entry into structural components, has pulled the flashing free of the roof, and is a hazard to fall. Recommend reattachment by a licensed and qualified contractor.

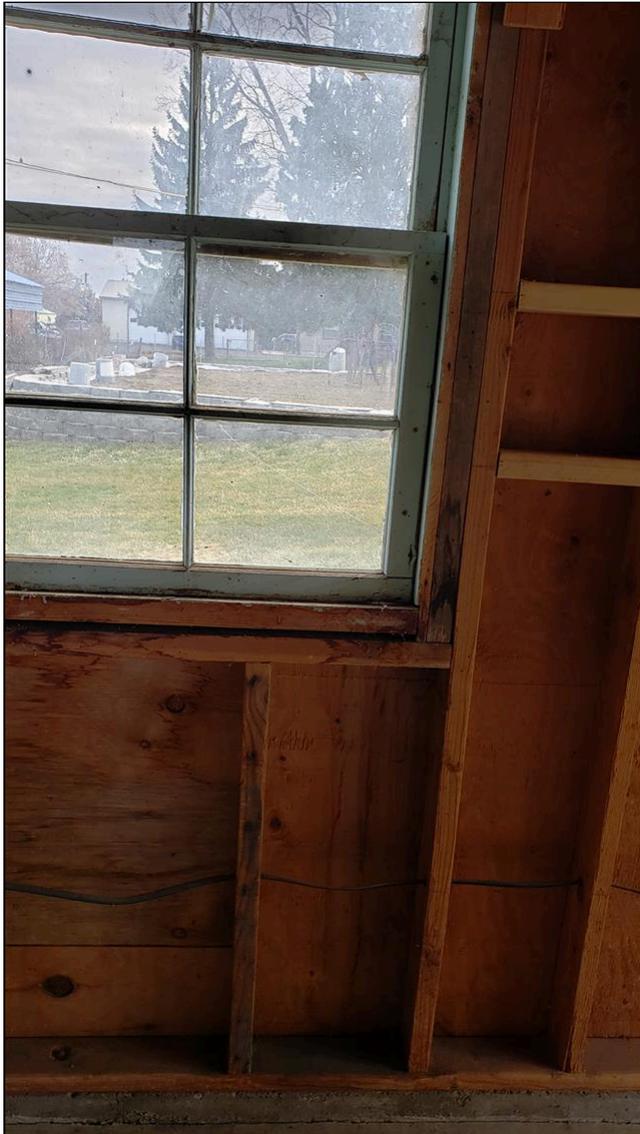
3.2 Item 1(Picture)

(1) One or more windows in the garage has one or more broken panes of glass and a damaged frame Recommend repair by a qualified and competent handyman/homeowner/window contractor.

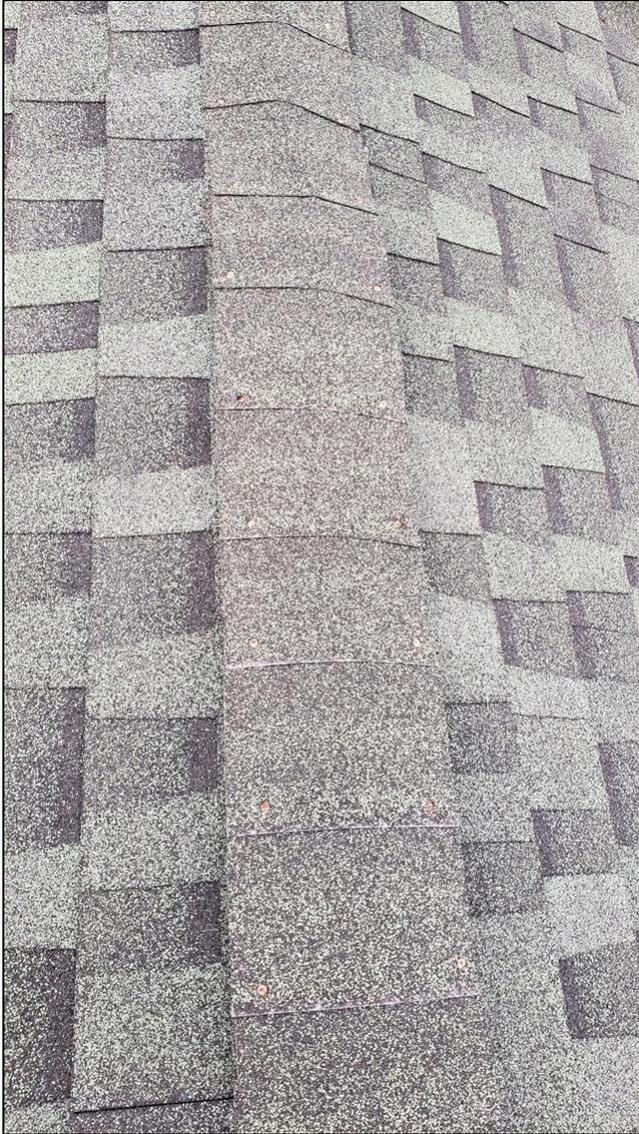
4.1 Item 3(Picture)

(5) Exposed nails present on the roof deck. These should be covered with caulk or roof sealant to prevent potential water intrusion to the rest of the home. Recommend correction of all such by a licensed and qualified roofing contractor.

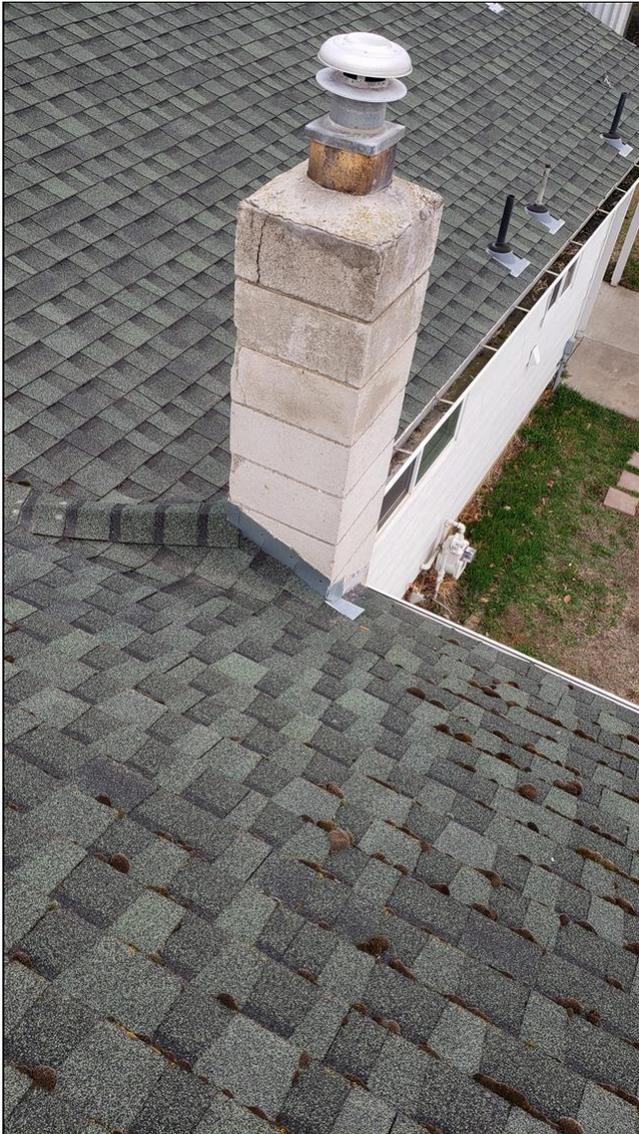
4.2 Item 1(Picture)

- (1) The plumbing, ventilation, and combustion flashings appeared in serviceable condition.
- (2) Chimney counter flashing is missing, poorly installed or damaged: Counter flashing is integral to the flashing system and leak prevention. Recommend further evaluation and repair. Be aware that with used or older structures that hidden conditions may exist.

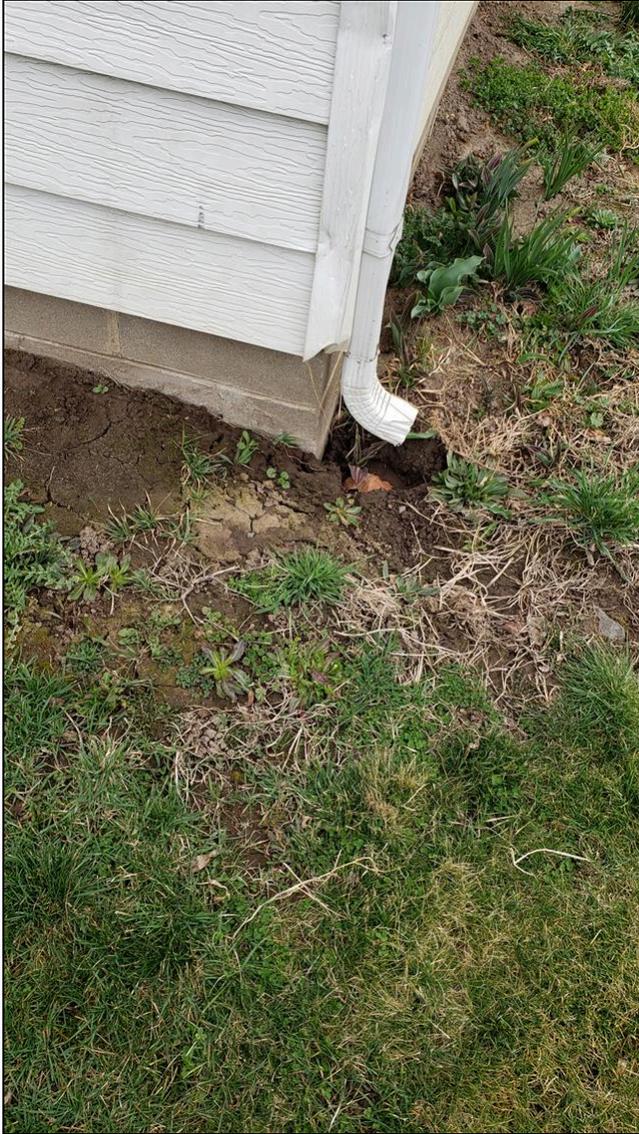
4.3 Item 1(Picture)

- (1) The roof drainage system consisted of conventional gutters hung from the roof edges feeding downspouts.
- (2) The downspouts and extensions/splashblocks gutters are not directing water sufficiently far from the foundation. They should direct all roof water run-off at least ten feet from the foundation walls. Recommend correcting all the existing discharge points to accomplish this by adding properly aligned splash blocks, extensions, or similar means.

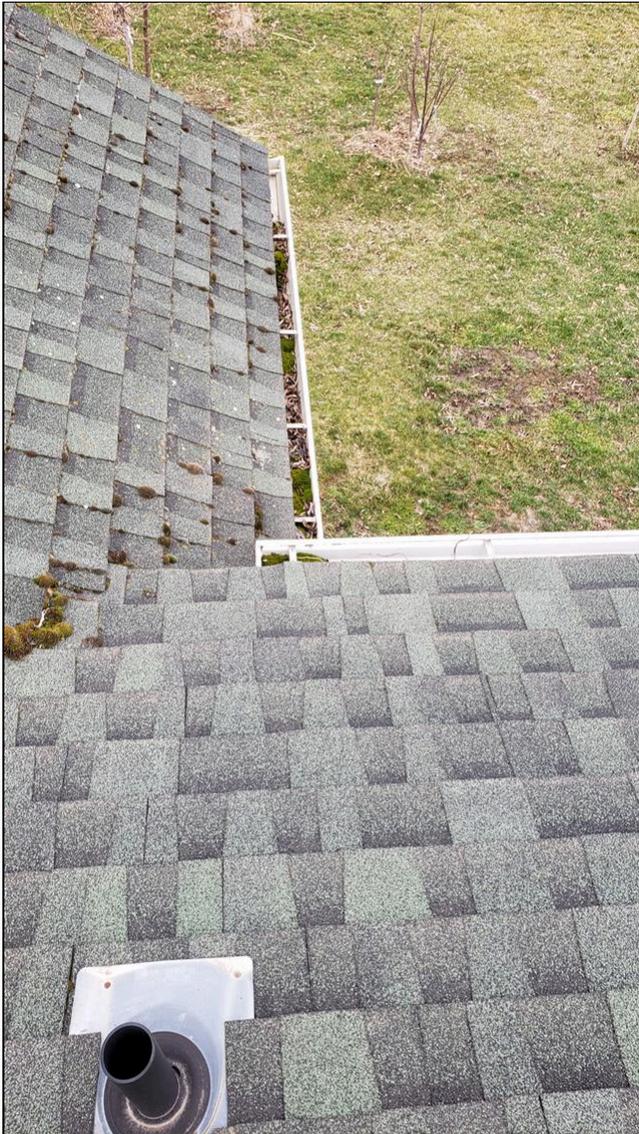
4.3 Item 2(Picture)

(4) The rear gutters are full of debris in areas and needs to be cleaned. The debris in gutters can also conceal rust, deterioration or leaks that are not visible until cleaned, and I am unable to determine if such conditions exist.

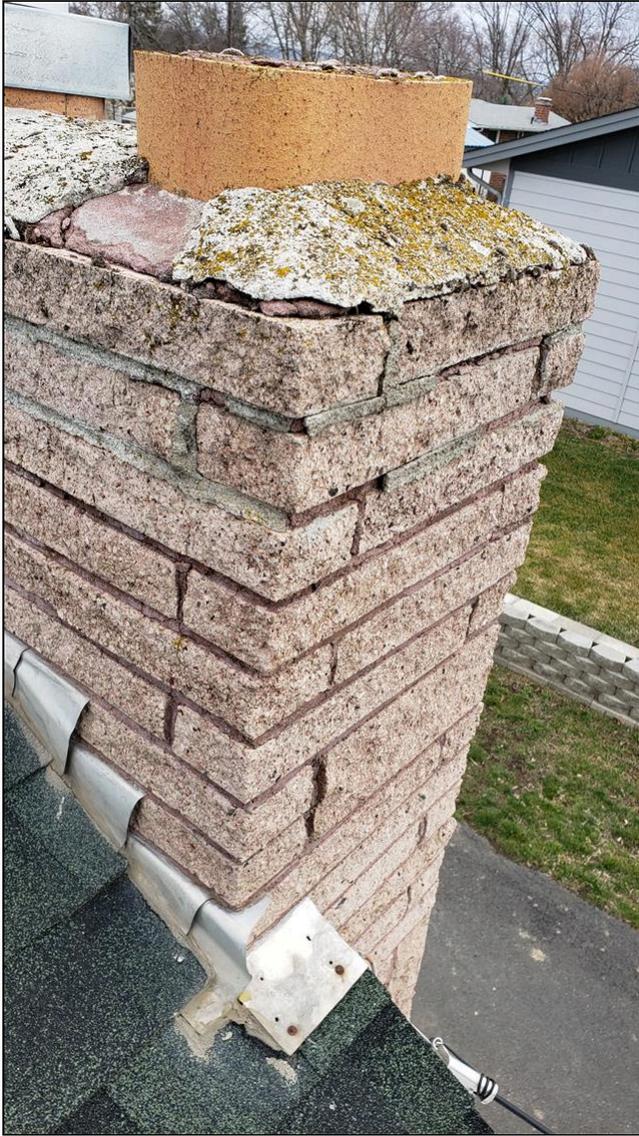
4.5 Item 1(Picture)

(1) The chimney had extensive deterioration at the mortar joints of the chimney and/or significant spalling of the brick/ block. This will tend to make the chimney unstable over time. Recommend repair by a licensed and qualified masonry or fireplace contractor.

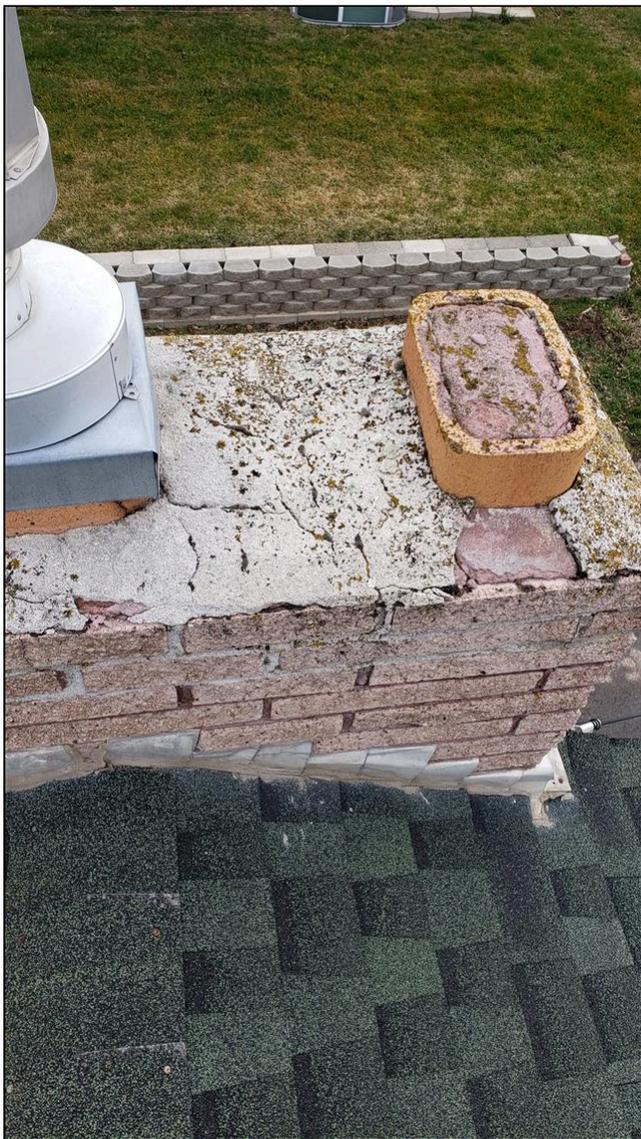
4.5 Item 3(Picture)

(2) The chimney cap had moderate to severe deterioration which should be repaired to avoid moisture intrusion of the chimney structure. Recommend repairs by a licensed and qualified contractor with experience performing work on chimneys.

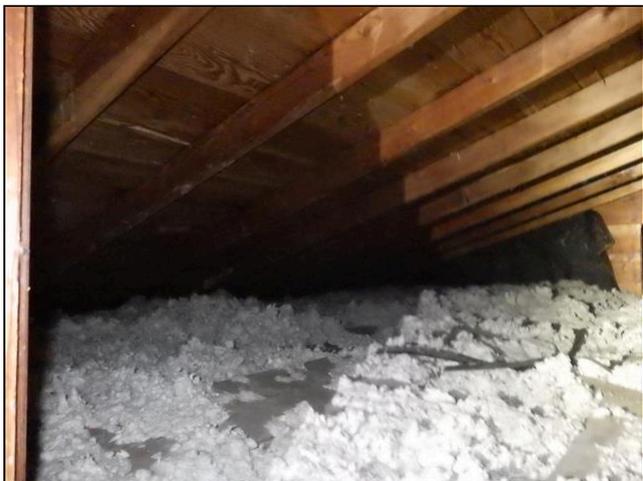
5.2 Item 3(Picture)

(2) Sagging visible in the roof rafters appeared to be caused by inadequate framing design of the roof structure typical of homes built in this area, during this time period, of this quality. Consider consulting with a qualified contractor to discuss options and costs for stabilization or correction.

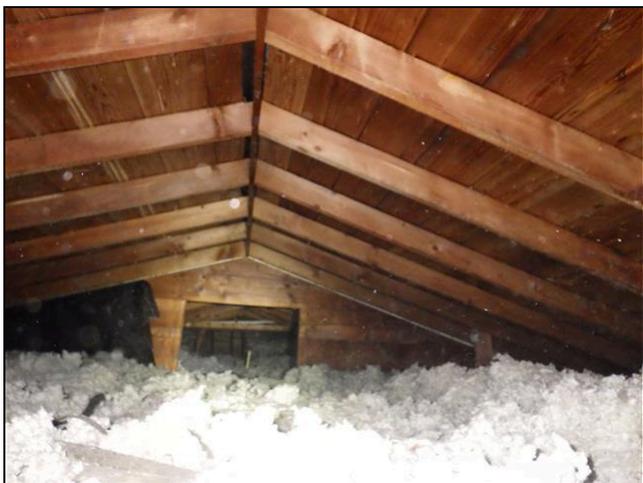
5.4 Item 1(Picture)

There were indications of previous leaks in the attic as evident by water marks on framing members and/or staining on the insulation. This is not unusual in older houses. These appeared dry at the time of inspection. However, even apparently dry areas can re-start under the right wind and rain conditions and there is no way to determine outside of those conditions. I recommend periodically checking the attic space during severe weather.

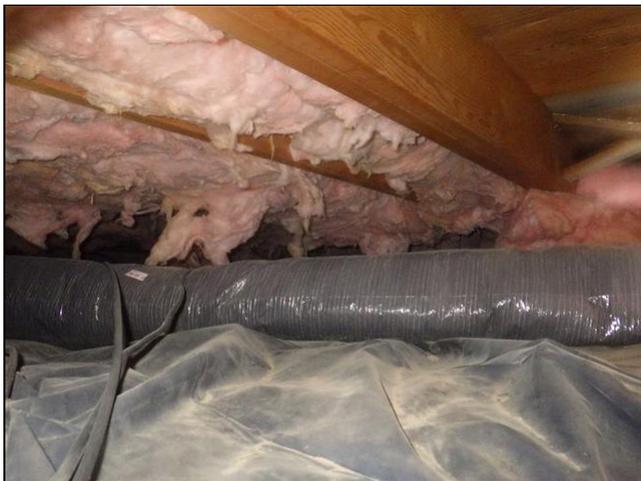
6.3 Item 1(Picture)

- (1) Current standards require one square foot of ventilation per 150 feet of area in the crawlspace with one ventilation opening located within three feet of corners. This appears to be present at this home.
- (2) The access appeared adequately sized. No significant deficiencies were noted.
- (3) Insulation is partially or completely blocking the vents. This may limit air flow and increase moisture levels in the crawlspace. Recommend adjusting/correcting to allow proper air flow.
- (4) The ductwork and plumbing prevented full access to approximately 30 percent of the crawlspace. The customer is advised that hidden conditions may be present. A second access should be created or a portion of the existing space should be dug out to allow for entry and inspection.

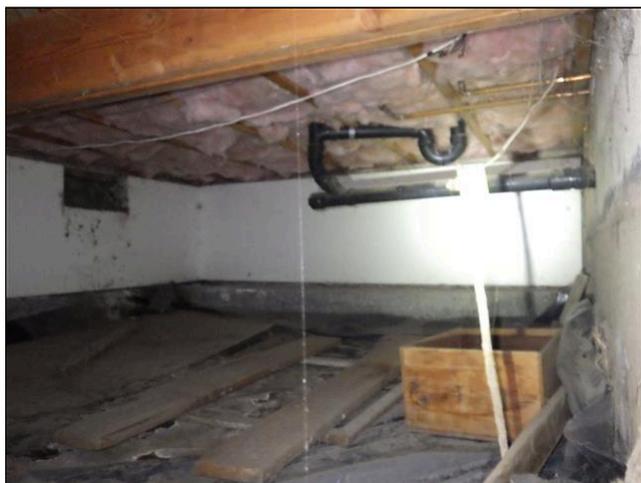
6.10 Item 1(Picture)

Left-over wood from construction is present in the crawlspace. This is considered a conducive condition for pest intrusion and wood-destroying fungus. Recommend removing all such materials.

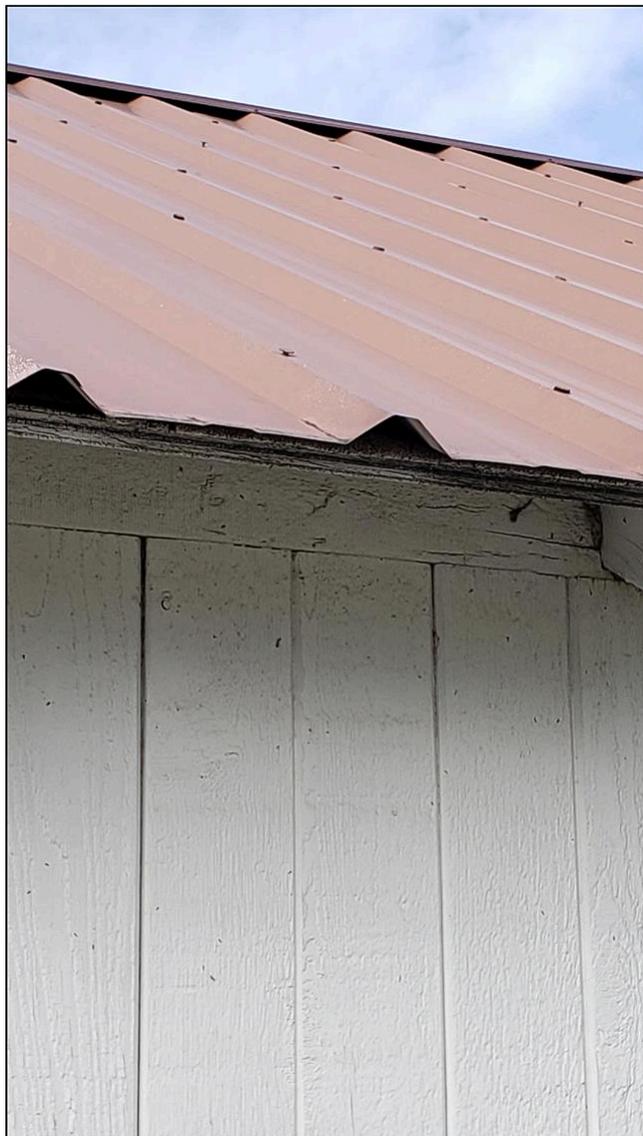
7.1 Item 1(Picture)

(2) Loose, protruding or missing fasteners visible at the time of the inspection. This condition should be corrected to avoid wind damage and/or damage from moisture intrusion. Recommend repair by a licensed and qualified roofing contractor.

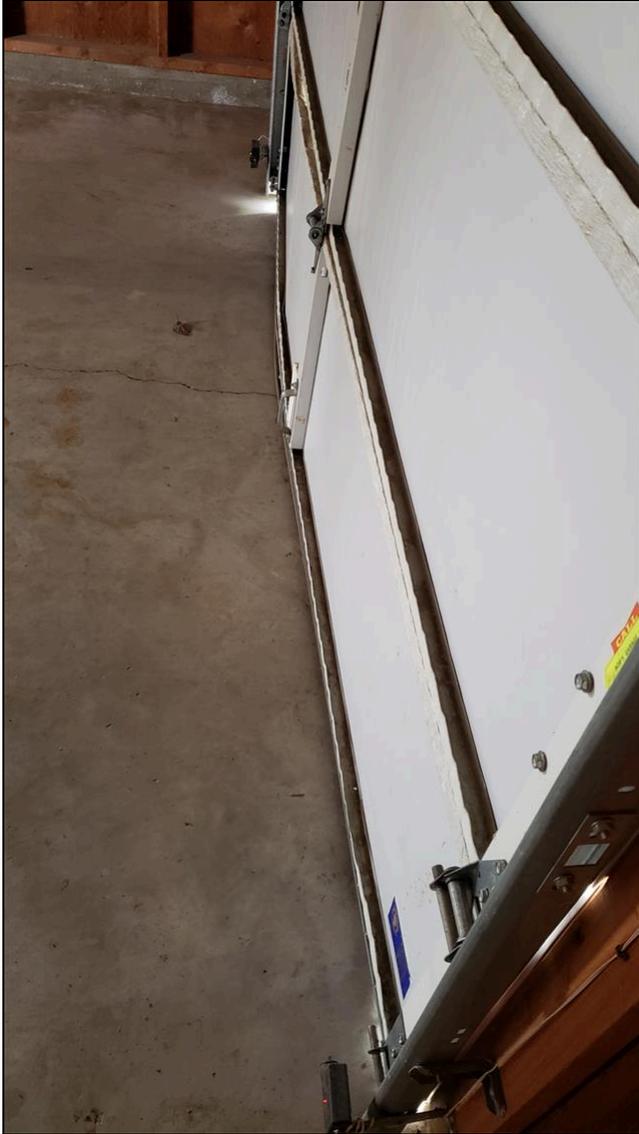
7.5 Item 1(Picture)

A garage vehicle door panel had severe damage visible which will require repair or replacement. Recommend consulting a garage door contractor to gain an idea of options and costs necessary to correct this condition.

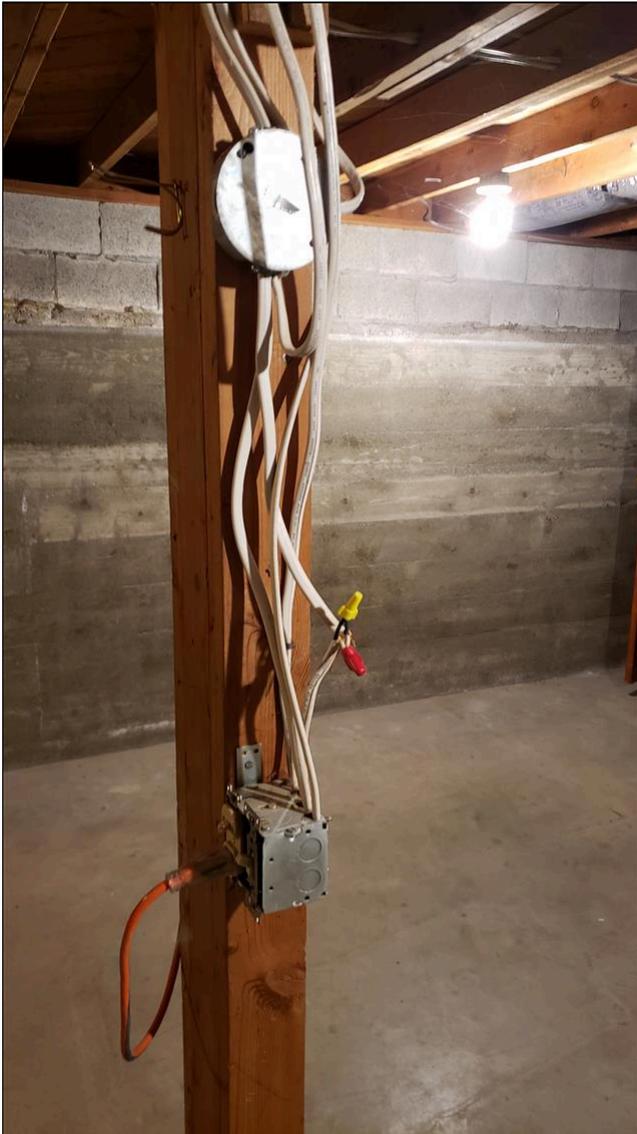
10.1 Item 1(Picture)

(2) The wiring in the basement appears to have been installed by a person unfamiliar with good electrical practices. Wiring is exposed to damage and the junction boxes are missing bushings. Recommend evaluation by a licensed and qualified electrical contractor.

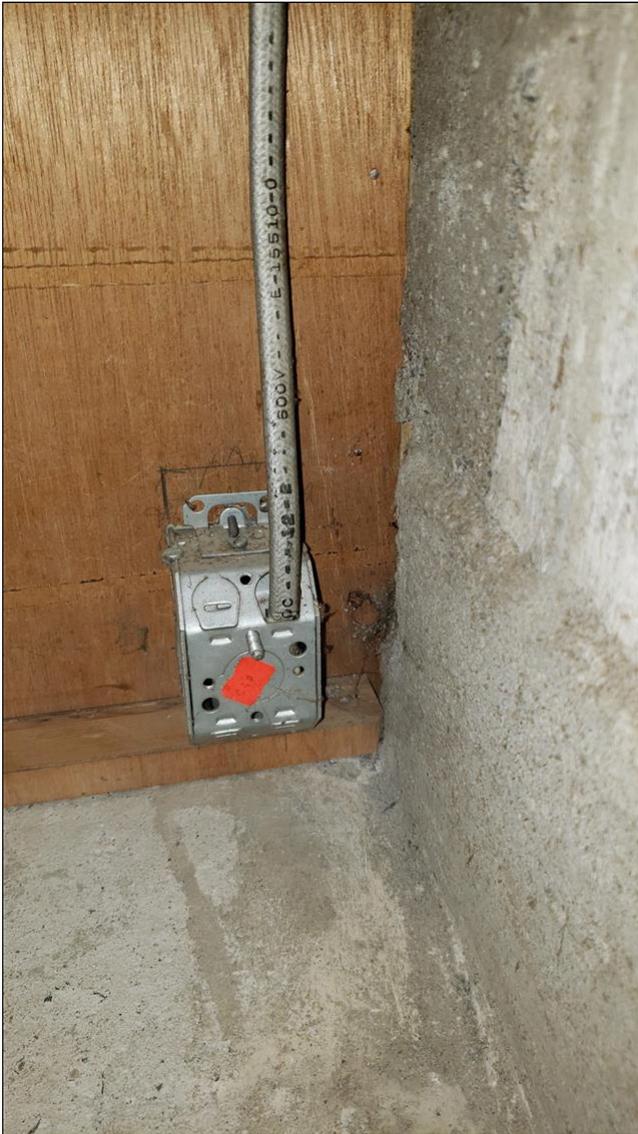
10.1 Item 2(Picture)

(3) The metal electrical receptacle boxes do not appear to have been properly grounded. Recommend correction by a licensed and qualified electrical contractor.

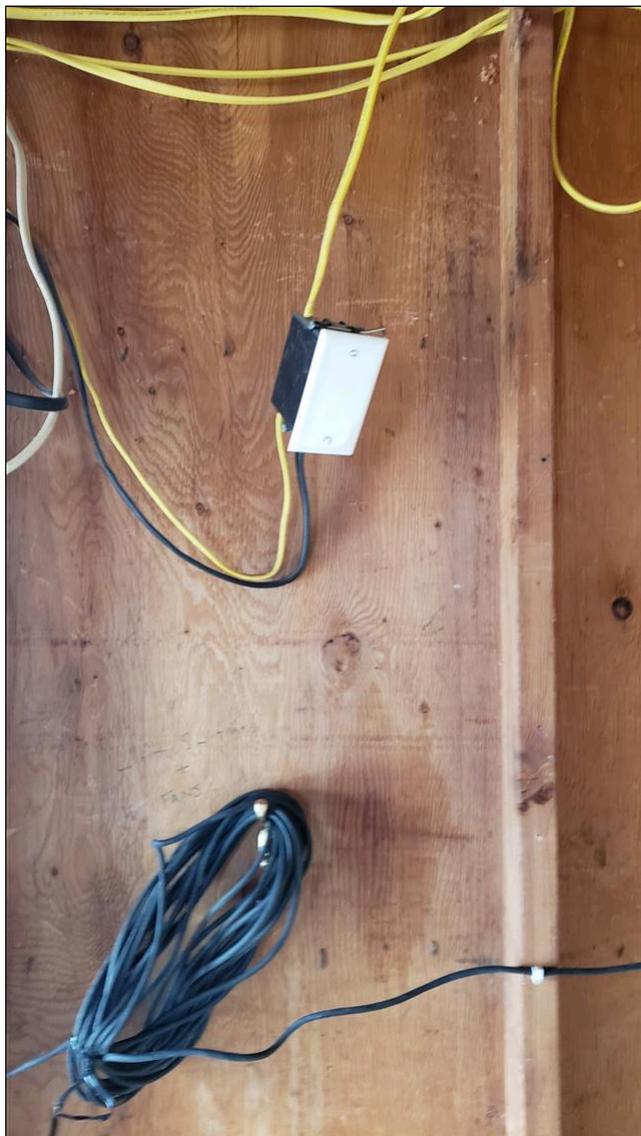
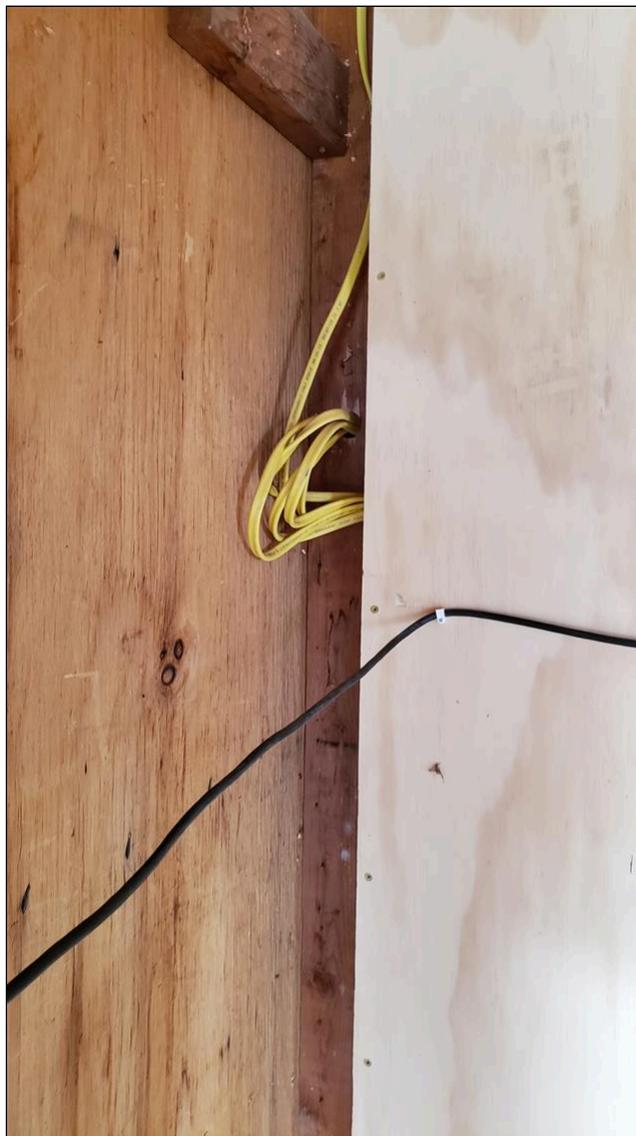
(5) Some of the wiring in the garage appears to have been installed by a person unfamiliar with good electrical practices. Wiring is exposed to damage and the junction boxes are missing bushings. Recommend evaluation by a licensed and qualified electrical contractor.

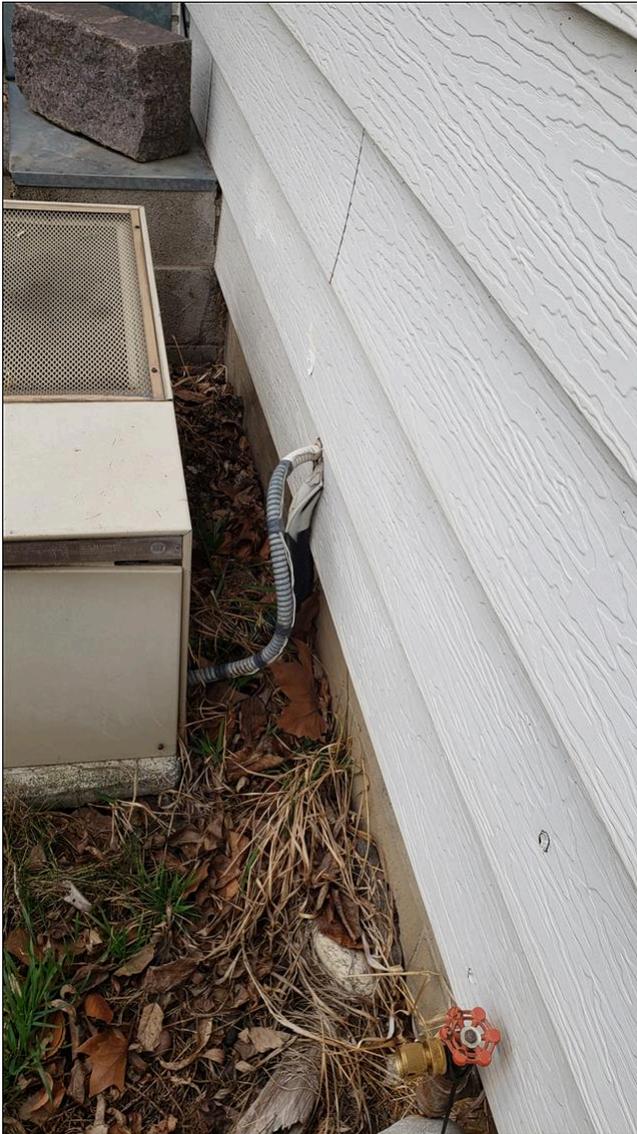
10.2 Item 1(Picture)

(2) The electrical service for the air conditioner is protected by conduit that is not weather tight. This can allow water into the service and cause damage to the wiring or create a shock hazard. Recommend repair by a licensed and qualified contractor.

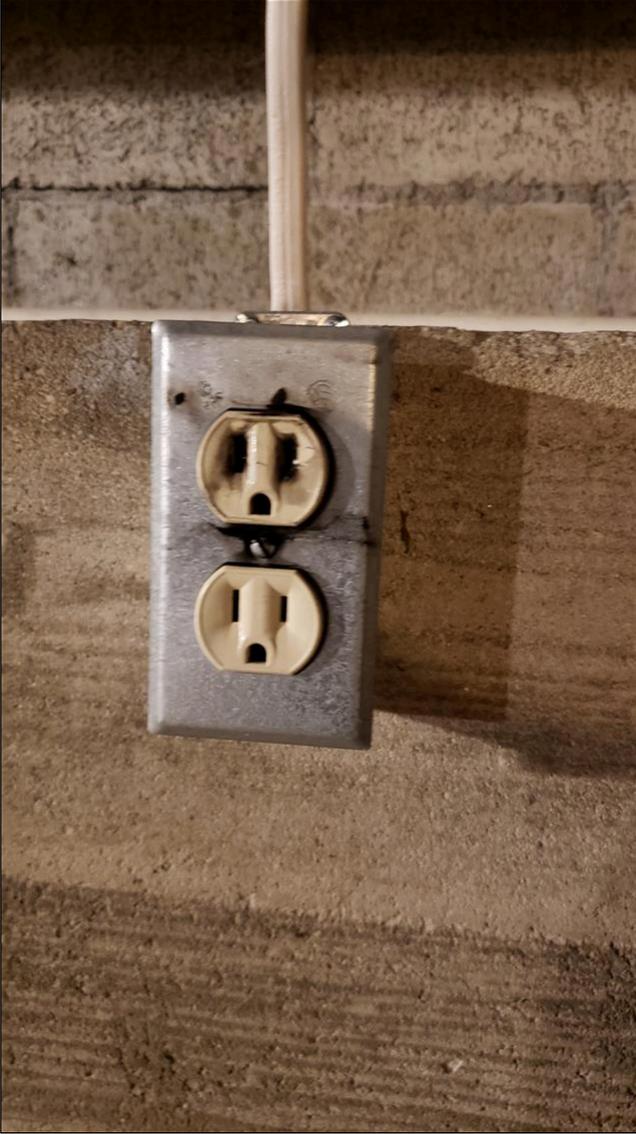
10.4 Item 1(Picture)

- (1) A representative number of receptacles were tested.
- (2) One or more receptacles in the unfinished basement has scorch marks and is considered damaged This is a fire hazard. Recommend repairs by a competent, qualified, and licensed electrical contractor.

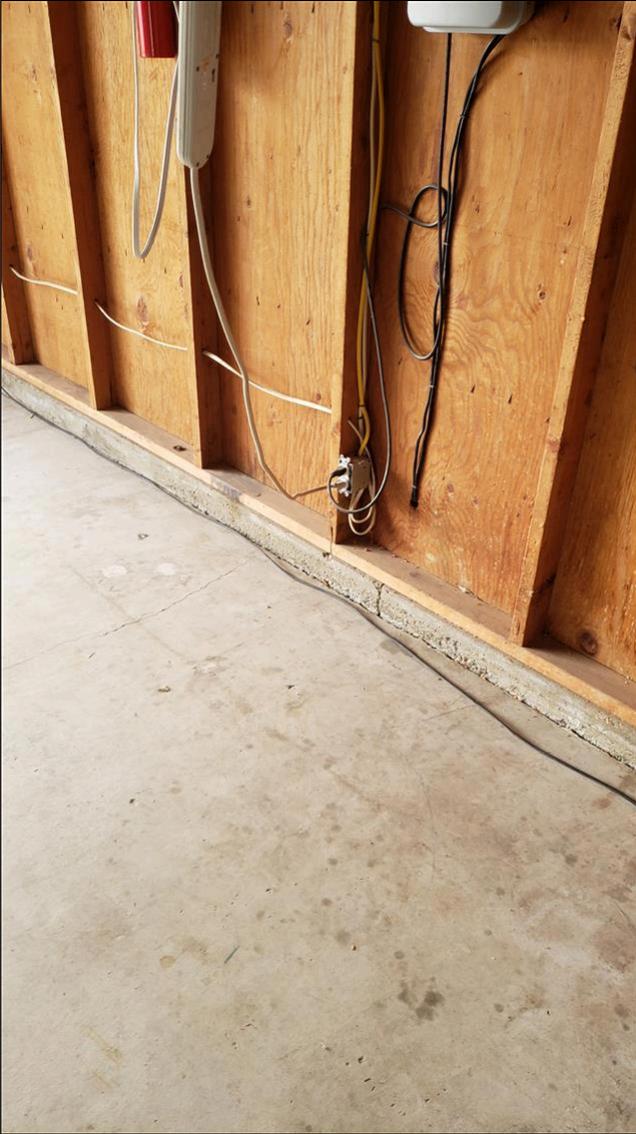
10.4 Item 2(Picture)

(3) Missing cover plates for electrical receptacles noted at garage. This is a shock hazard. Recommend installing appropriate covers on all uncovered receptacles and junctions boxes.

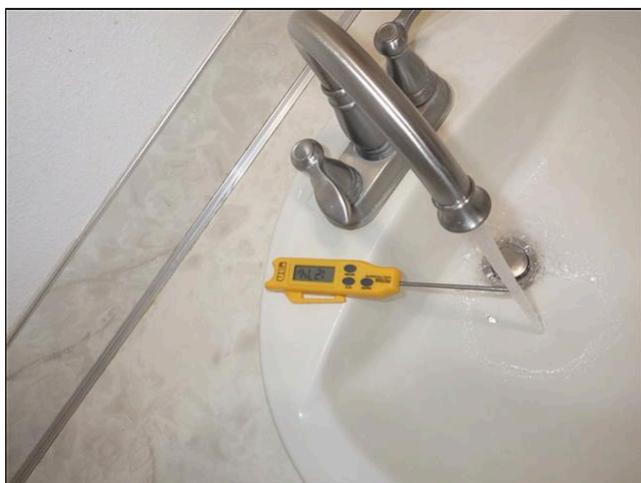
14.2 Item 1(Picture)

This water heater was generating water hotter (more than 130 degrees) than the generally accepted safe water temperature is 120 degrees Fahrenheit. This poses a scald or burn hazard, especially to the elderly and infants. Scald time for adults is approximately 30 seconds. Young children and the elderly scald faster. Recommend turning the water temperature down to the recommended level.

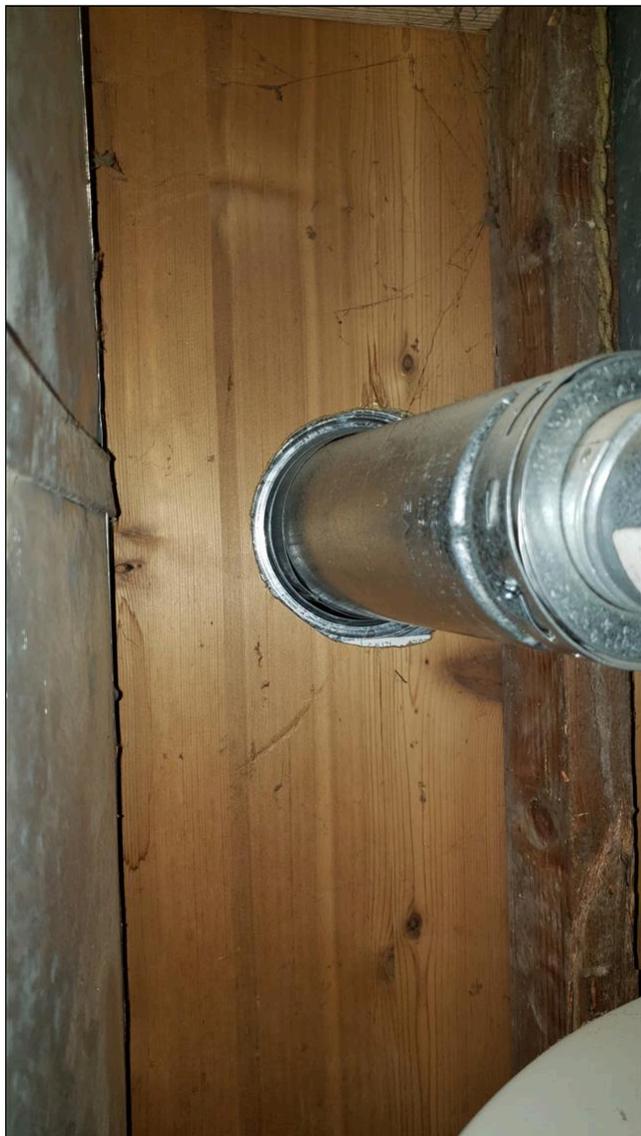
14.3 Item 1(Picture)

The gas-fired water heater exhaust flue had inadequate clearance from combustibles. This type of exhaust flue requires 1-inch clearance from combustible materials. This condition is a potential fire hazard and should be corrected by a qualified contractor.

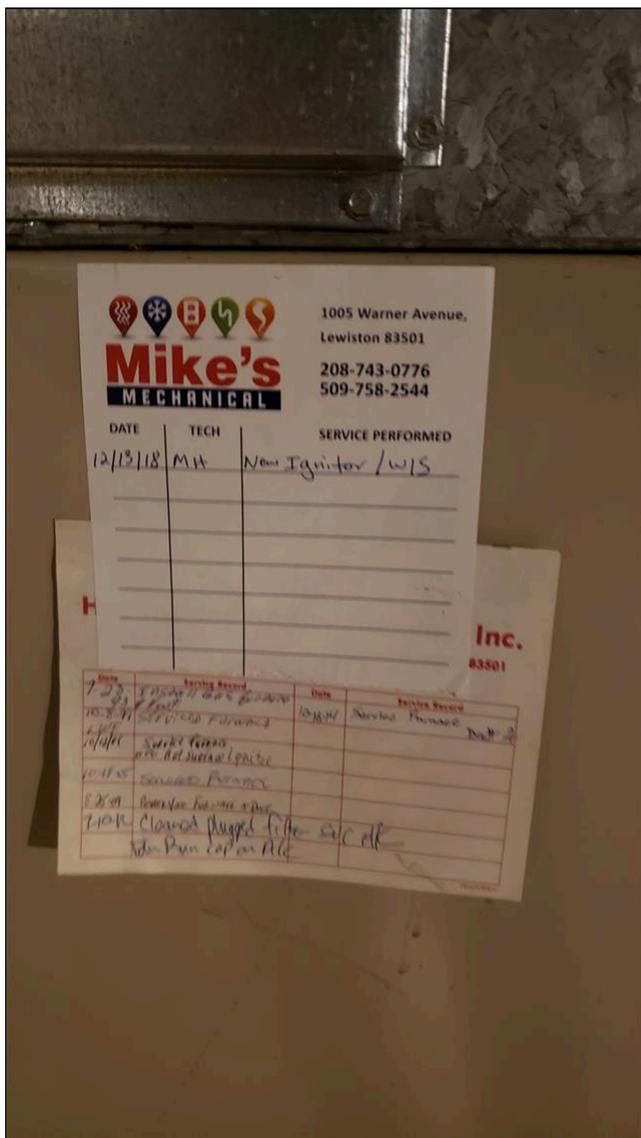
15.0 Item 5(Picture)

(5) The furnace does not appear to have been recently serviced (no service sticker was observed/not current). Safe@Home recommends that furnace cleaning, service and certification be performed by a qualified contractor in accordance with manufacturer's instructions. If the current owner has had the unit serviced but the servicing company did not put on a sticker, he/she should have records and receipts that could be accepted in lieu of the new service.

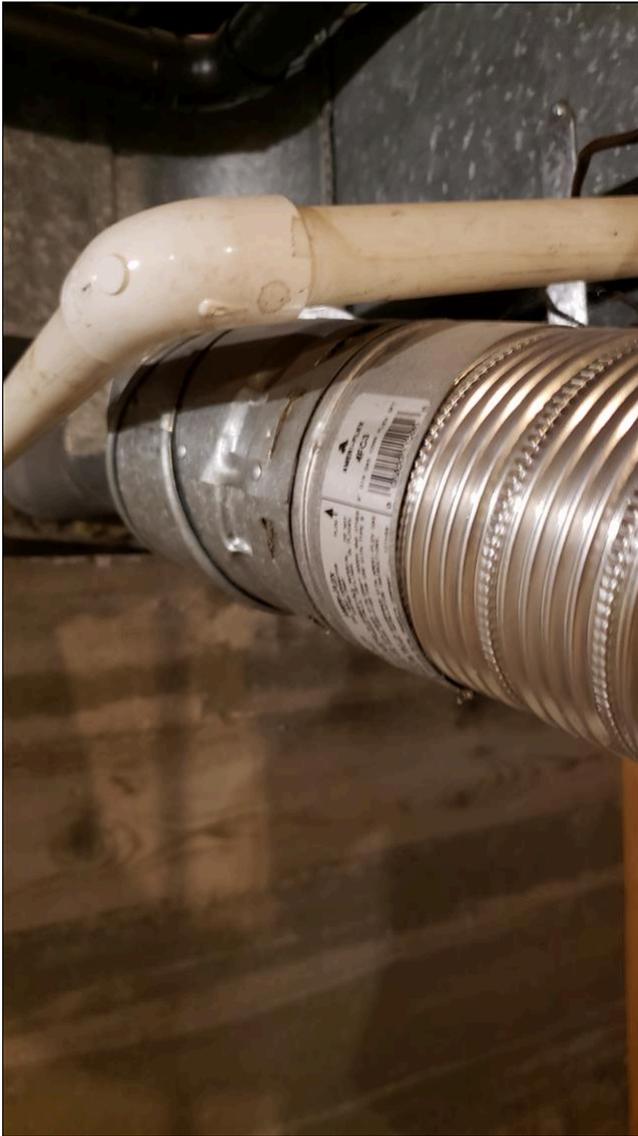
15.3 Item 2(Picture)

(3) The furnace exhaust flue pipe had improper clearance from combustibles materials. This type of vent requires 1-inch minimum clearance. This condition is a potential fire hazard. Recommend correction by a licensed and qualified HVAC contractor.

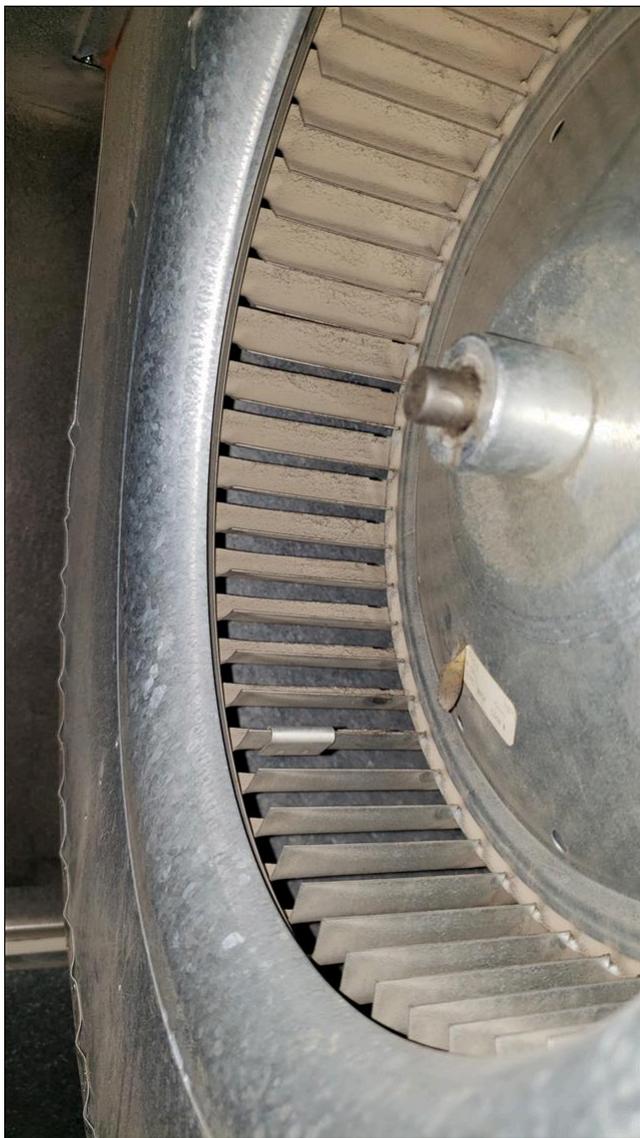
16.0 Item 1(Picture)

(1) The blower unit is dirty. Dirty blower components can lead to poor efficiency and potentially damage the blower system. Recommend maintenance by a licensed and qualified HVAC contractor.

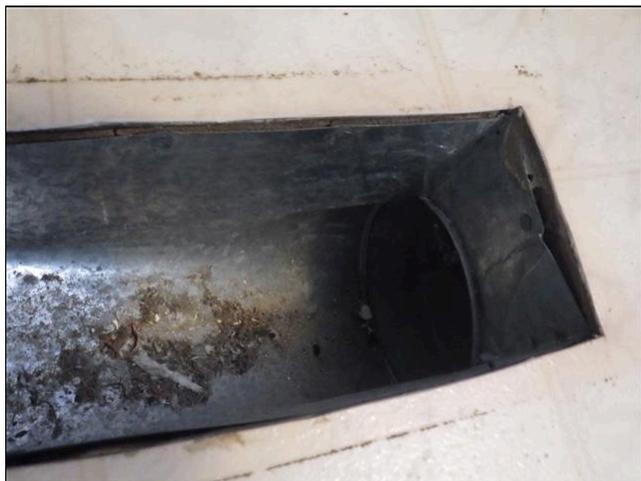
16.2 Item 1(Picture)

(2) Removal of room registers allowed observation of the ductwork leading into various rooms. The ductwork appears to need cleaning as evident by the level of materials visible. Recommend duct cleaning by a licensed and qualified specialist.

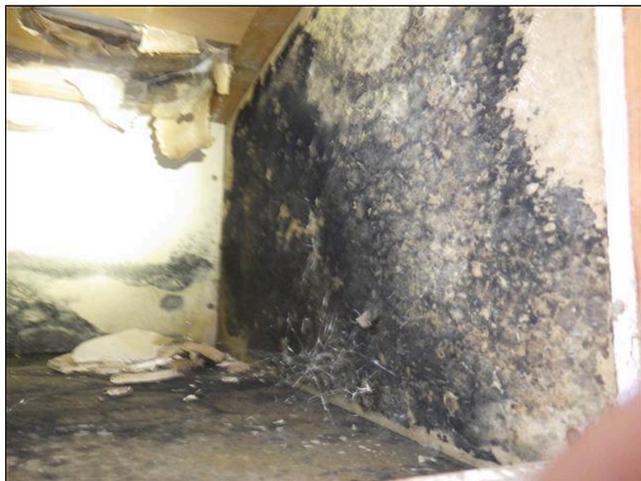
19.2 Item 1(Picture)

(2) Signs of fungi growth is present in under the bench of the shower of the master bathroom. We did not inspect, test or determine if this growth is or is not a health hazard. The underlying cause is moisture. I recommend you contact a mold inspector or expert for investigation or correction if needed.

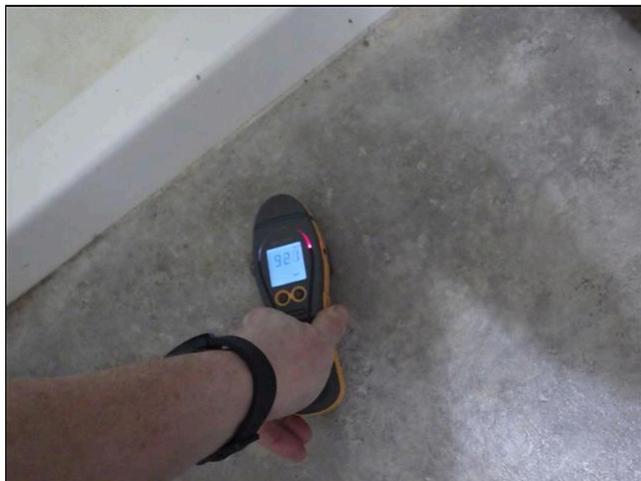
19.3 Item 1(Picture)

(2) The subflooring in the master bathroom was soft around the tub/shower indicating past or present damage due to water intrusion. Active water intrusion is present as measured with a moisture meter. Recommend repair of the sub-floor and shower enclosure by a competent and qualified contractor.

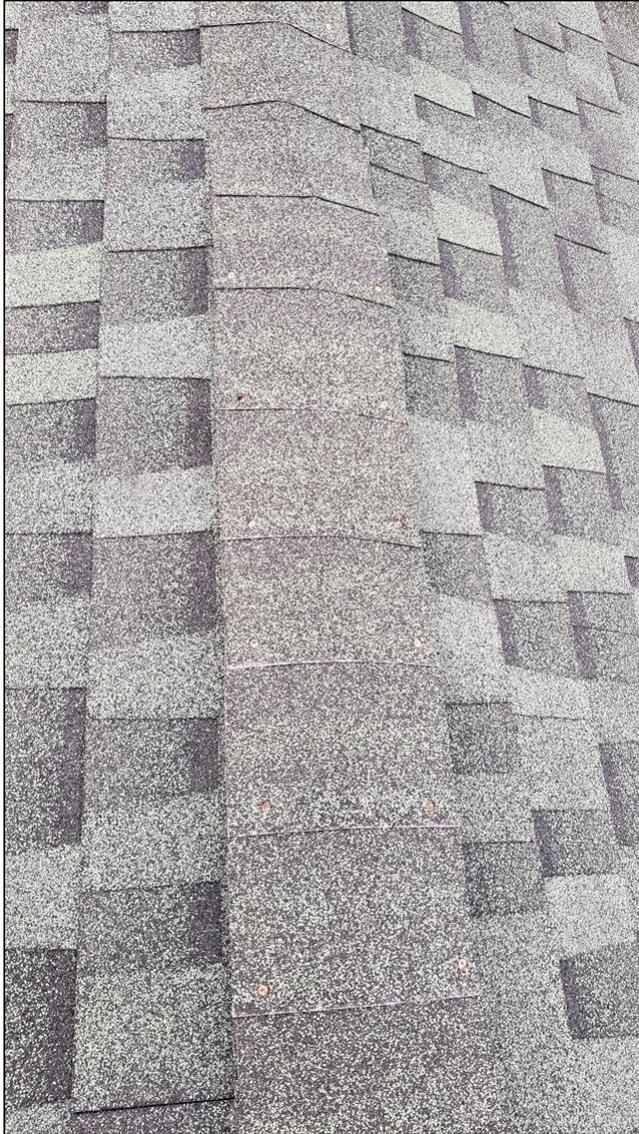
4.1 Item 3(Picture)

(5) Exposed nails present on the roof deck. These should be covered with caulk or roof sealant to prevent potential water intrusion to the rest of the home. Recommend correction of all such by a licensed and qualified roofing contractor.

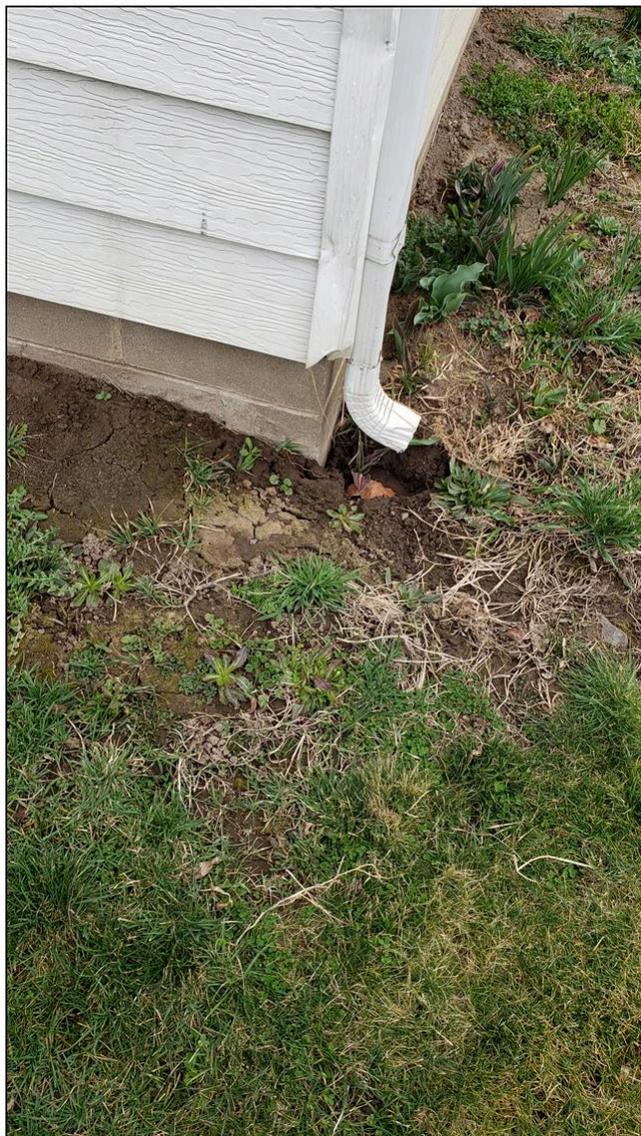
4.3 Item 1(Picture)

(2) The downspouts and extensions/splashblocks gutters are not directing water sufficiently far from the foundation. They should direct all roof water run-off at least ten feet from the foundation walls. Recommend correcting all the existing discharge points to accomplish this by adding properly aligned splash blocks, extensions, or similar means.

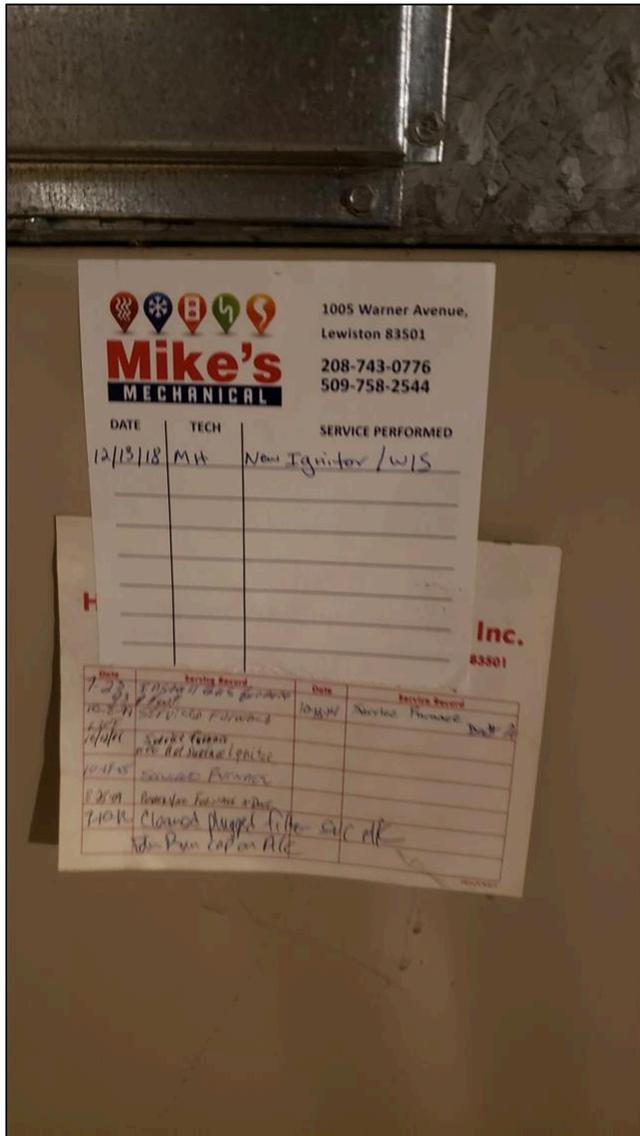
15.0 Item 5(Picture)

(5) The furnace does not appear to have been recently serviced (no service sticker was observed/not current). Safe@Home recommends that furnace cleaning, service and certification be performed by a qualified contractor in accordance with manufacturer's instructions. If the current owner has had the unit serviced but the servicing company did not put on a sticker, he/she should have records and receipts that could be accepted in lieu of the new service.
