Inspection Report

Property Address:
1123 Linden Ave
Lewiston ID 83501

Safe@Home Inspections, LLC

Date: 3/14/2022	Time: 09:00 AM	Report ID: 20220314-1123-Linden-Ave
Property: 1123 Linden Ave Lewiston ID 83501	Customer: Harry Mills	Real Estate Professional: Tom Scher Windermere All-Star

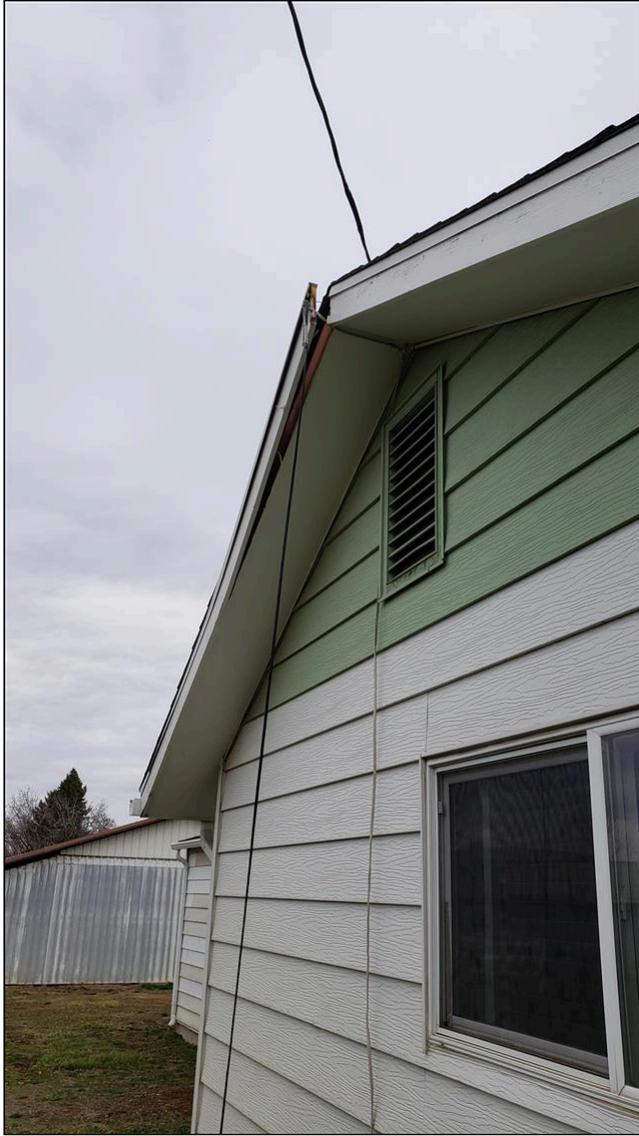
2.4 Item 1(Picture)

(1) The fascia board on the westside gable has detached from the home. This allows for water entry into structural components, has pulled the flashing free of the roof, and is a hazard to fall. Recommend reattachment by a licensed and qualified contractor.

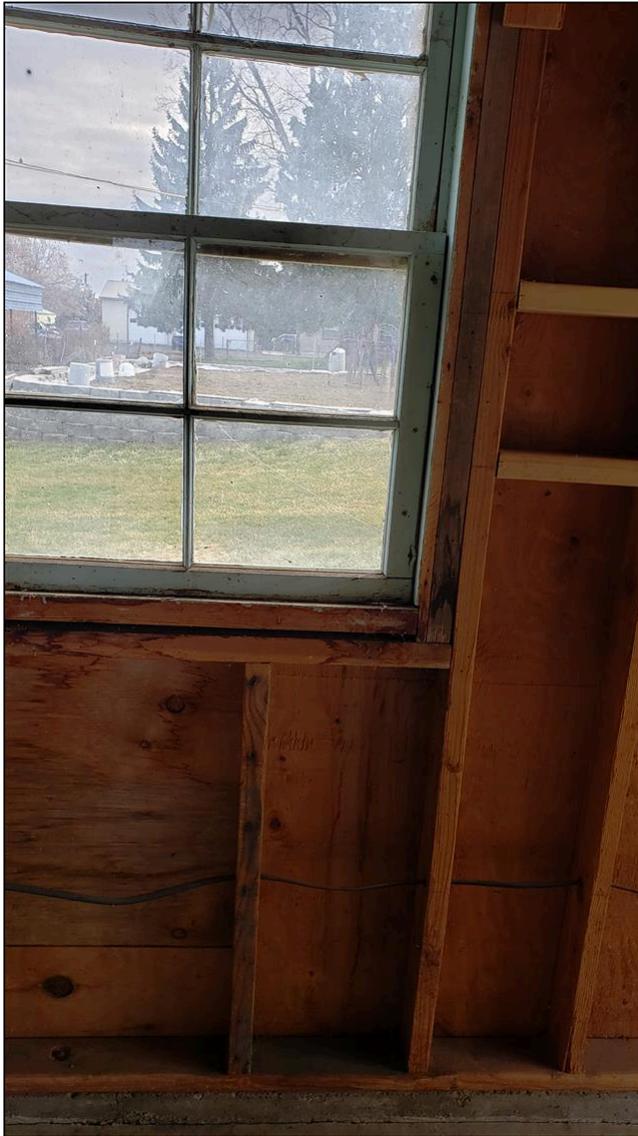
3.2 Item 1(Picture)

(1) One or more windows in the garage has one or more broken panes of glass and a damaged frame Recommend repair by a qualified and competent handyman/homeowner/window contractor.

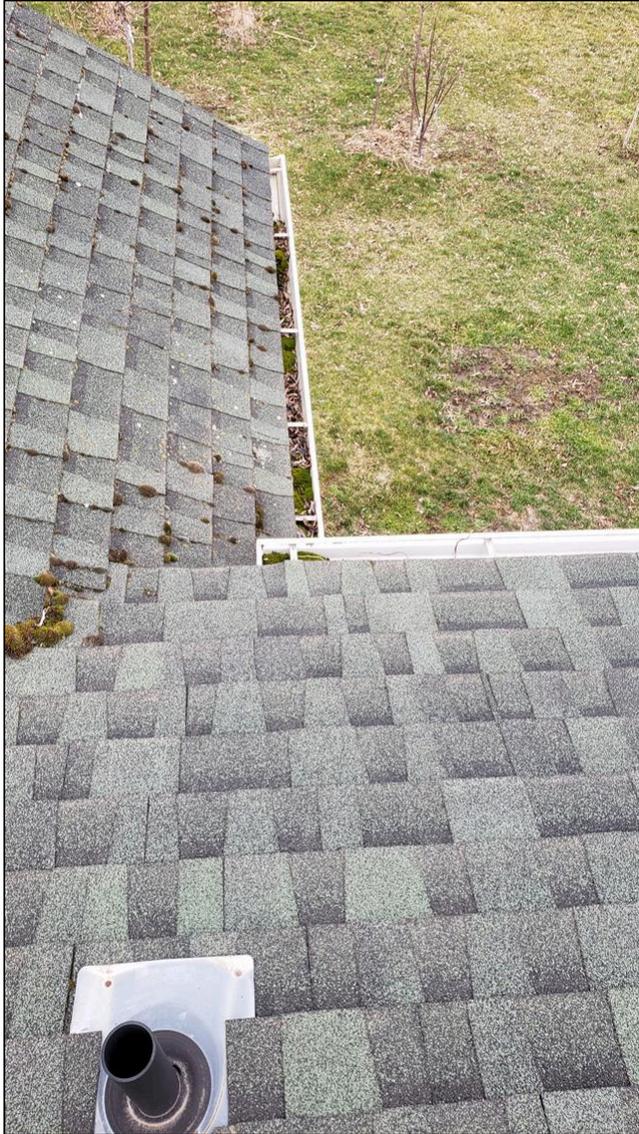
4.3 Item 2(Picture)

(4) The rear gutters are full of debris in areas and needs to be cleaned. The debris in gutters can also conceal rust, deterioration or leaks that are not visible until cleaned, and I am unable to determine if such conditions exist.
