All-Home Inspections

Harry Mills
1123 Linden Ave

Table of Contents

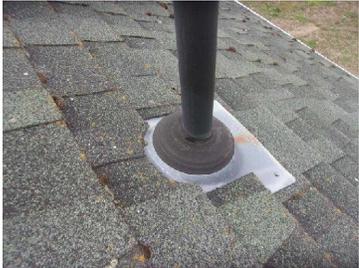
9. Plumbing Vents: ABS plastic pipe. Galvanized - / The seals around the vent pipes are in good condition, with no damage or leak concerns noted.

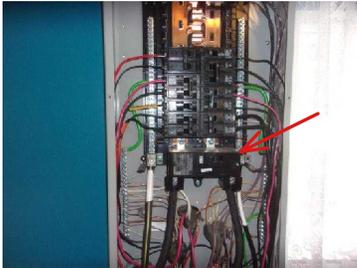
Laundry room Electric Panel

- 10. Manufacturer: Siemens
- 11. Maximum Capacity: 200 Amps
- 12. Main Breaker Size: 200 Amps

- 13. Breakers: No electrical defects noted
- 14. Fuses:
- 15. AFCI:
- 16. GFCI: At GFCI receptacles only

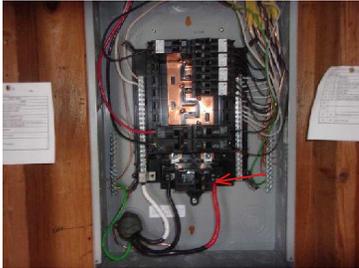
Garage Electric Panel

21. Breakers: No electrical defects noted

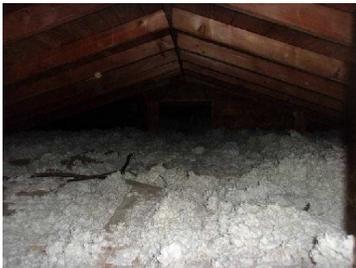
5. Ventilation: Gable and ridge venting
6. Insulation: Blown in

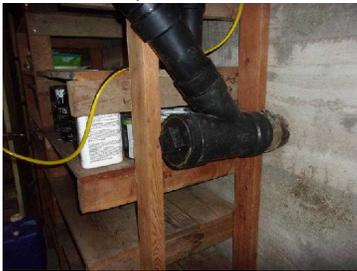
4. Drain Pipes: ABS
5. Service Caps: In basement

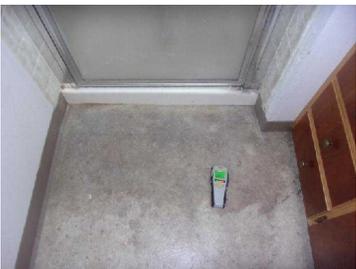
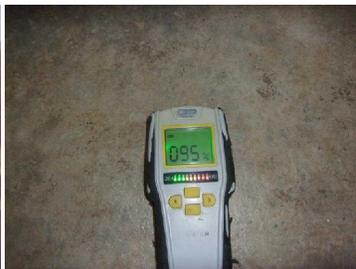
6. Master Bathroom Floor: Linoleum - / Excessively water damaged floor covering noted. High moisture readings noted in multiple locations. Due to concerns in the flooring, recommend a licensed contractor evaluate and repair as needed.

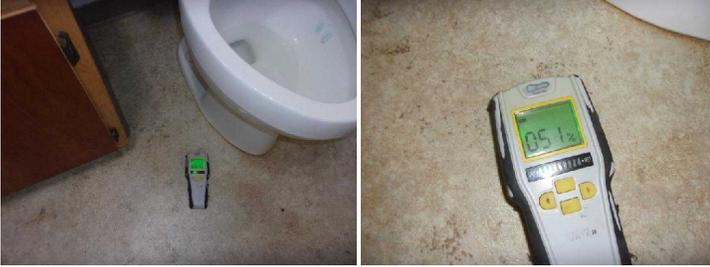
10. Hallway Bathroom Electrical: Standard 110 volt electrical outlets and light fixtures. / Although not required when the home was built, current safety requirements recommend GFCI protected outlets in this room. Please consider having a licensed electrician install approved GFCI outlets where required.
11. Hallway Bathroom Toilets: Water Saver style toilet - / The toilet is loose at the floor and will require replacement of the wax seal and the anchor bolt kit to prevent leaking.

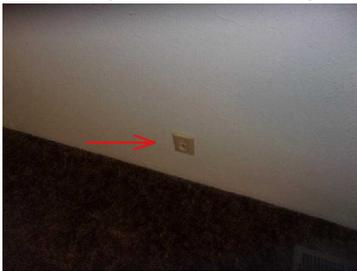
13. West Bedroom Electrical: Standard 110 volt electrical outlets and light fixtures. / Some of the electrical outlets are loose. Replacement or repair by a licensed electrician is recommended.

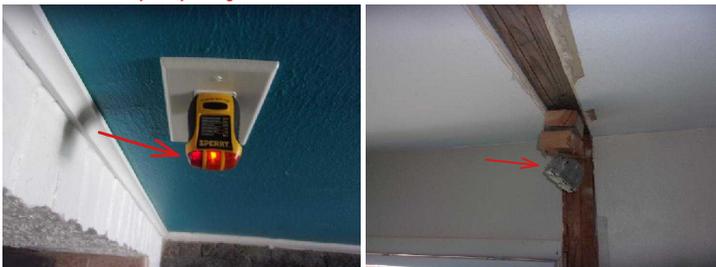
14. Living Room Living Space Electrical: Standard 110 volt electrical outlets and light fixtures. / Reversed polarity noted (hot & neutral wires are reversed) in some outlets. Evaluation and repair by a licensed electrician is recommended.

Outlets not properly mounted.
