All-Home Inspections

Harry Mills
1123 Linden Ave

Property Address 1123 Linden Ave

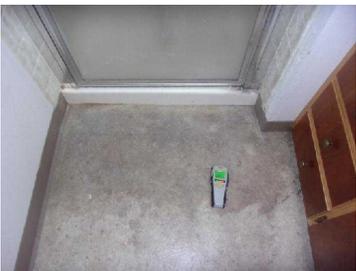
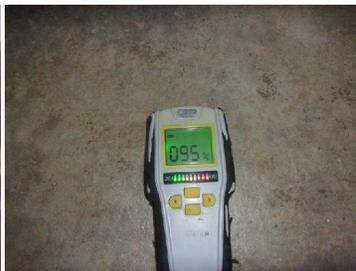
6. Master Bathroom Floor: Linoleum - / Excessively water damaged floor covering noted. High moisture readings noted in multiple locations. Due to concerns in the flooring, recommend a licensed contractor evaluate and repair as needed.
