# Inspection Report

## Harry Mills

1123 Linden Ave  
Lewiston ID 83501

## Safe@Home Inspections, LLC

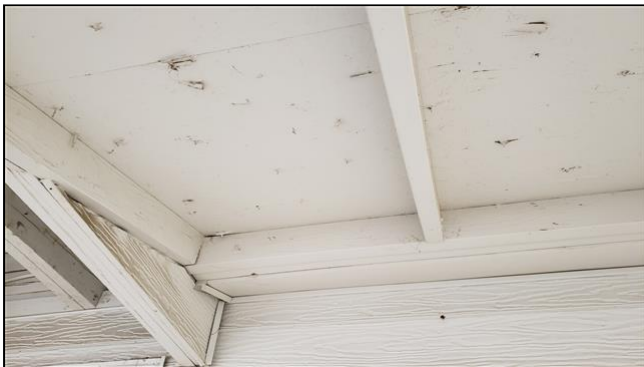
1.5 Item 2(Picture)

(2) The cover for the patio was not bolted to the home but attached with nails. Joists should be attached with hangers. Recommend repair by a competent and qualified contractor.

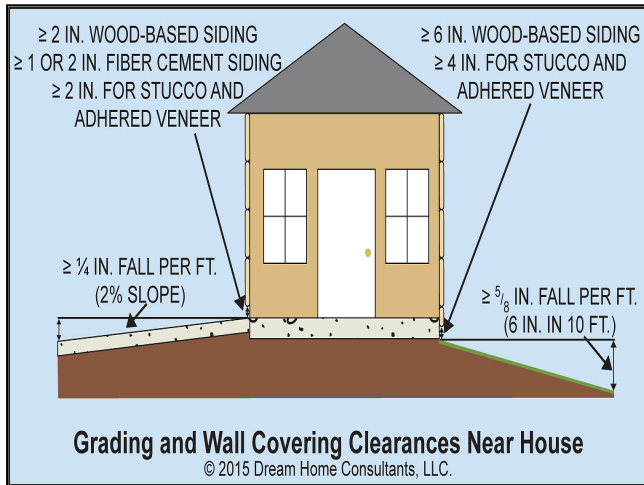
#### 1.7 Item 1(Picture) Grading

The home had some areas of neutral or negative drainage at the foundation which will route runoff from precipitation toward the home. If the ground does not slope away, the water can go to the foundation and may cause issues such as water intrusion or soil settlement/erosion under the footing. Ideally, the ground should slope away from the home 6 inches per 10 feet from the foundation. Recommend evaluation and correction by a qualified and competent contractor where feasible. If uncorrected, Safe@Home recommends that you monitor the runoff during and immediately after precipitation.

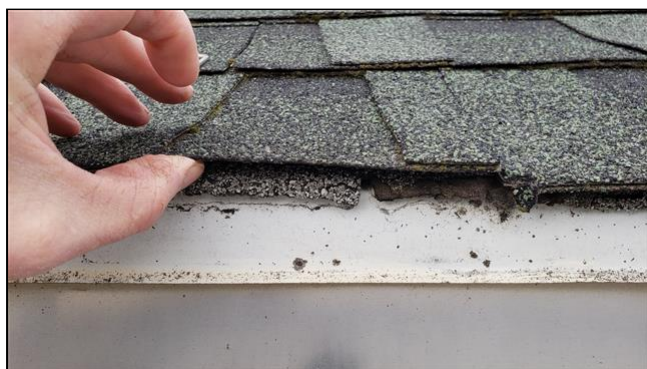
4.1 Item 1(Picture)

(3) The roof had two existing layers of composition asphalt shingles installed at the time of the inspection. This condition will result in the following: Reduced asphalt shingle lifespan compared to similar shingles installed over a proper substrate. Any warranty which may have been in effect will be void. Shingles will be more easily damaged by hail. When new roofing is required, all layers will need to be removed before new roofing material can be installed. This is much more expensive than simply adding another layer and you may wish to take this into account in your consideration of this property.

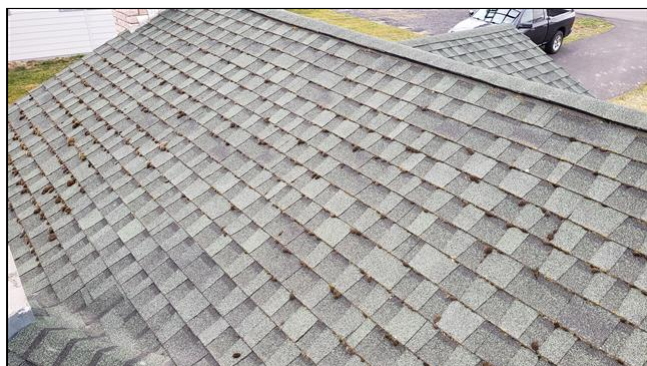
4.1 Item 2(Picture)

(4) There is moss growing on the roof. Safe@Home recommends having a competent and qualified individual remove the moss.

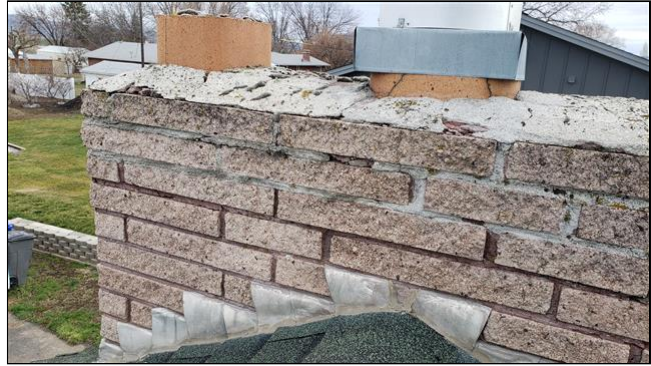
4.5 Item 2(Picture)

(2) The chimney cap had moderate to severe deterioration which should be repaired to avoid moisture intrusion of the chimney structure. Recommend repairs by a licensed and qualified contractor with experience performing work on chimneys.

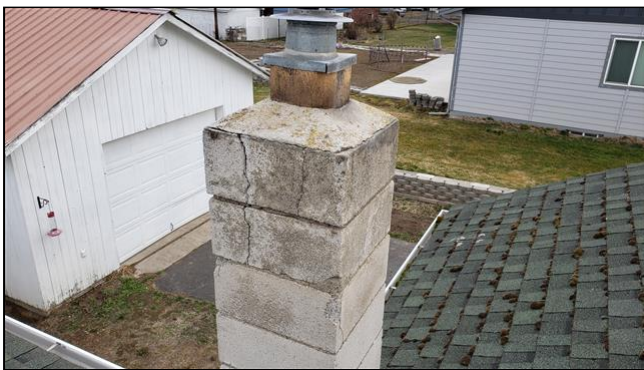
4.5 Item 5(Picture)

(4) Extensive cracking noted in the chimney structure. This crack a to be related to settlement. The suggestion inadequate Foundation below the chimney. Unable to locate a footing underneath the chimney. Recommend further

investigation by a licensed and qualified contractor to determine the full scope of necessary repairs.

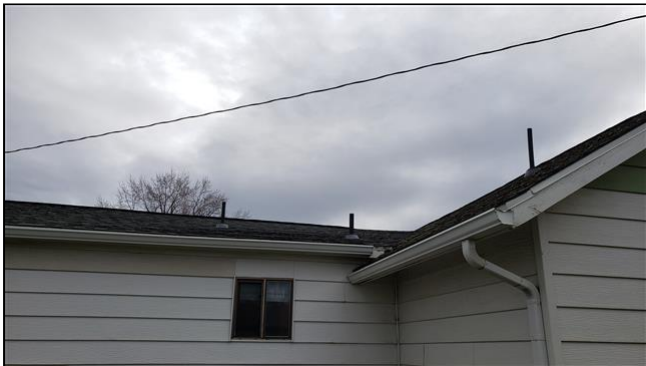
5.2 Item 1(Picture)

- 5.0 Obstacles to Inspection  
Comments: Not Present
- 5.1 Attic Access  
Comments: Inspected
- 5.2 Attic Framing  
Comments: Inspected  
(1) Some sagging/deflection is noted on the roof that is likely the result of natural sag in the rafters. This is a common finding on older structures and is generally related to the construction practices of the time.

(2) Sagging visible in the roof rafters appeared to be caused by inadequate framing design of the roof structure typical of homes built in this area, during this time period, of this quality. Consider consulting with a qualified contractor to discuss options and costs for stabilization or correction.

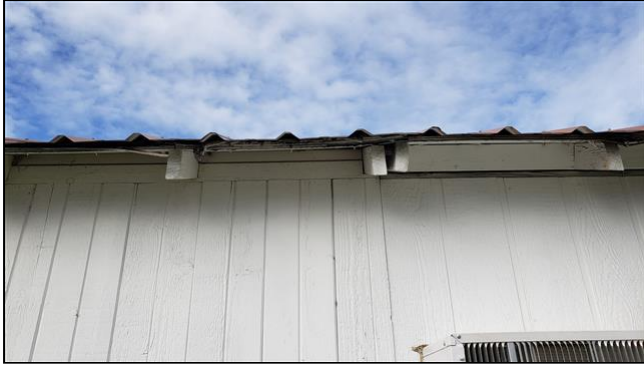
7.1 Item 2(Picture)

(3) The garage roof is missing drip edge flashing. This will allow for water entry at the eave and likely lead to damage to the substrate materials. Recommend installation of drip edge flashing after all repair work is complete.

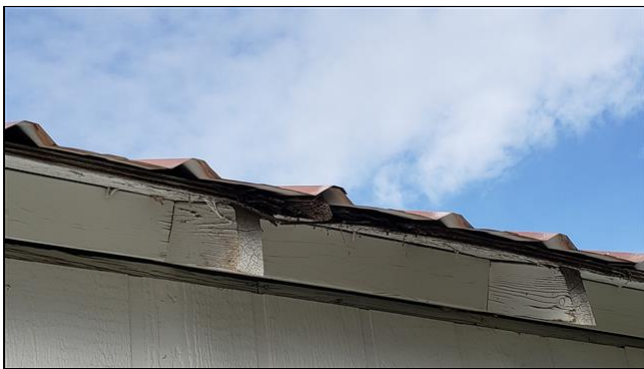
7.1 Item 3(Picture)

(4) Water intrusion noted on the inside of the garage. Substantial damage to underlying sheathing noted at the eaves. Recommend repair of all damaged materials. All work should be completed by licensed and qualified contractor.

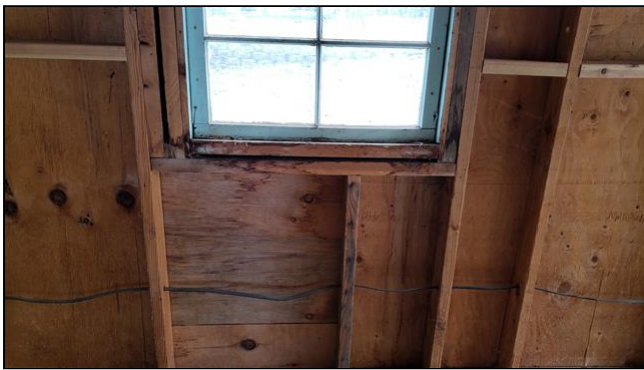
7.3 Item 1(Picture)

Leakage noted around the windows and electrical receptacles. Recommend repair by a licensed and qualified siding contractor.

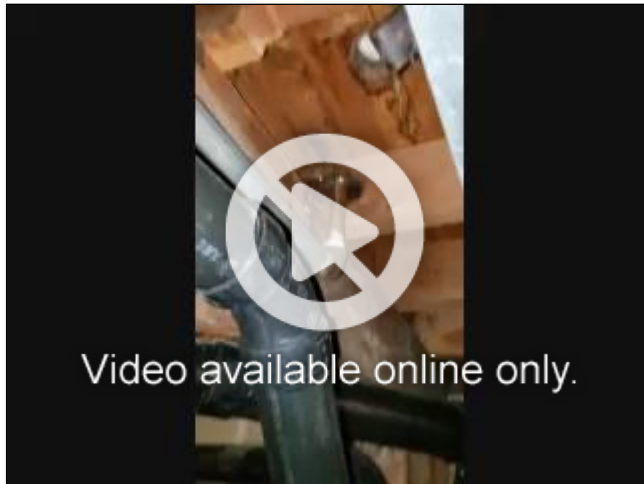
11.2 Item 1(Video)

(2) Plumbing distribution pipes in contact with dissimilar materials were present which may cause galvanic corrosion which in turn will result in deterioration and eventual leakage. Safe@Home recommends installation of dielectric unions by a licensed and qualified plumbing contractor at all locations necessary to protect the plumbing supply system.

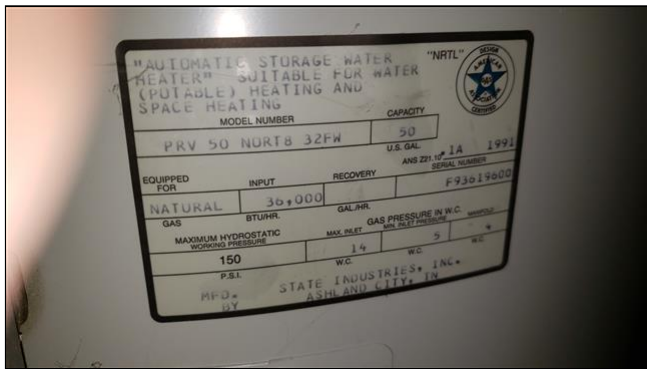
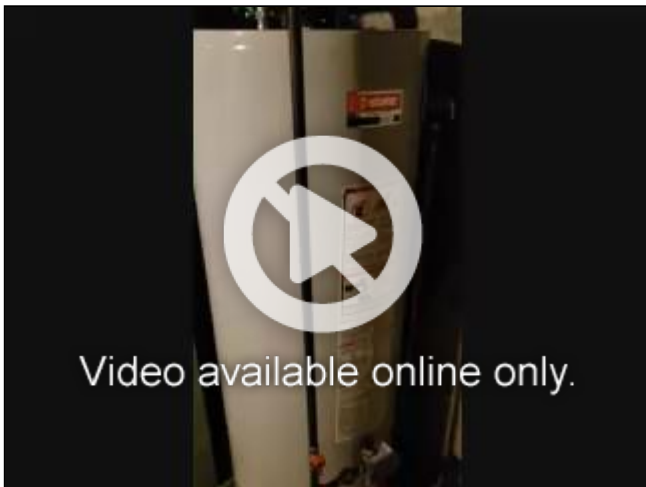
(2) The water heater is more than 20 years old and well beyond the end of a normal service life. The unit was operating at the time of inspection, but I recommend servicing and evaluation at this time. That evaluation should include the service technician's best estimate of remaining service life. **It would be very prudent for the client to make plans for replacement.**

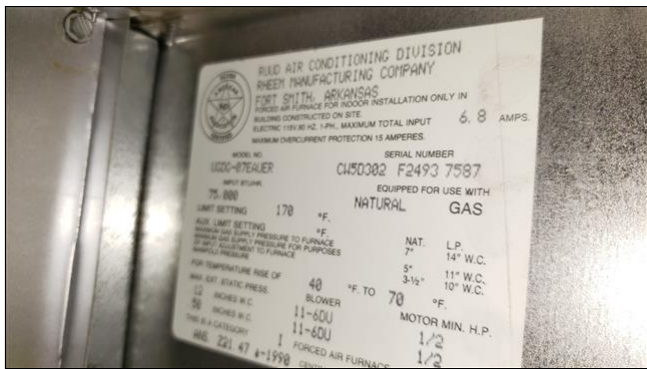
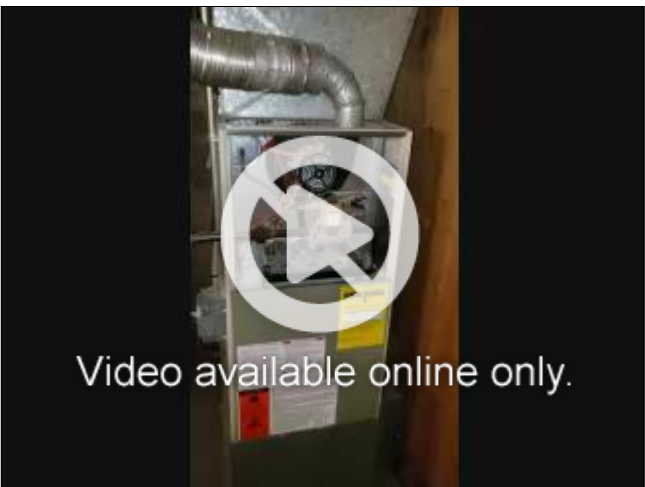
(2) The furnace is beyond a normal service life based on national estimates and local conditions. It is not possible for me to give a reliable estimate of service life remaining. It would be prudent to make plans for replacement.

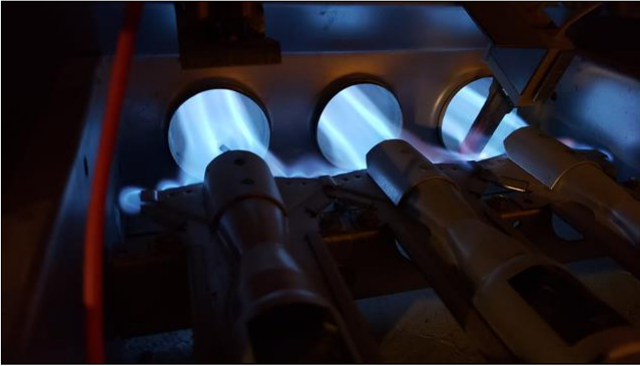
15.3 Item 1(Picture)

(1) Removal of the service panels and observation revealed a strong blue flame which is a sign of proper burning.

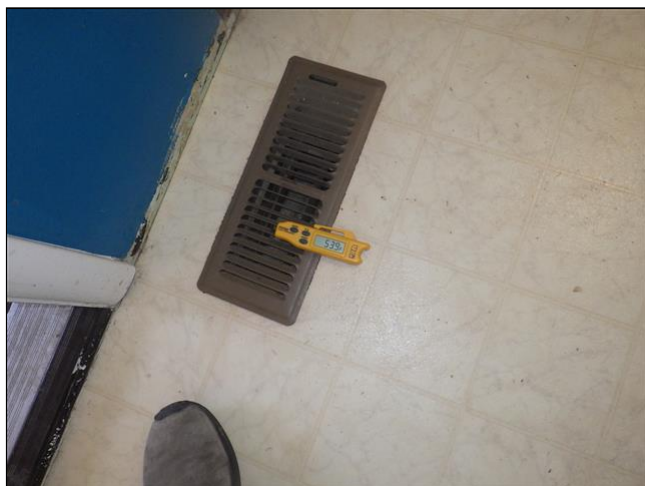
15.5 Item 1(Picture)

The ambient air test was performed by using thermometers on the air handler to determine if the difference in temperatures of the supply and return air are between 14 degrees and 24 degrees which indicates that the unit is cooling as intended. This unit passed this test.

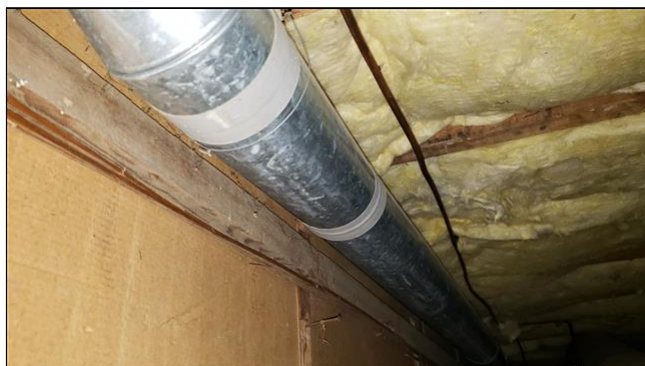
16.3 Item 1(Picture)

It appeared that there was an asbestos containing material used to wrap the ducting. Some of the material appears to be damaged. It is not possible to determine the presence of asbestos without sampling (by an Accredited Asbestos Inspector) and laboratory testing. The recommendation from the EPA is too either use professionals to remove the suspected materials or to encapsulate so that the particles cannot get airborne. Asbestos is most hazardous when airborne. More information is available at the [EPA Asbestos website](#).

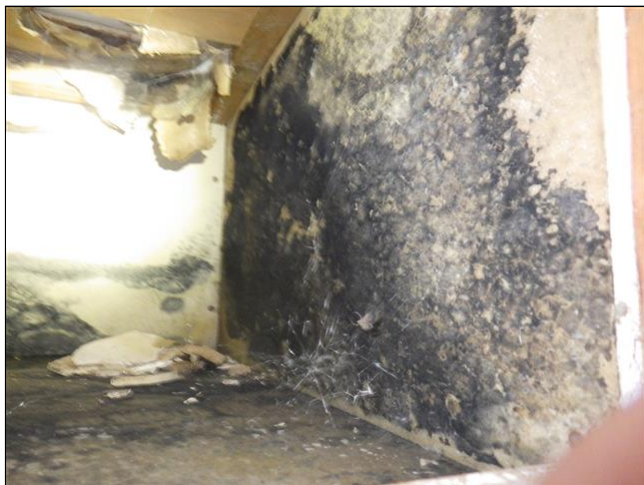
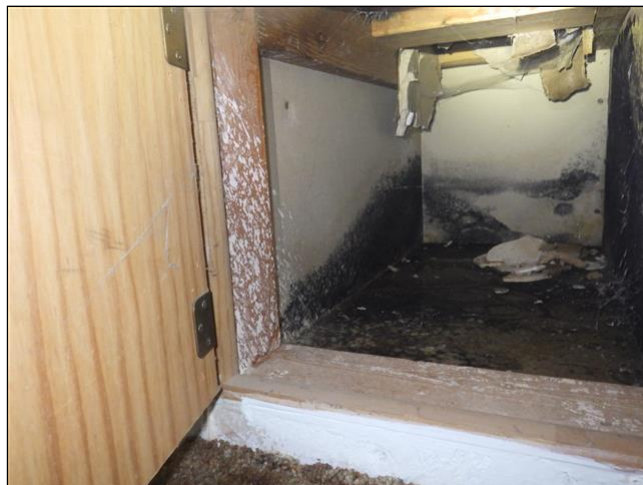
(2) Signs of fungi growth is present in under the bench of the shower of the master bathroom. We did not inspect, test or determine if this growth is or is not a health hazard. The underlying cause is moisture. I recommend you contact a mold inspector or expert for investigation or correction if needed.

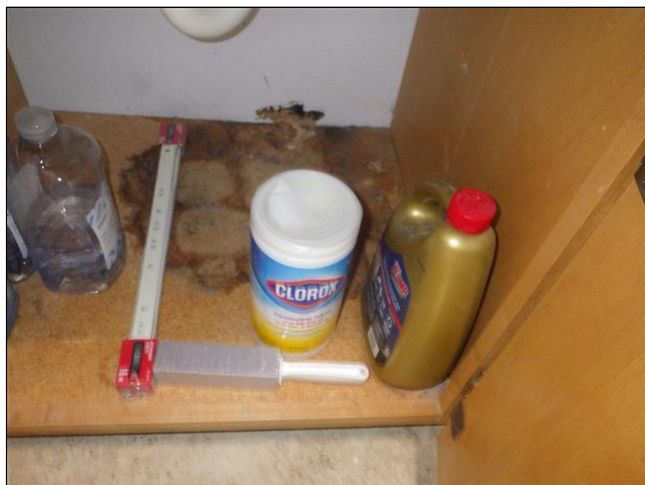
19.6 Item 1(Picture)

The sink base in master shows evidence from a previous leak but appeared dry at this time. I recommend upgrading this component when feasible.

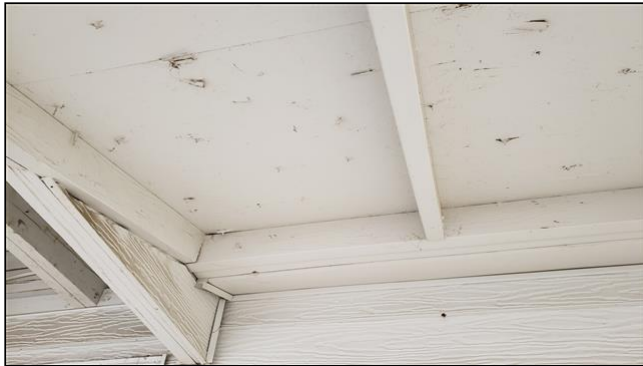
1.5 Item 2(Picture)

(2) The cover for the patio was not bolted to the home but attached with nails. Joists should be attached with hangers. Recommend repair by a competent and qualified contractor.

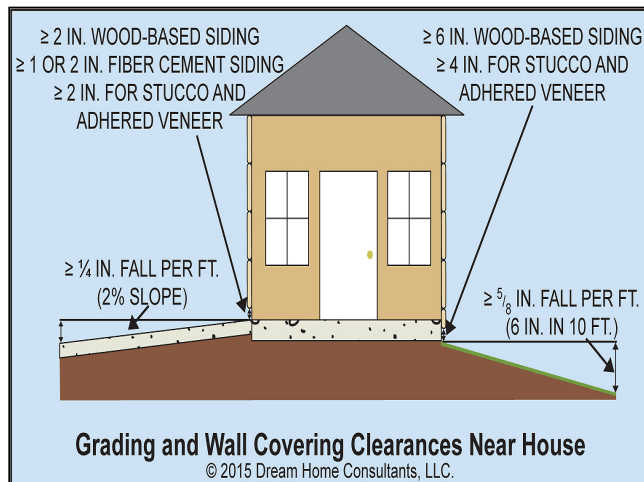
1.7 Item 1(Picture) Grading

The home had some areas of neutral or negative drainage at the foundation which will route runoff from precipitation toward the home. If the ground does not slope away, the water can go to the foundation and may cause issues such as water intrusion or soil settlement/erosion under the footing. Ideally, the ground should slope away from the home 6 inches per 10 feet from the foundation. Recommend evaluation and correction by a qualified and competent contractor where feasible. If uncorrected, Safe@Home recommends that you monitor the runoff during and immediately after precipitation.

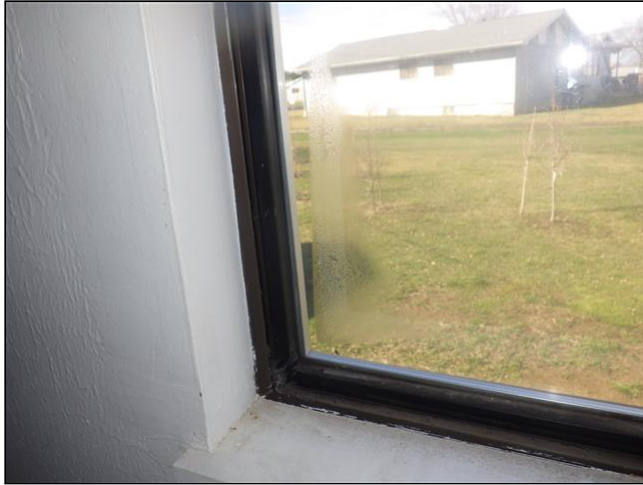
3.2 Item 3(Picture)

(3) One or more windows in the rear bedroom has considerable fogging. This does not substantially impact its weatherproofing capacity or insulative capacity, but does interfere with light transmittance. Recommend replacement of the affected window assembly.

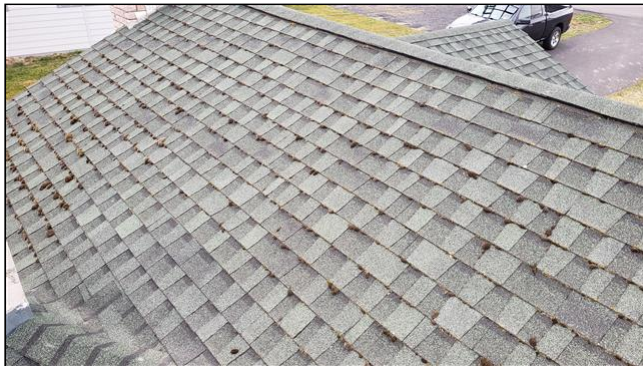
4.1 Item 2(Picture)

(4) There is moss growing on the roof. Safe@Home recommends having a competent and qualified individual remove the moss.

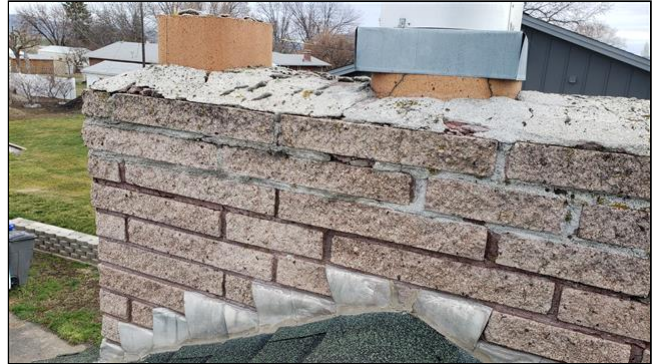
4.5 Item 2(Picture)

(2) The chimney cap had moderate to severe deterioration which should be repaired to avoid moisture intrusion of the chimney structure. Recommend repairs by a licensed and qualified contractor with experience performing work on chimneys.

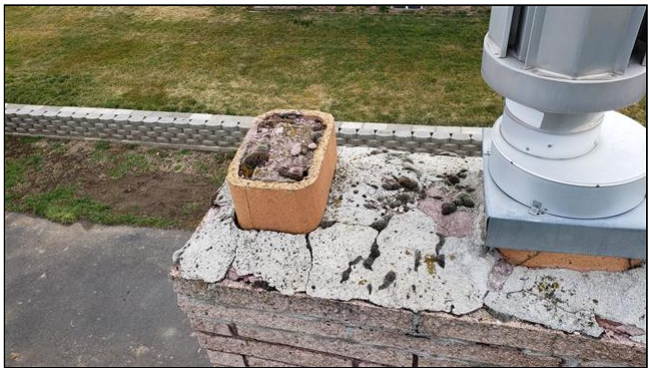
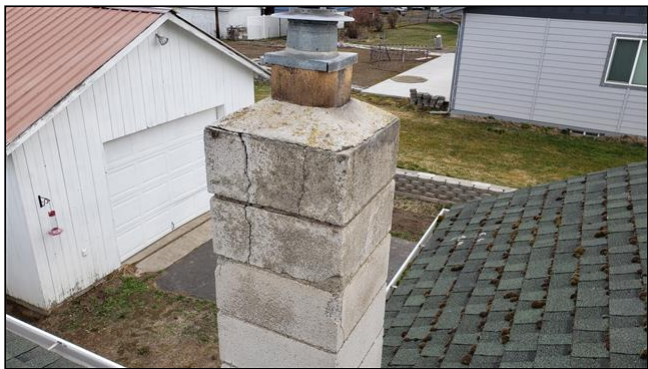
(3) Extensive cracking noted in the chimney structure. Recommend repair by a lciensed and qualified chimney or masonry contractor.

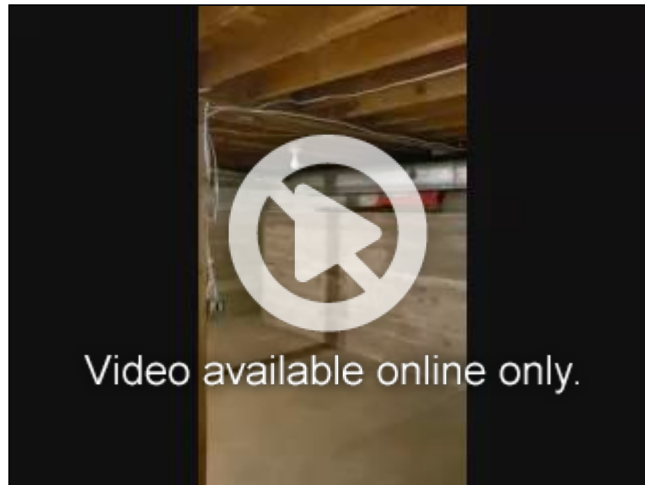
6.4 Item 1(Video)

There is inadequate support for the kitchen addition. Recommend repair by a licensed and qualified contractor.

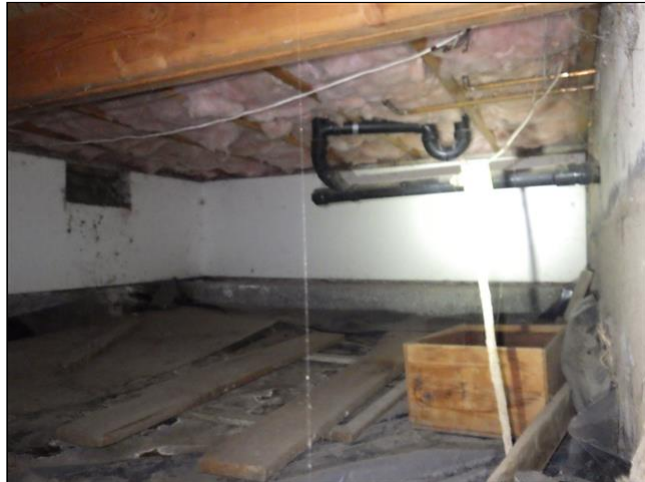
6.10 Item 1(Picture)

Left-over wood from construction is present in the crawlspace. This is considered a conducive condition for pest intrusion and wood-destroying fungus. Recommend removing all such materials.

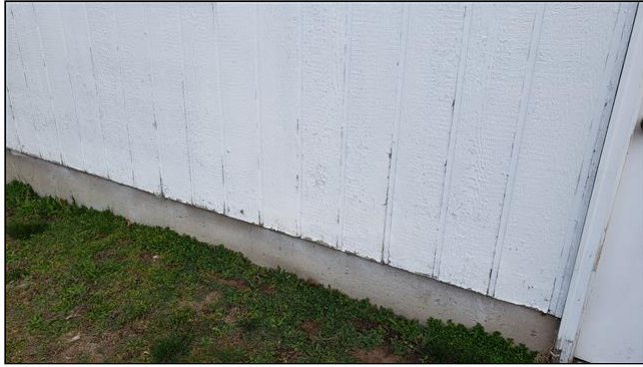
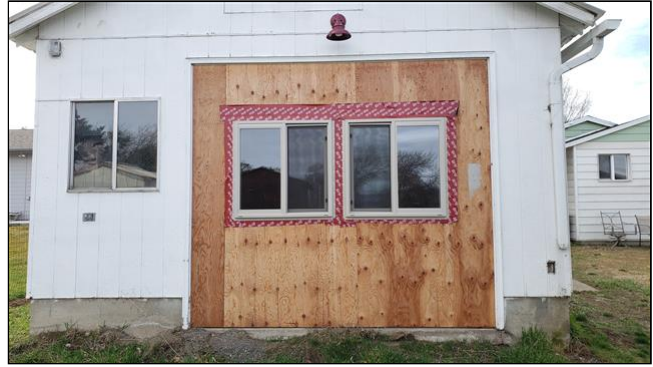
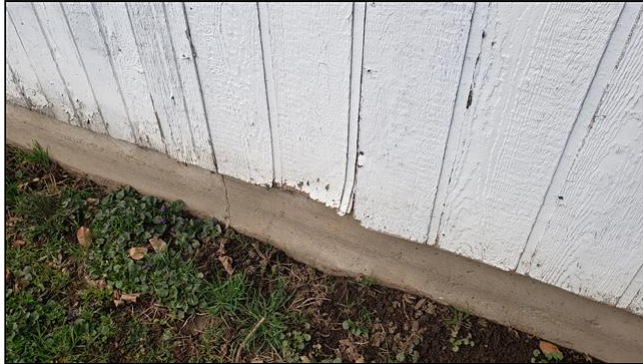
The rear of the building does not have siding.

Have the siding evaluated by a licensed siding contractor familiar with composite siding issues for a full cost estimate. There is a possibility other damage or conditions conducive to may be present that are not readily identifiable at visual means at the time of inspection. This home inspection report is not a warranty or guarantee that all damage or conducive conditions associated with the composition siding have been identified.

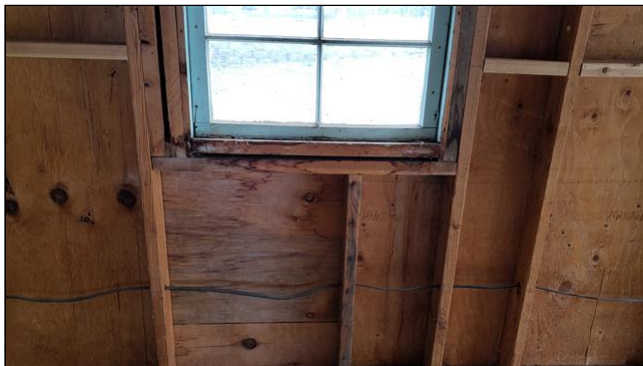
7.3 Item 1(Picture)

Leakage noted around the windows and electrical receptacles. Recommend repair by a licensed and qualified siding contractor.

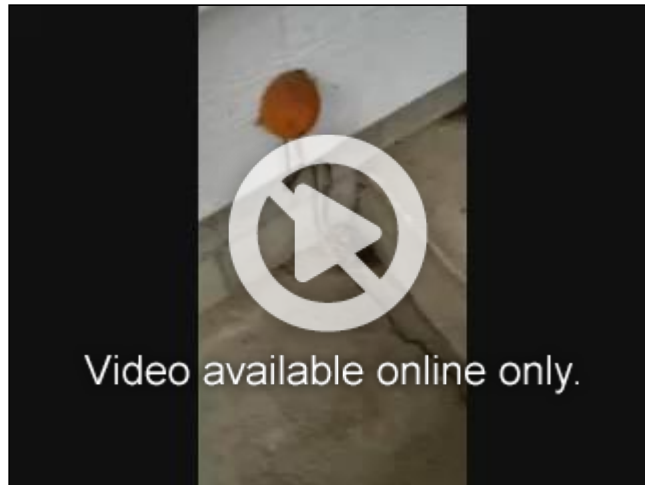
8.1 Item 1(Video)

(2) The ground wire is loose or broken and not performing as intended. Recommend repair by a licensed and qualified electrical contractor.

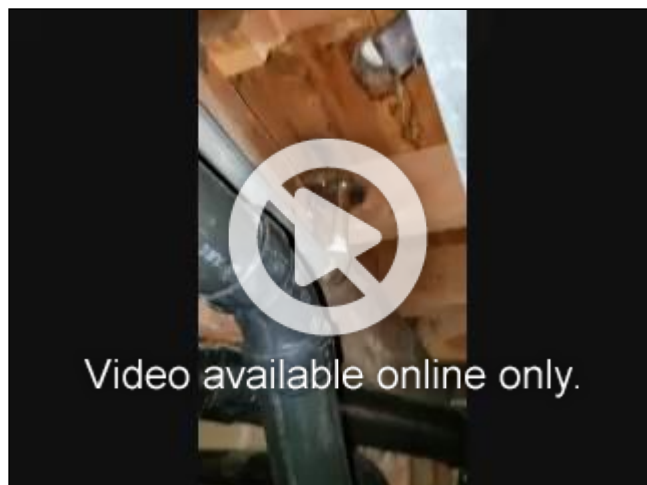
11.2 Item 1(Video)

(2) Plumbing distribution pipes in contact with dissimilar materials were present which may cause galvanic corrosion which in turn will result in deterioration and eventual leakage. Safe@Home recommends installation of dielectric unions by a licensed and qualified plumbing contractor at all locations necessary to protect the plumbing supply system.

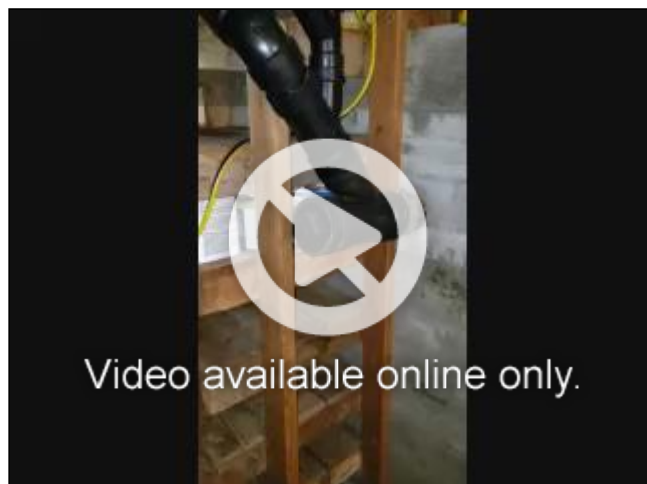
11.3 Item 1(Video)

(1) This inspection did not access the septic tank or determine its location. A home inspector does not and cannot identify issues that are not readily visible or accessible. For a more detailed inspection, THE FOLLOWING SHOULD BE DONE: a licensed and qualified septic pumping company should inspect the tank and related systems BEFORE YOU CLOSE.

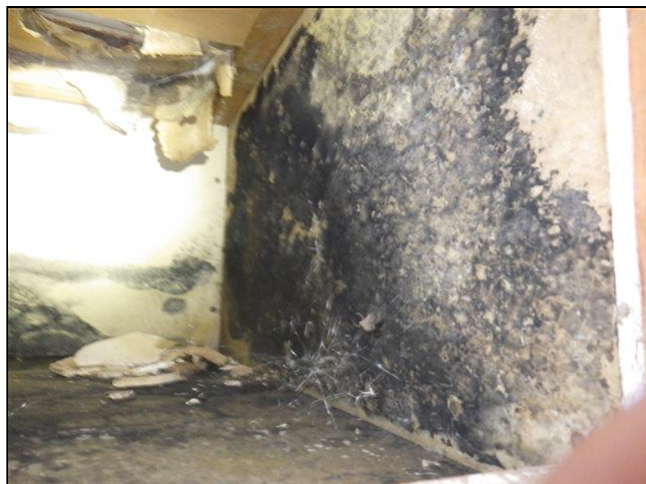
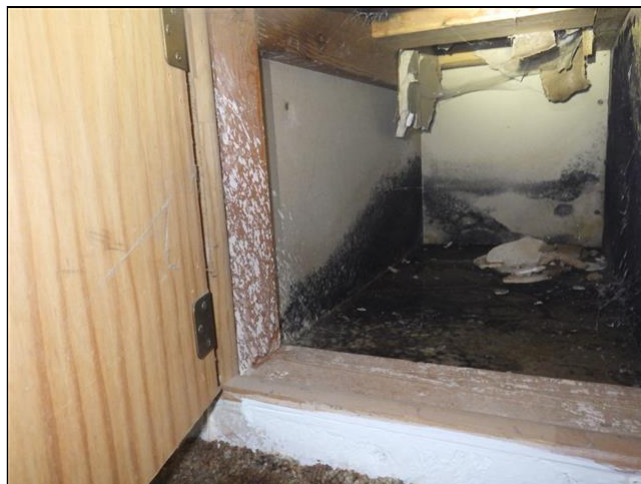
(2) Signs of fungi growth is present in under the bench of the shower of the master bathroom. We did not inspect, test or determine if this growth is or is not a health hazard. The underlying cause is moisture. I recommend you contact a mold inspector or expert for investigation or correction if needed.

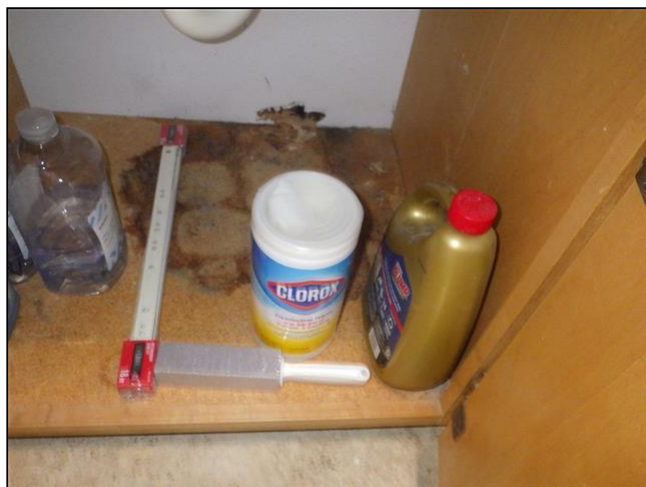
19.6 Item 1(Picture)

The sink base in master shows evidence from a previous leak but appeared dry at this time. I recommend upgrading this component when feasible.

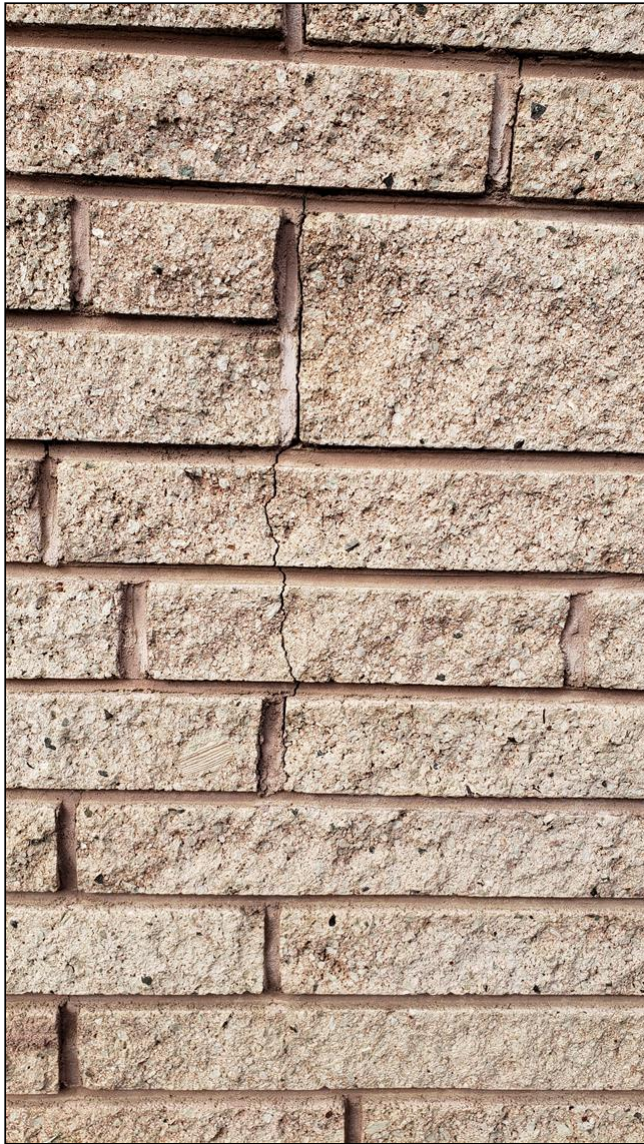
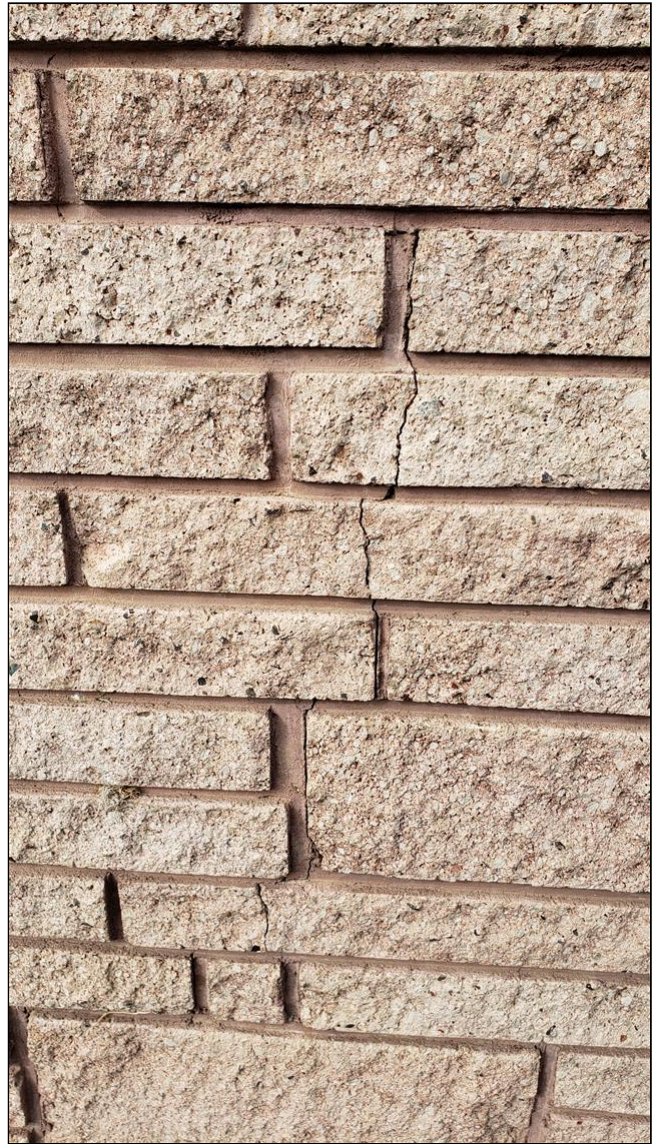
(4) Extensive cracking noted in the chimney structure. This crack a to be related to settlement. The suggestion inadequate Foundation below the chimney. Unable to locate a footing underneath the chimney. Recommend further investigation by a licensed and qualified contractor to determine the full scope of necessary repairs.
