Inspection Report

Property Address:
1123 Linden Ave
Lewiston ID 83501

Safe@Home Inspections, LLC

Date: 3/14/2022	Time: 09:00 AM	Report ID: 20220314-1123-Linden-Ave
Property: 1123 Linden Ave Lewiston ID 83501	Customer: Harry Mills	Real Estate Professional: Tom Scher Windermere All-Star

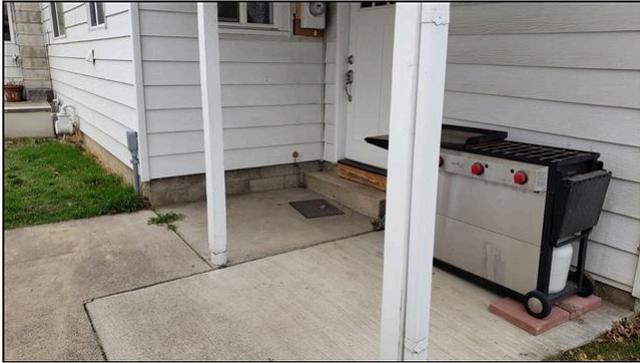
1.5 Item 1(Picture)

(1) The patio appears to be serviceable for the purpose intended.

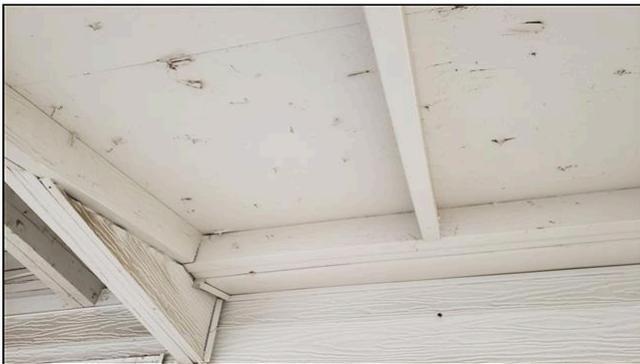
1.5 Item 2(Picture)

(2) The cover for the patio was not bolted to the home but attached with nails. Joists should be attached with hangers. Recommend repair by a competent and qualified contractor.

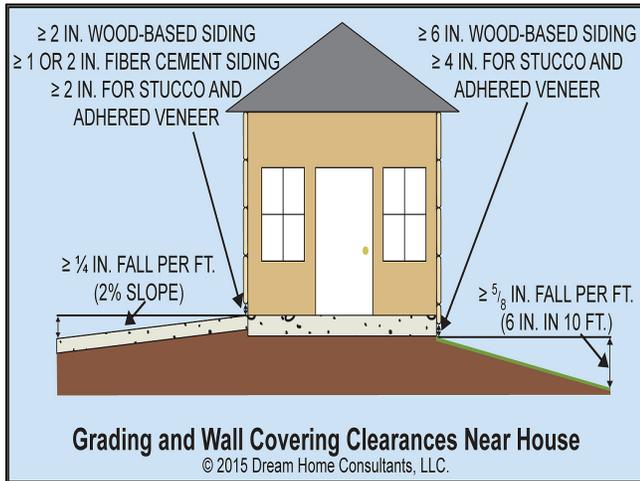
1.7 Item 1(Picture) Grading

The home had some areas of neutral or negative drainage at the foundation which will route runoff from precipitation toward the home. If the ground does not slope away, the water can go to the foundation and may cause issues such as water intrusion or soil settlement/erosion under the footing. Ideally, the ground should slope away from the home 6 inches per 10 feet from the foundation. Recommend evaluation and correction by a qualified and competent contractor where feasible. If uncorrected, Safe@Home recommends that you monitor the runoff during and immediately after precipitation.

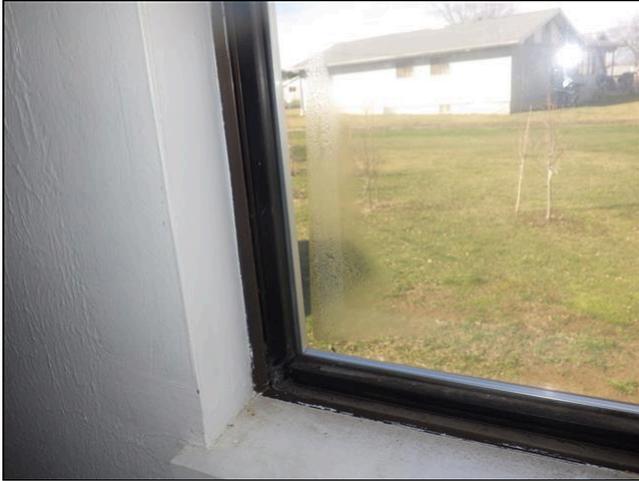
3.2 Item 3(Picture)

(3) One or more windows in the rear bedroom has considerable fogging. This does not substantially impact its weatherproofing capacity or insulative capacity, but does interfere with light transmittance. Recommend replacement of the affected window assembly.

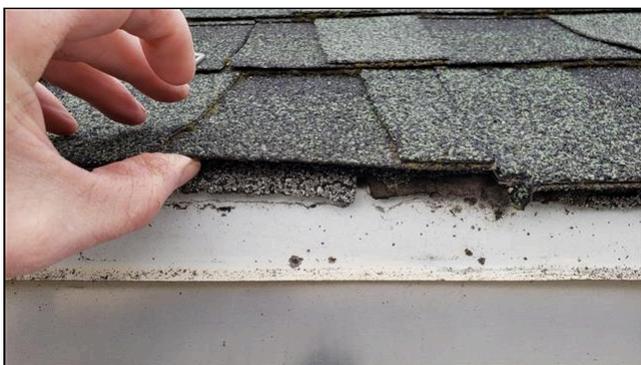
4.1 Item 1(Picture)

(3) The roof had two existing layers of composition asphalt shingles installed at the time of the inspection. This condition will result in the following: Reduced asphalt shingle lifespan compared to similar shingles installed over a proper substrate. Any warranty which may have been in effect will be void. Shingles will be more easily damaged by hail. When new roofing is required, all layers will need to be removed before new roofing material can be installed. This is much more expensive than simply adding another layer and you may wish to take this into account in your consideration of this property.

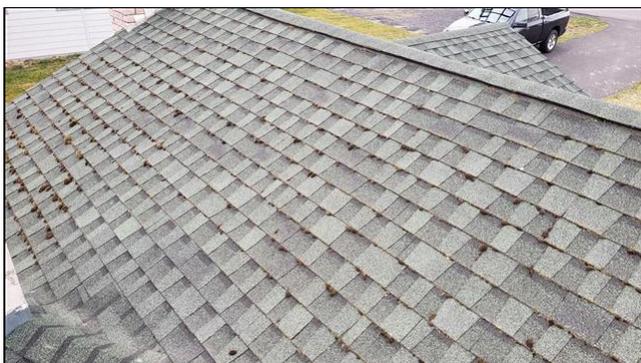
4.1 Item 2(Picture)

(4) There is moss growing on the roof. Safe@Home recommends having a competent and qualified individual remove the moss.

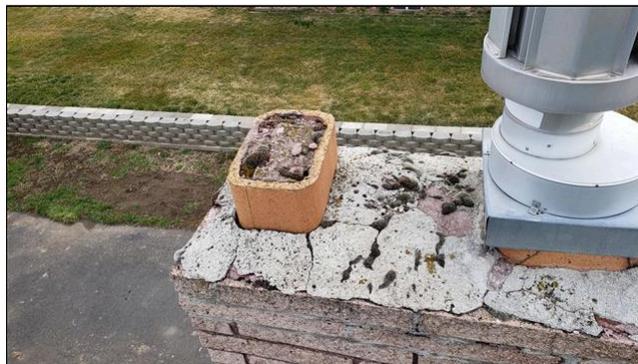
4.5 Item 4(Picture)

(2) The chimney cap had moderate to severe deterioration which should be repaired to avoid moisture intrusion of the chimney structure. Recommend repairs by a licensed and qualified contractor with experience performing work on chimneys.

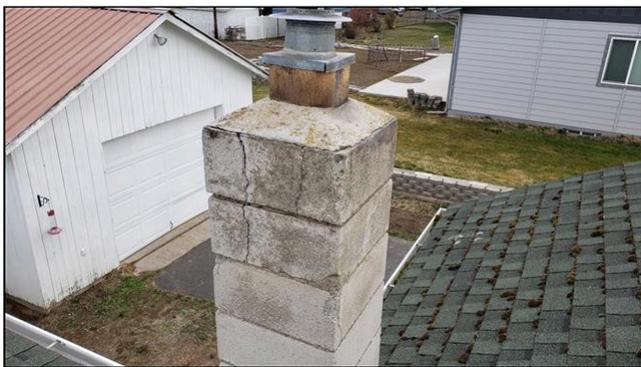
4.5 Item 5(Picture)

(3) Extensive cracking noted in the chimney structure. Recommend repair by a licensed and qualified chimney or masonry contractor.

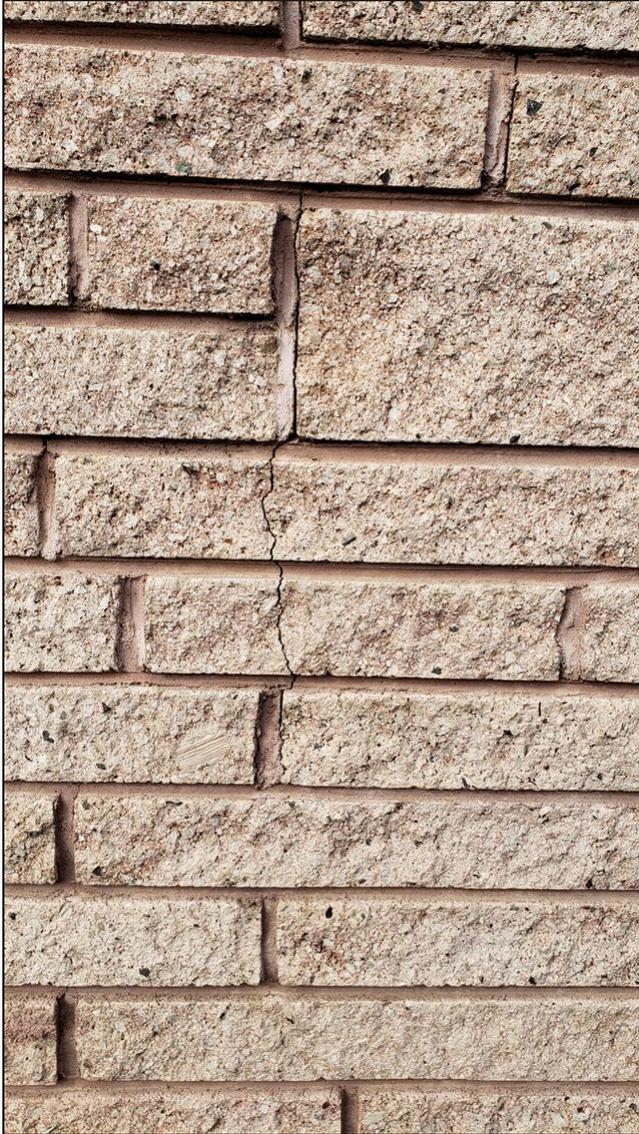
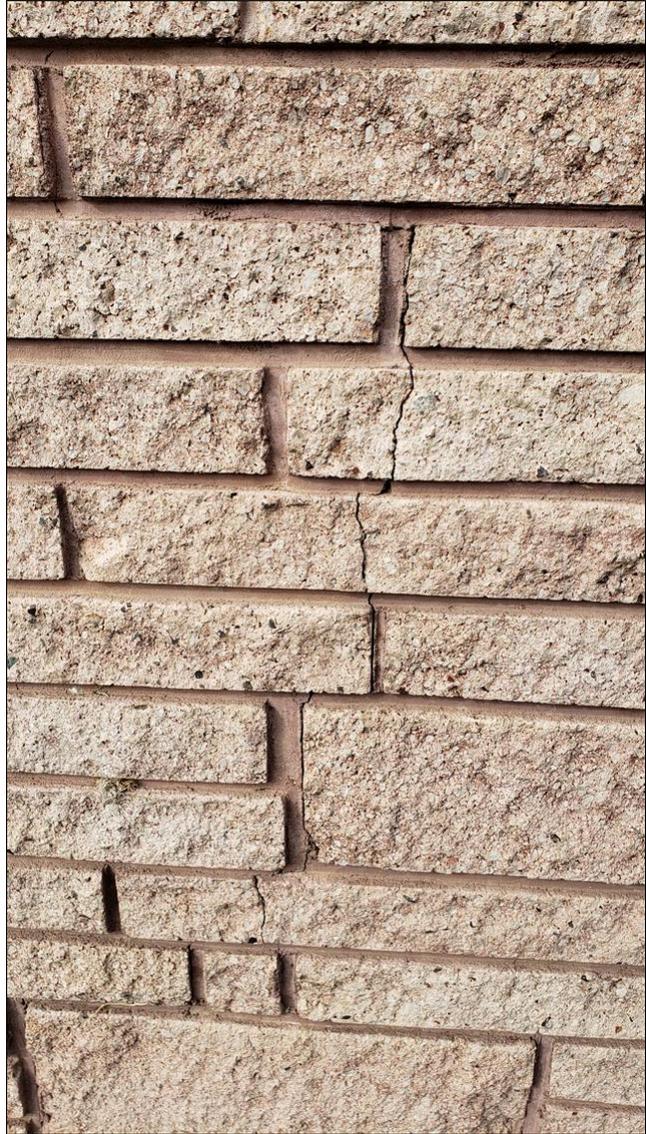
(4) Extensive cracking noted in the chimney structure. This crack a to be related to settlement. The suggestion inadequate Foundation below the chimney. Unable to locate a footing underneath the chimney. Recommend further

investigation by a licensed and qualified contractor to determine the full scope of necessary repairs.

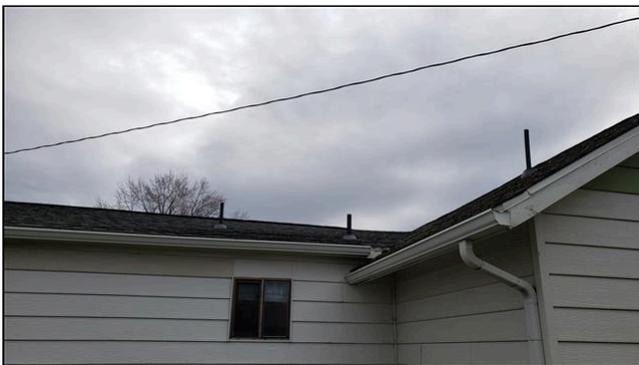
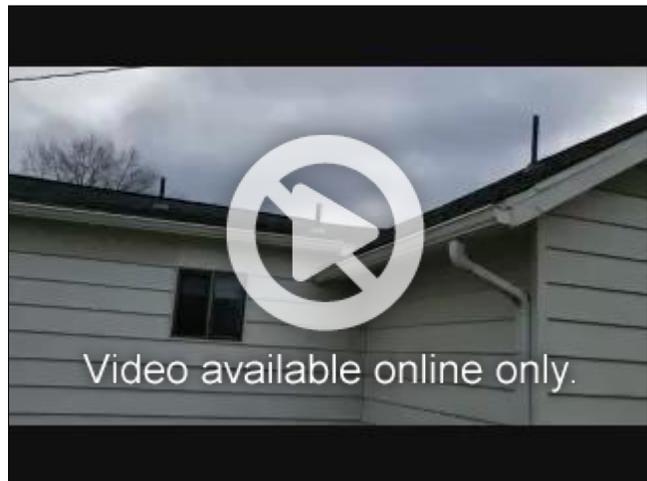
5.2 Item 1(Picture)

(1) Some sagging/deflection is noted on the roof that is likely the result of natural sag in the rafters. This is a common finding on older structures and is generally related to the construction practices of the time.

(2) Sagging visible in the roof rafters appeared to be caused by inadequate framing design of the roof structure typical of homes built in this area, during this time period, of this quality. Consider consulting with a qualified contractor to discuss options and costs for stabilization or correction.

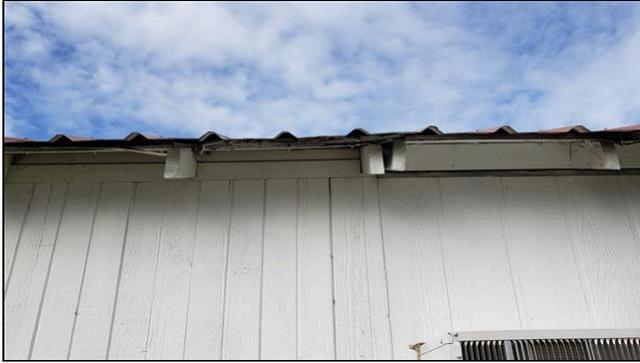
7.1 Item 2(Picture)

(3) The garage roof is missing drip edge flashing. This will allow for water entry at the eave and likely lead to damage to the substrate materials. Recommend installation of drip edge flashing after all repair work is complete.

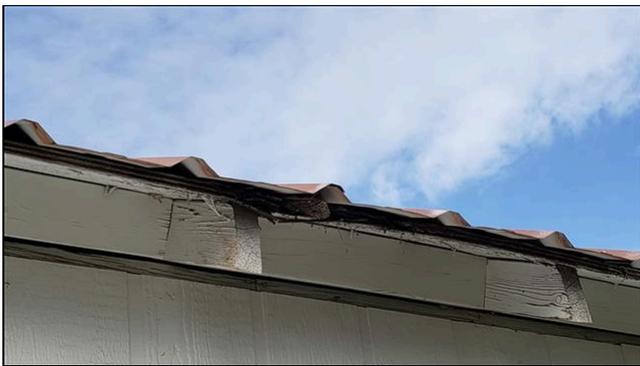
7.1 Item 3(Picture)

(4) Water intrusion noted on the inside of the garage. Substantial damage to underlying sheathing noted at the eaves. Recommend repair of all damaged materials. All work should be completed by licensed and qualified contractor.

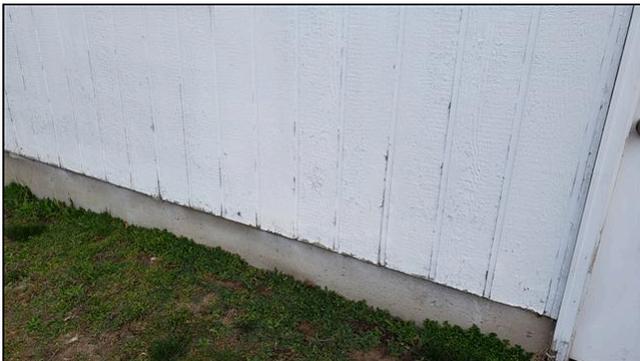
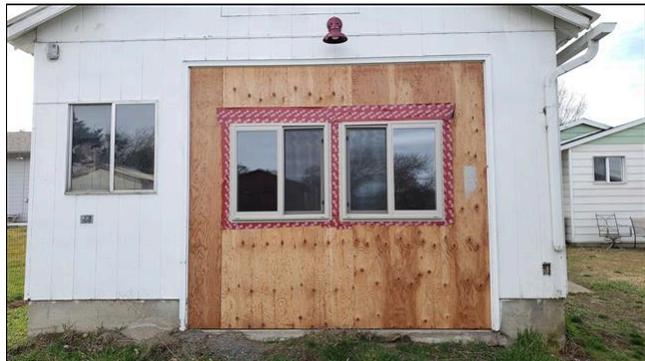
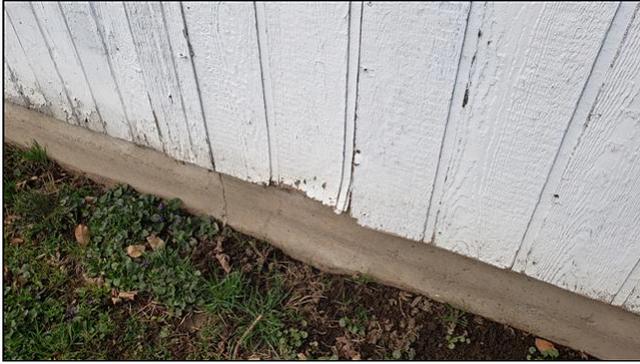
The rear of the building does not have siding.

Have the siding evaluated by a licensed siding contractor familiar with composite siding issues for a full cost estimate. There is a possibility other damage or conditions conducive to may be present that are not readily identifiable at visual means at the time of inspection. This home inspection report is not a warranty or guarantee that all damage or conducive conditions associated with the composition siding have been identified.

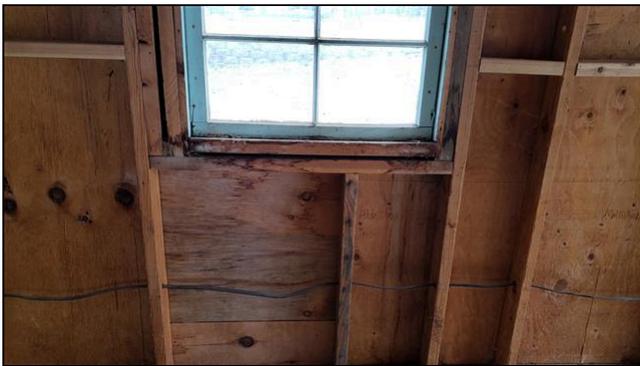
7.3 Item 1(Picture)

Leakage noted around the windows and electrical receptacles. Recommend repair by a licensed and qualified siding contractor.

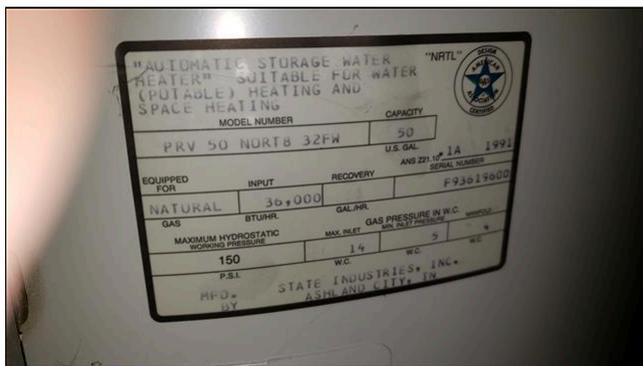
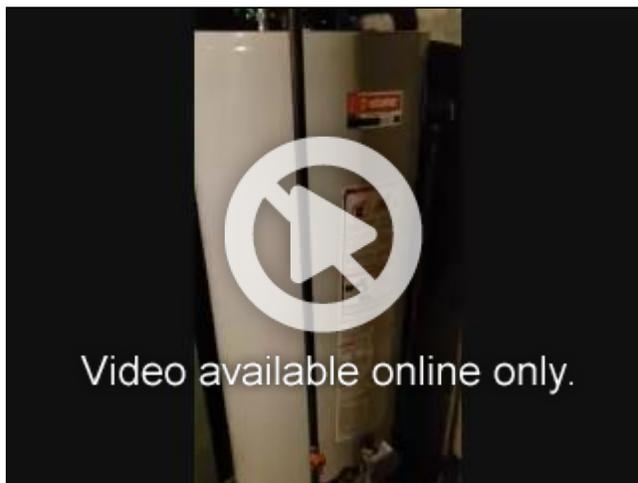
(1) The water heater is gas-fired using natural gas from the local utility provider.

(2) The water heater is more than 20 years old and well beyond the end of a normal service life. The unit was operating at the time of inspection, but I recommend servicing and evaluation at this time. That evaluation should include the service technician's best estimate of remaining service life. **It would be very prudent for the client to make plans for replacement.**

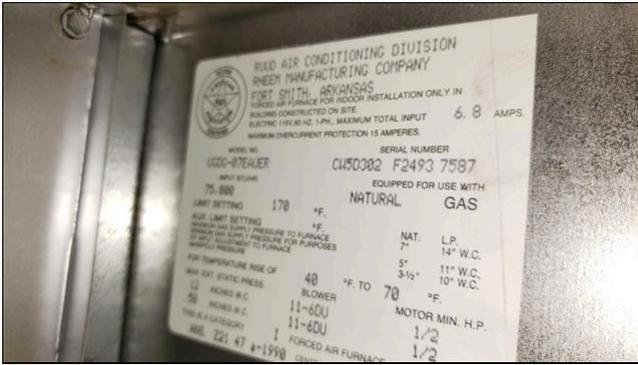
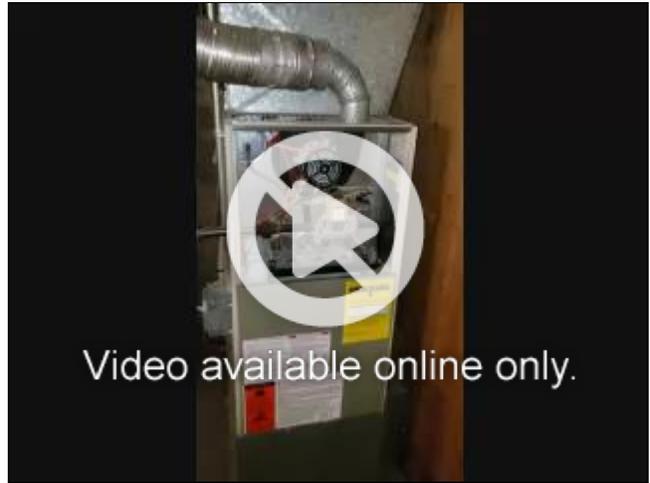
(1) This home has a mid-efficiency gas-fired furnace. Typically, these are approximately 80% to 83% efficient (AFUE).

(2) The furnace is beyond a normal service life based on national estimates and local conditions. It is not possible for me to give a reliable estimate of service life remaining. It would be prudent to make plans for replacement.

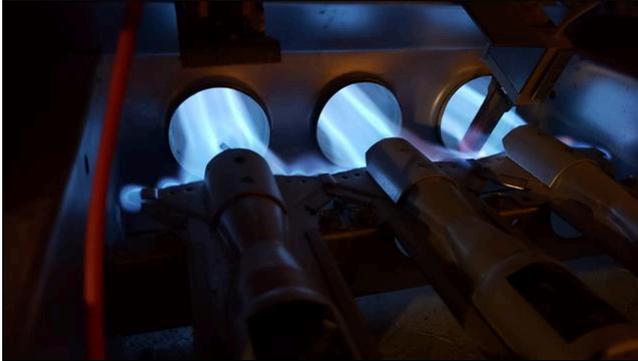
15.3 Item 1(Picture)

(1) Removal of the service panels and observation revealed a strong blue flame which is a sign of proper burning.

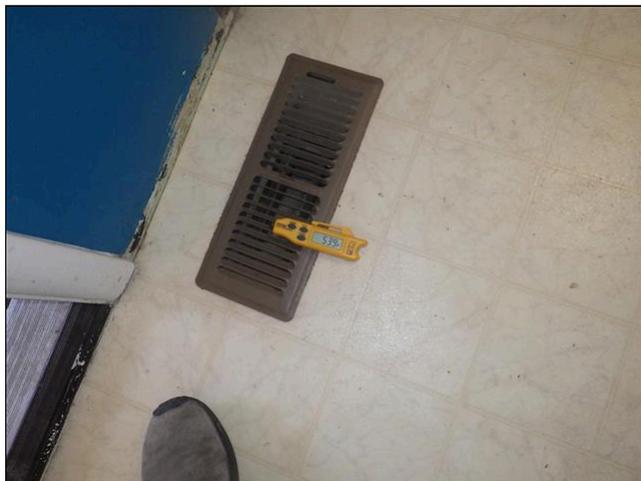
15.5 Item 1(Picture)

The ambient air test was performed by using thermometers on the air handler to determine if the difference in temperatures of the supply and return air are between 14 degrees and 24 degrees which indicates that the unit is cooling as intended. This unit passed this test.

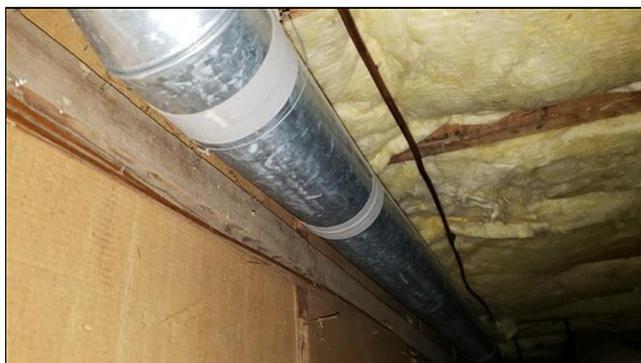
16.3 Item 1(Picture)

It appeared that there was an asbestos containing material used to wrap the ducting. Some of the material appears to be damaged. It is not possible to determine the presence of asbestos without sampling (by an Accredited Asbestos Inspector) and laboratory testing. The recommendation from the EPA is too either use professionals to remove the suspected materials or to encapsulate so that the particles cannot get airborne. Asbestos is most hazardous when airborne. More information is available at the [EPA Asbestos website](#).

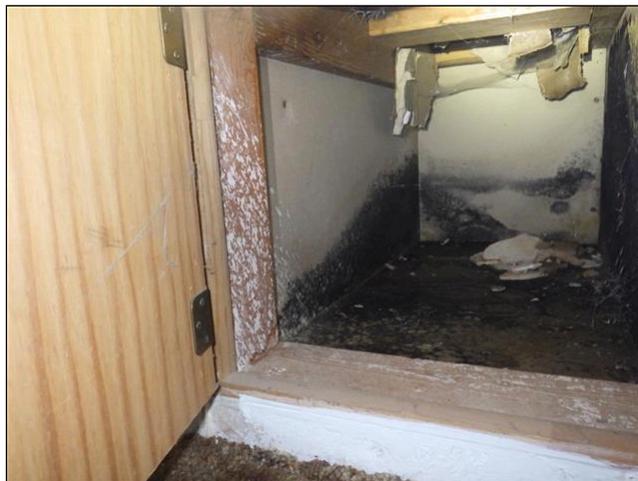
19.2 Item 2(Picture)

(2) Signs of fungi growth is present in under the bench of the shower of the master bathroom. We did not inspect, test or determine if this growth is or is not a health hazard. The underlying cause is moisture. I recommend you contact a mold inspector or expert for investigation or correction if needed.

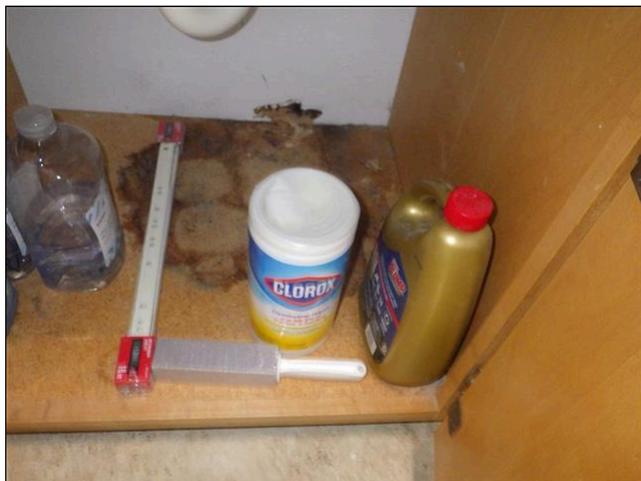
19.6 Item 1(Picture)

The sink base in master shows evidence from a previous leak but appeared dry at this time. I recommend upgrading this component when feasible.

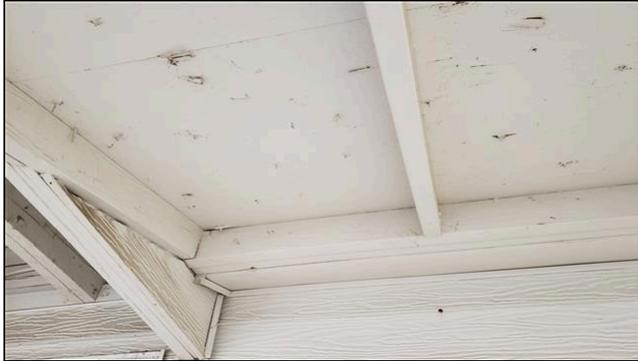
1.5 Item 2(Picture)

(2) The cover for the patio was not bolted to the home but attached with nails. Joists should be attached with hangers. Recommend repair by a competent and qualified contractor.

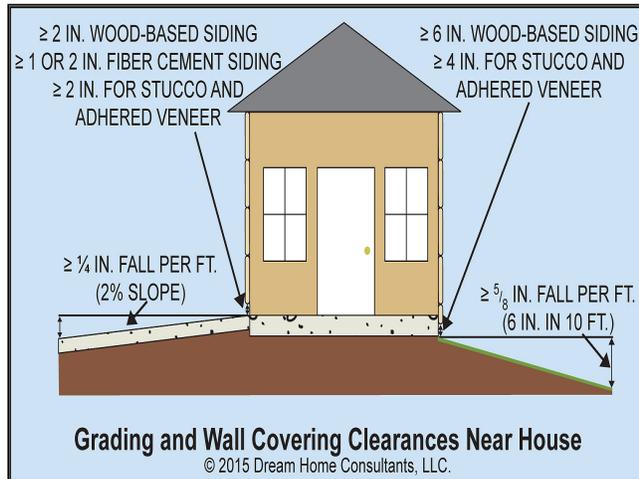
1.7 Item 1(Picture) Grading

The home had some areas of neutral or negative drainage at the foundation which will route runoff from precipitation toward the home. If the ground does not slope away, the water can go to the foundation and may cause issues such as water intrusion or soil settlement/erosion under the footing. Ideally, the ground should slope away from the home 6 inches per 10 feet from the foundation. Recommend evaluation and correction by a qualified and competent contractor where feasible. If uncorrected, Safe@Home recommends that you monitor the runoff during and immediately after precipitation.

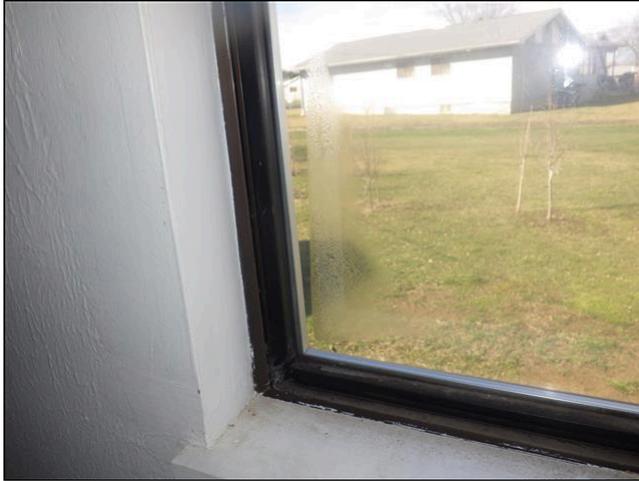
3.2 Item 3(Picture)

(2) One or more windows in the kitchen has considerable fogging. This does not substantially impact its weatherproofing capacity or insulative capacity, but does interfere with light transmittance. Recommend replacement of the affected window assembly.

(3) One or more windows in the rear bedroom has considerable fogging. This does not substantially impact its weatherproofing capacity or insulative capacity, but does interfere with light transmittance. Recommend replacement of the affected window assembly.

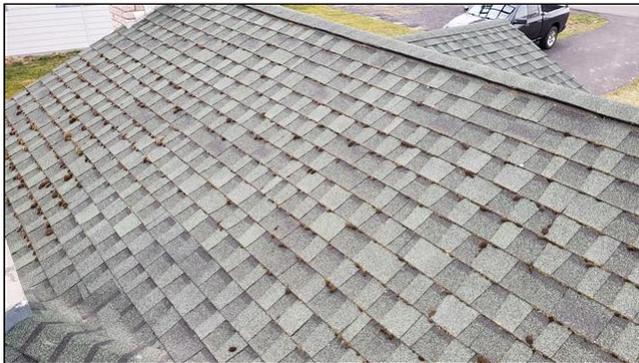
4.1 Item 2(Picture)

(4) There is moss growing on the roof. Safe@Home recommends having a competent and qualified individual remove the moss.

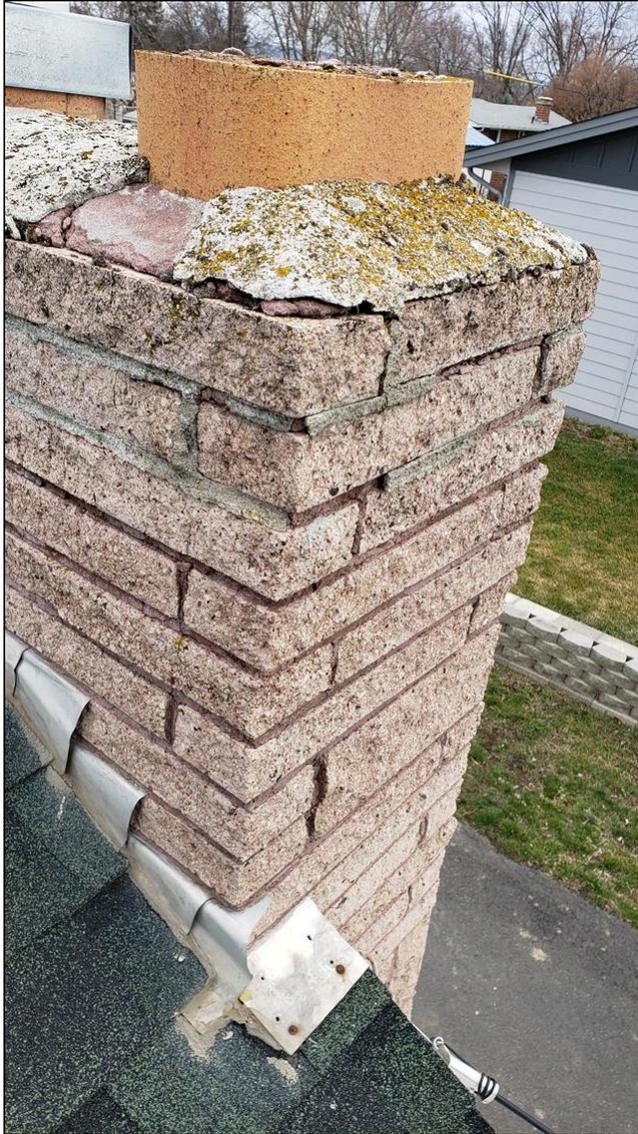
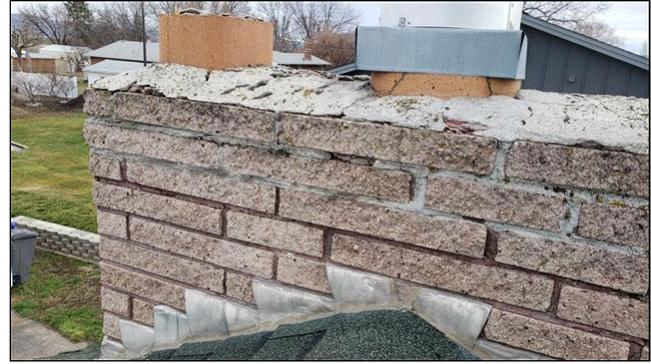
(1) The chimney had extensive deterioration at the mortar joints of the chimney and/or significant spalling of the brick/block. This will tend to make the chimney unstable over time. Recommend repair by a licensed and qualified masonry or fireplace contractor.

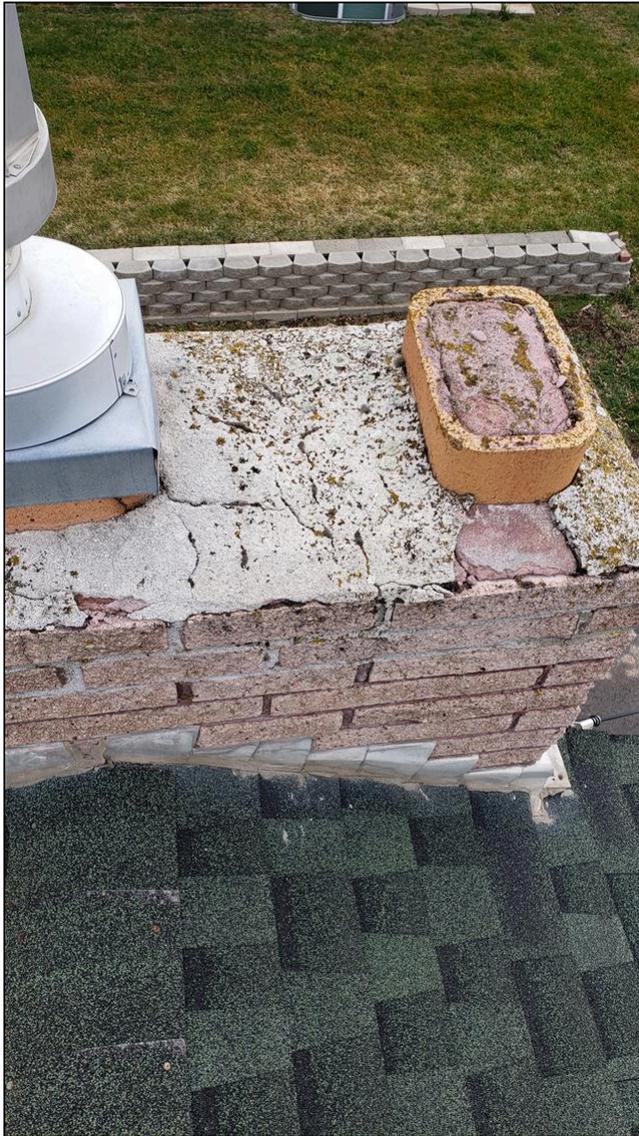
4.5 Item 3(Picture)

(2) The chimney cap had moderate to severe deterioration which should be repaired to avoid moisture intrusion of the chimney structure. Recommend repairs by a licensed and qualified contractor with experience performing work on chimneys.

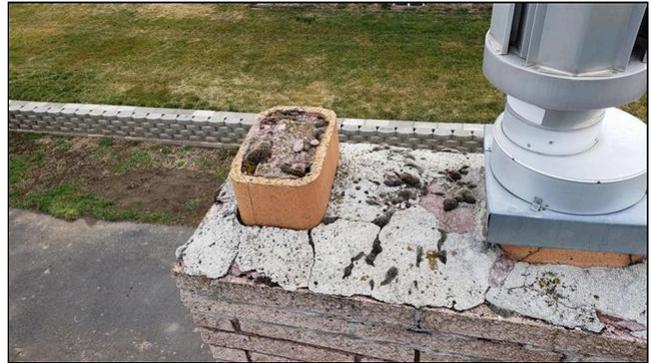
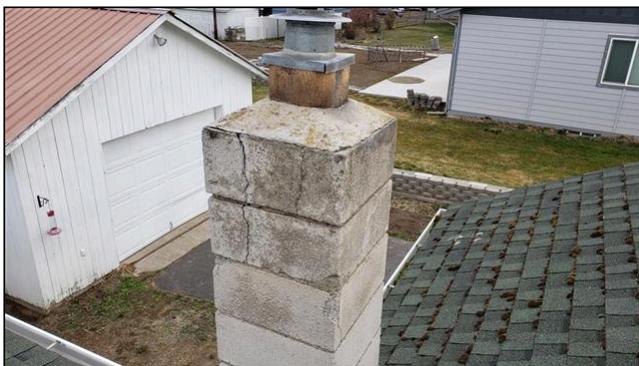
(3) Extensive cracking noted in the chimney structure. Recommend repair by a licensed and qualified chimney or masonry contractor.

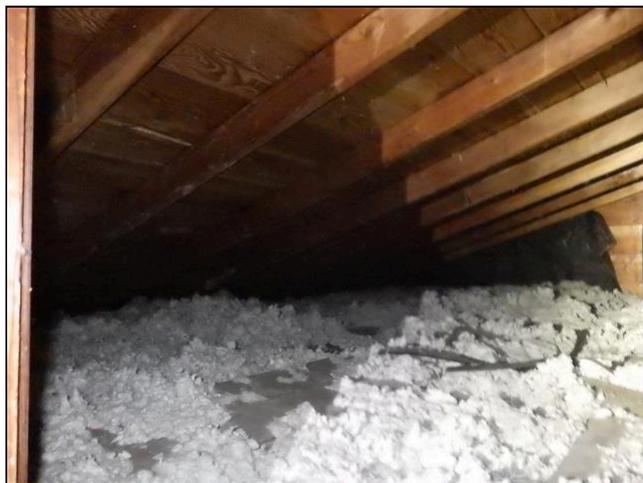
5.2 Item 3(Picture)

(2) Sagging visible in the roof rafters appeared to be caused by inadequate framing design of the roof structure typical of homes built in this area, during this time period, of this quality. Consider consulting with a qualified contractor to discuss options and costs for stabilization or correction.

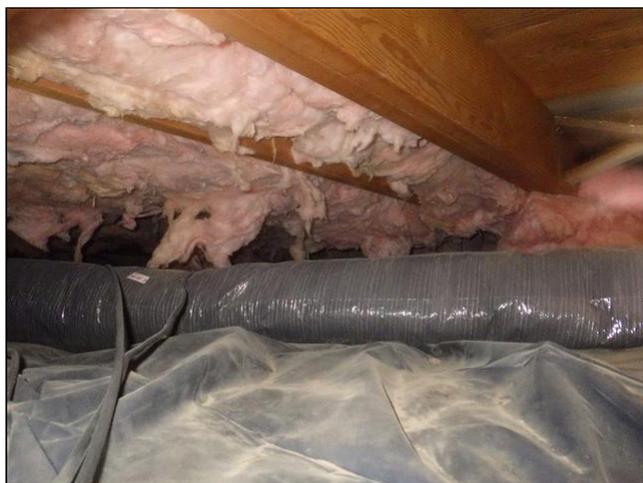
6.3 Item 1(Picture)

(3) Insulation is partially or completely blocking the vents. This may limit air flow and increase moisture levels in the crawlspace. Recommend adjusting/correcting to allow proper air flow.

(4) The ductwork and plumbing prevented full access to approximately 30 percent of the crawlspace. The customer is advised that hidden conditions may be present. A second access should be created or a portion of the existing space should be dug out to allow for entry and inspection.

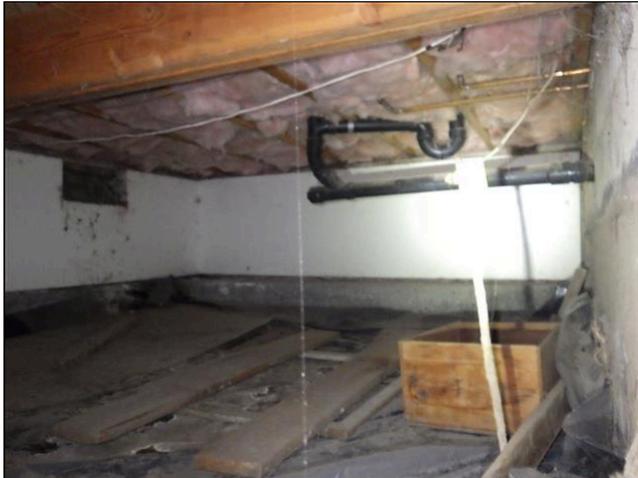
6.10 Item 1(Picture)

Left-over wood from construction is present in the crawlspace. This is considered a conducive condition for pest intrusion and wood-destroying fungus. Recommend removing all such materials.

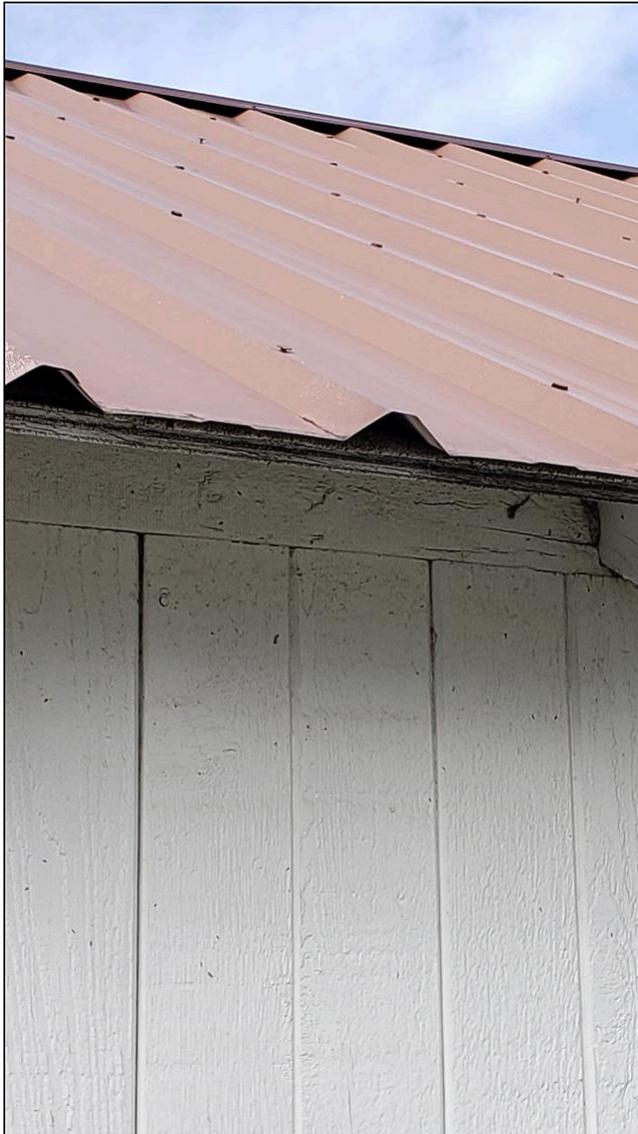
7.1 Item 1(Picture)

(2) Loose, protruding or missing fasteners visible at the time of the inspection. This condition should be corrected to avoid wind damage and/or damage from moisture intrusion. Recommend repair by a licensed and qualified roofing contractor.

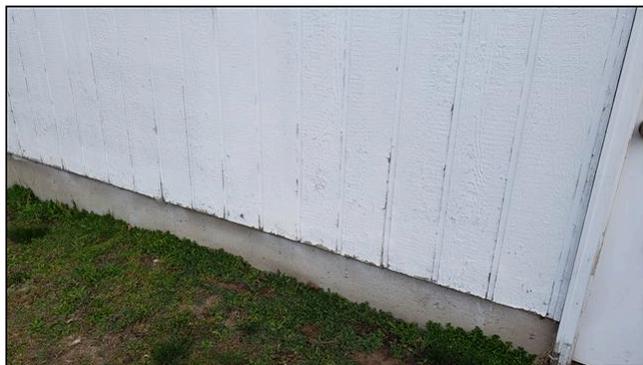
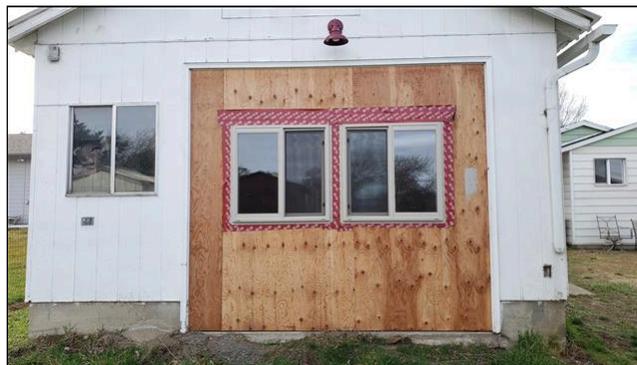
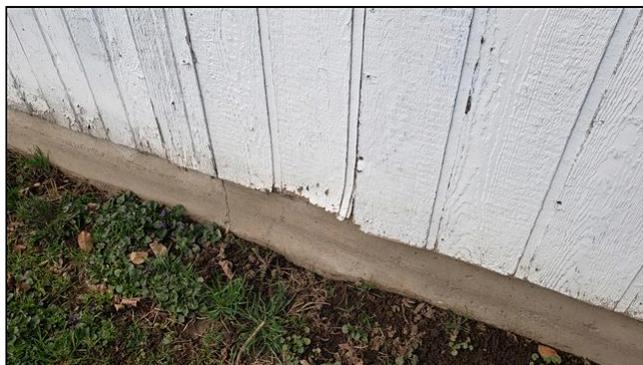
The rear of the building does not have siding.

Have the siding evaluated by a licensed siding contractor familiar with composite siding issues for a full cost estimate. There is a possibility other damage or conditions conducive to may be present that are not readily identifiable at visual means at the time of inspection. This home inspection report is not a warranty or guarantee that all damage or conducive conditions associated with the composition siding have been identified.

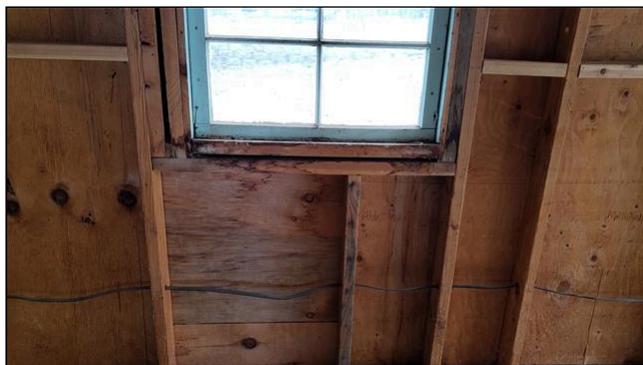
7.3 Item 1(Picture)

Leakage noted around the windows and electrical receptacles. Recommend repair by a licensed and qualified siding contractor.

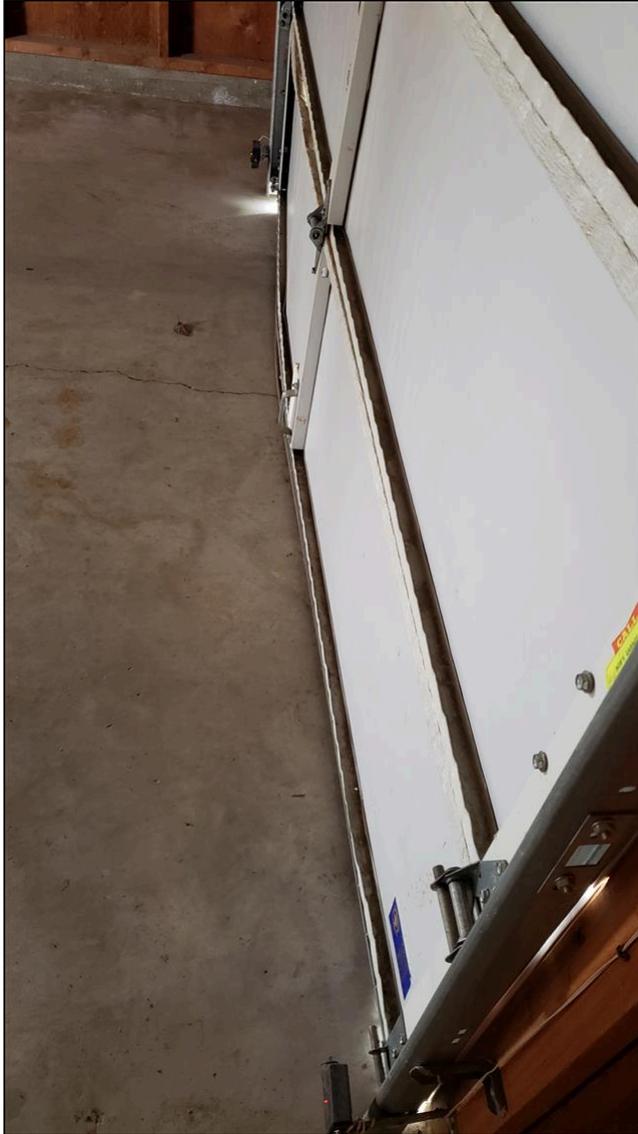
7.5 Item 1(Picture)

A garage vehicle door panel had severe damage visible which will require repair or replacement. Recommend consulting a garage door contractor to gain an idea of options and costs necessary to correct this condition.

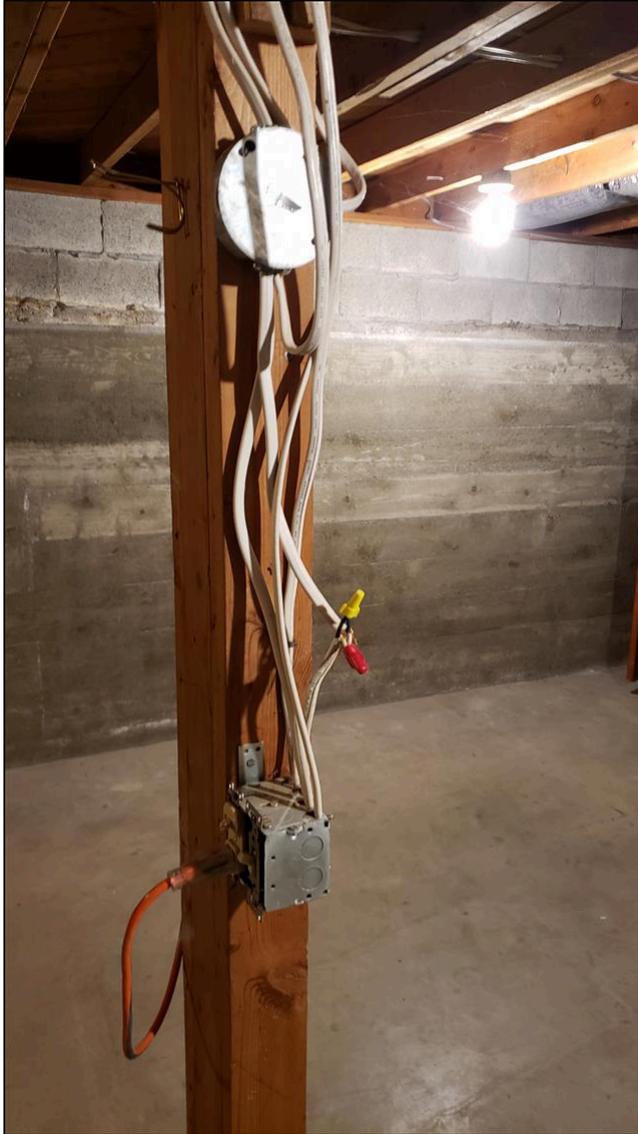
10.1 Item 1(Picture)

(1) Missing covers noted on junction boxes, switches, or receptacles in unfinished basement. This is a potential shock hazard. Recommend having a competent handyman/homeowner install covers in all locations where necessary. Not every location may be noted within the report due to access issues.

(2) The wiring in the basement appears to have been installed by a person unfamiliar with good electrical practices. Wiring is exposed to damage and the junction boxes are missing bushings. Recommend evaluation by a licensed and qualified electrical contractor.

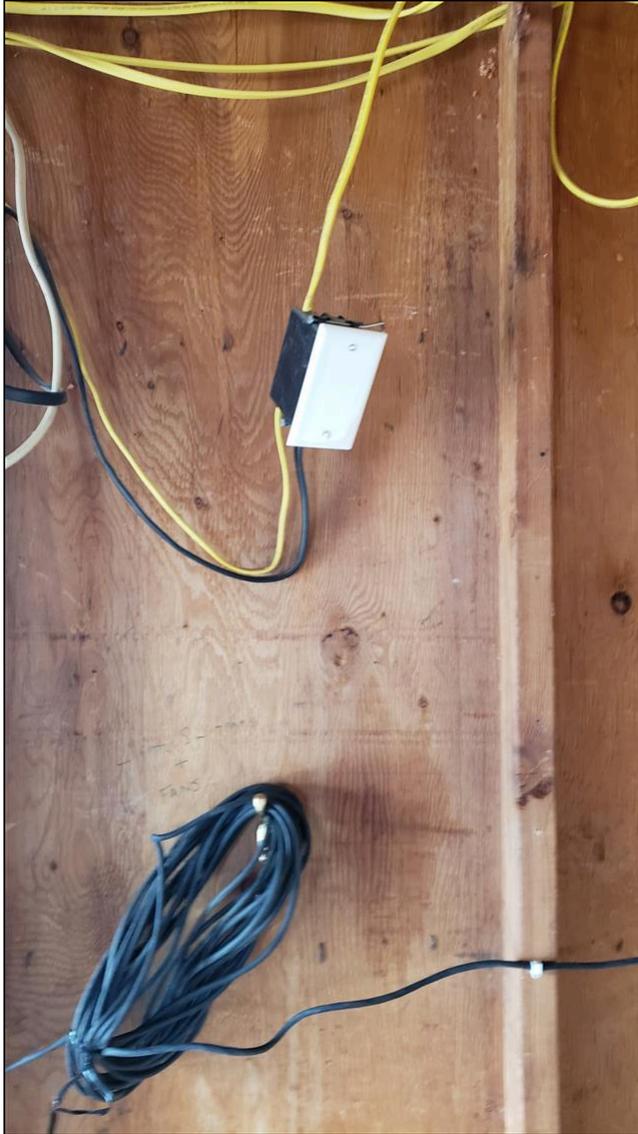
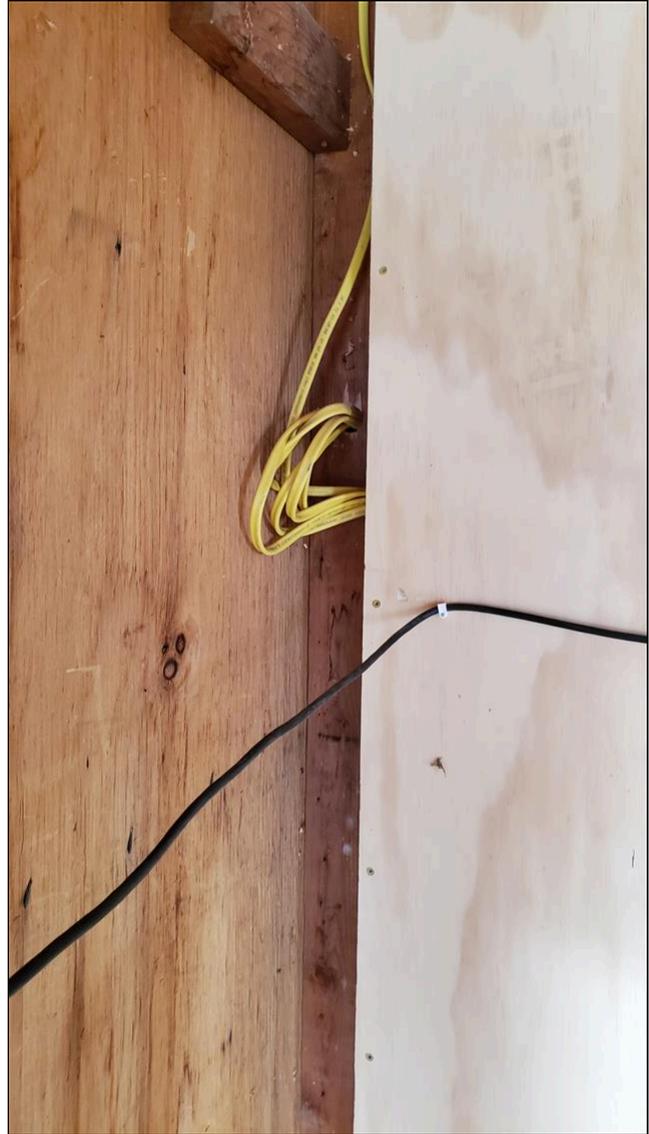
(5) Some of the wiring in the garage appears to have been installed by a person unfamiliar with good electrical practices. Wiring is exposed to damage and the junction boxes are missing bushings. Recommend evaluation by a licensed and qualified electrical contractor.

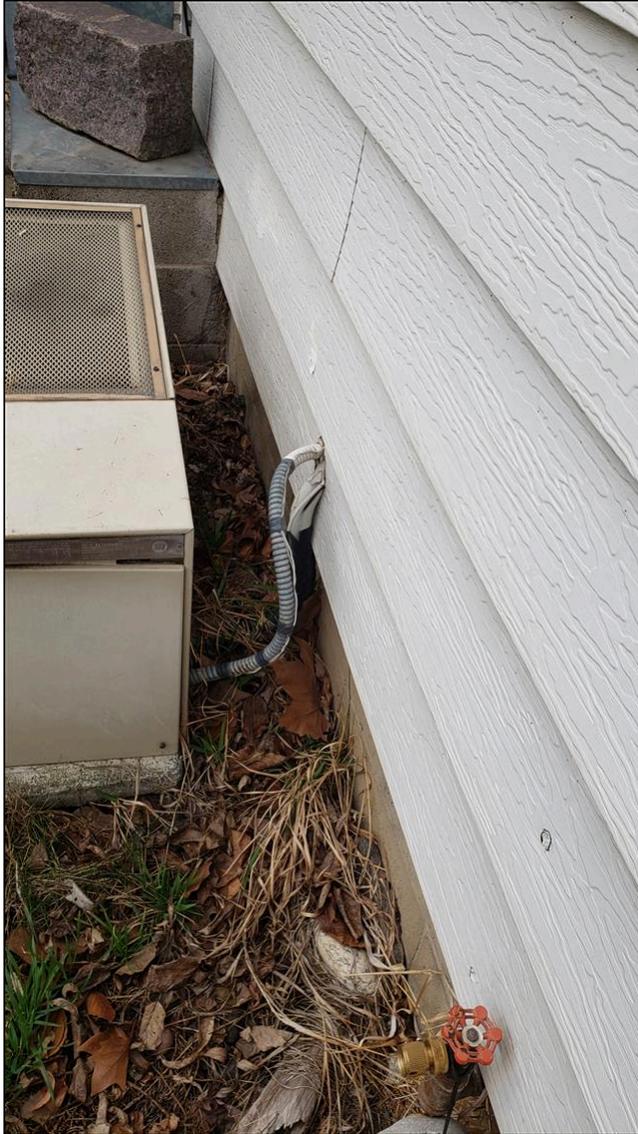
10.2 Item 1(Picture)

(1) Electrical conductors not rated for exterior use were used for an exterior application at the patio of the home. This condition is a potential fire hazard. The SAFE@HOME recommends correction by a qualified electrical contractor.

(2) The electrical service for the air conditioner is protected by conduit that is not weather tight. This can allow water into the service and cause damage to the wiring or create a shock hazard. Recommend repair by a licensed and qualified contractor.

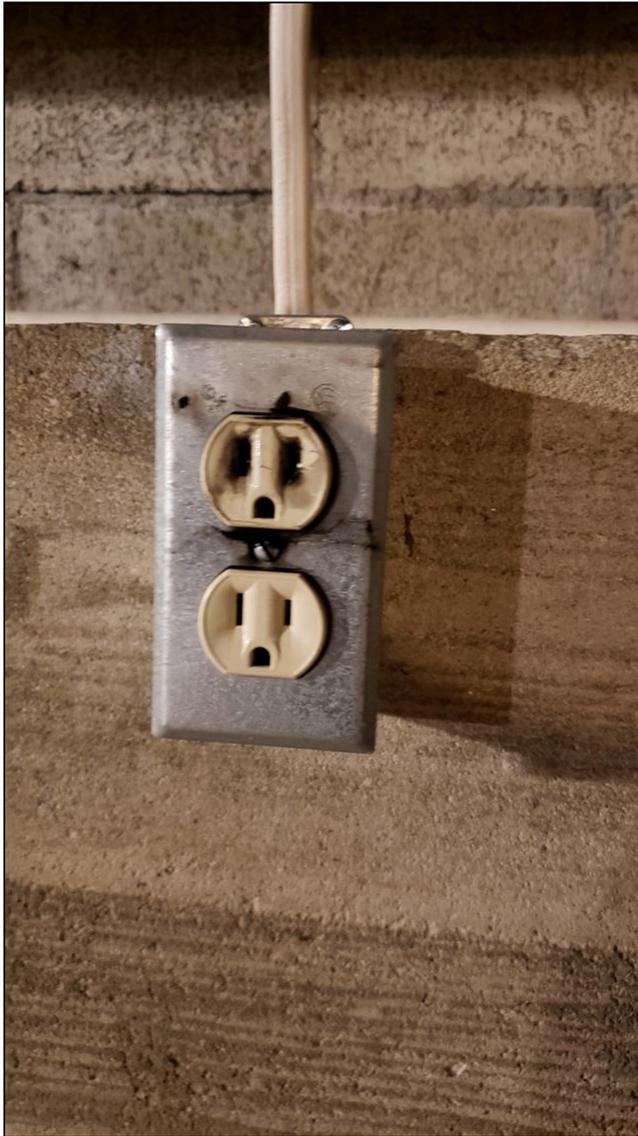
10.4 Item 1(Picture)

(2) One or more receptacles in the unfinished basement has scorch marks and is considered damaged This is a fire hazard. Recommend repairs by a competent, qualified, and licensed electrical contractor.

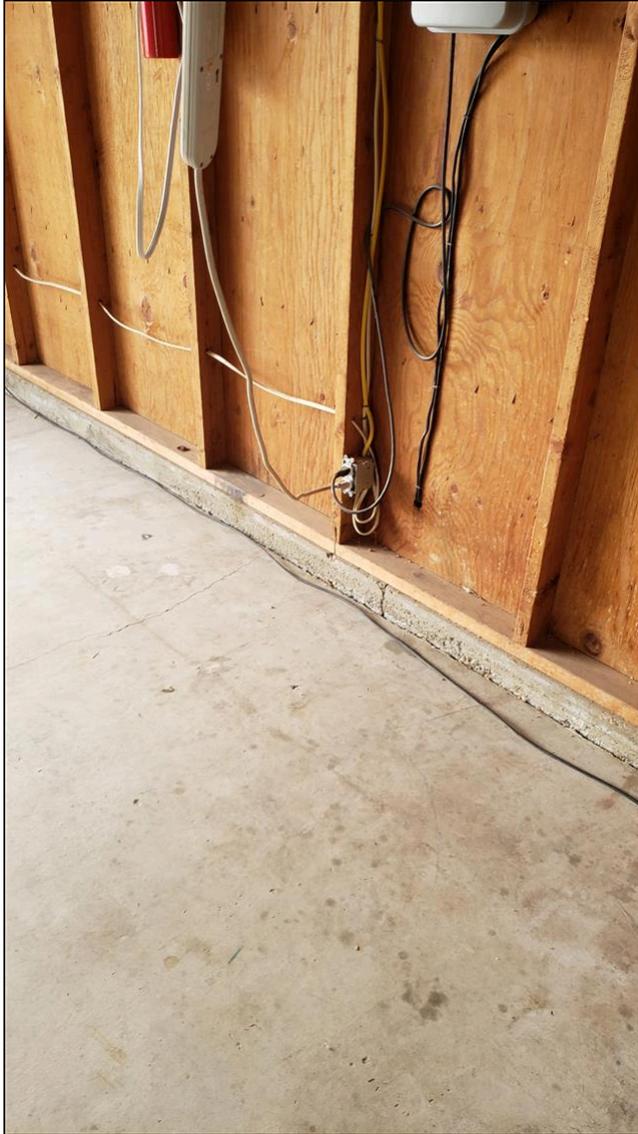
10.4 Item 2(Picture)

(3) Missing cover plates for electrical receptacles noted at garage. This is a shock hazard. Recommend installing appropriate covers on all uncovered receptacles and junctions boxes.

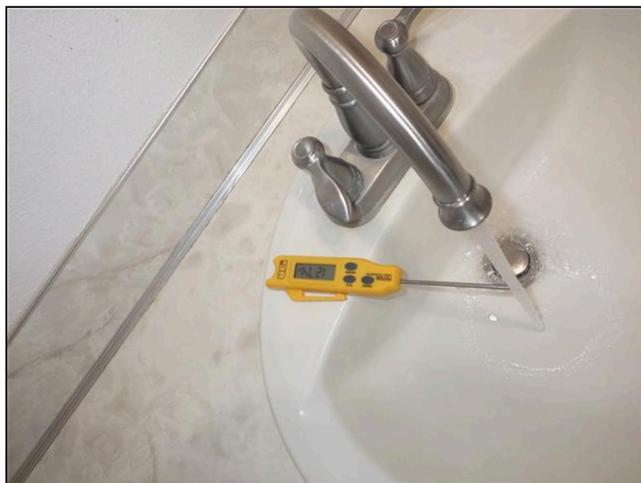
14.2 Item 1(Picture)

This water heater was generating water hotter (more than 130 degrees) than the generally accepted safe water temperature is 120 degrees Fahrenheit. This poses a scald or burn hazard, especially to the elderly and infants. Scald time for adults is approximately 30 seconds. Young children and the elderly scald faster. Recommend turning the water temperature down to the recommended level.
