Inspection Report

Property Address:
1123 Linden Ave
Lewiston ID 83501

Safe@Home Inspections, LLC

Date: 3/14/2022	Time: 09:00 AM	Report ID: 20220314-1123-Linden-Ave
Property: 1123 Linden Ave Lewiston ID 83501	Customer: Harry Mills	Real Estate Professional: Tom Scher Windermere All-Star

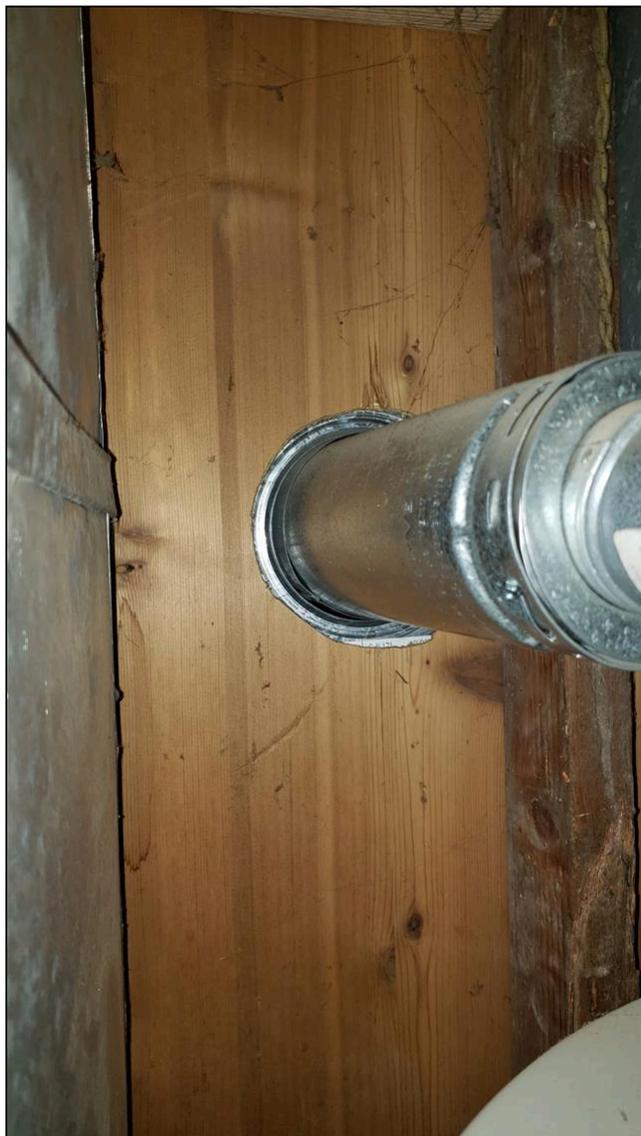
14.3 Item 1(Picture)

The gas-fired water heater exhaust flue had inadequate clearance from combustibles. This type of exhaust flue requires 1-inch clearance from combustible materials. This condition is a potential fire hazard and should be corrected by a qualified contractor.

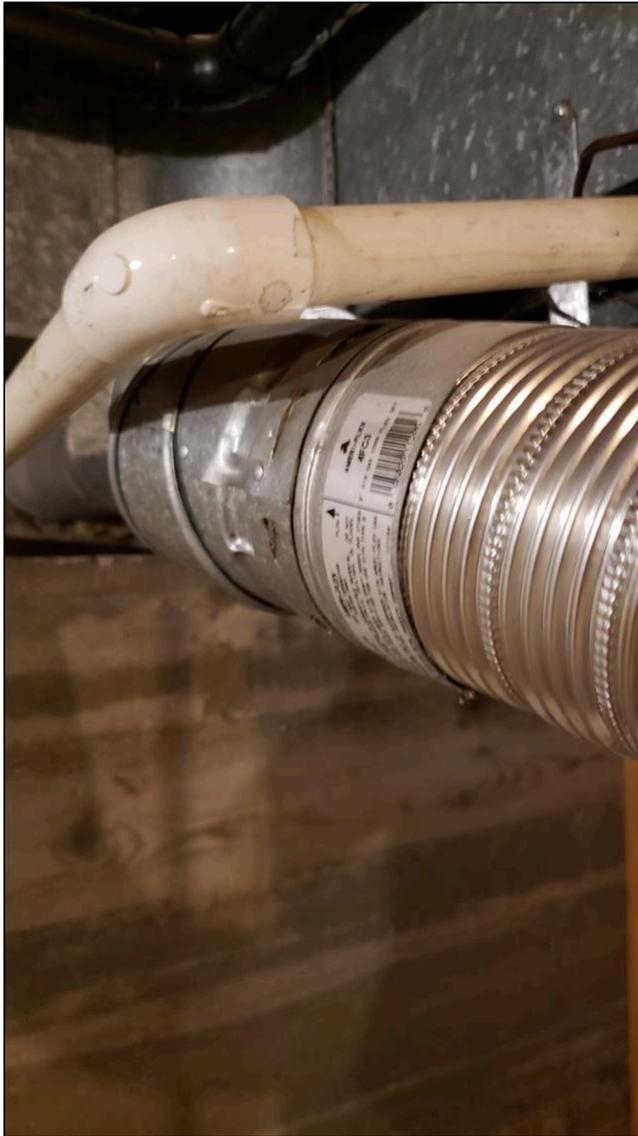
15.3 Item 2(Picture)

(3) The furnace exhaust flue pipe had improper clearance from combustibles. This type of vent requires 1-inch minimum clearance. This condition is a potential fire hazard. Recommend correction by a licensed and qualified HVAC contractor.

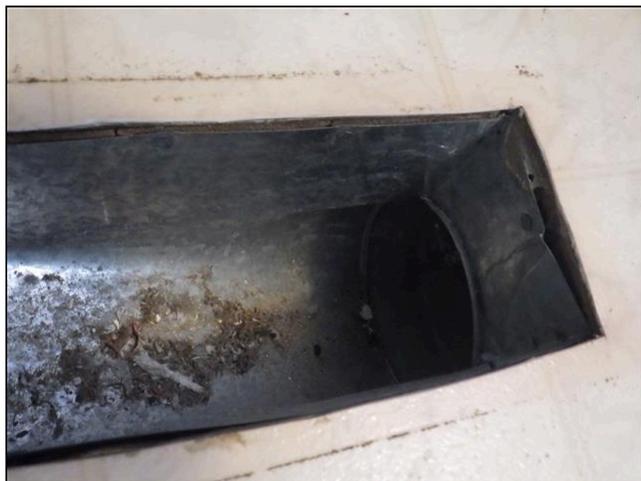
16.2 Item 1(Picture)

(2) Removal of room registers allowed observation of the ductwork leading into various rooms. The ductwork appears to need cleaning as evident by the level of materials visible. Recommend duct cleaning by a licensed and qualified specialist.

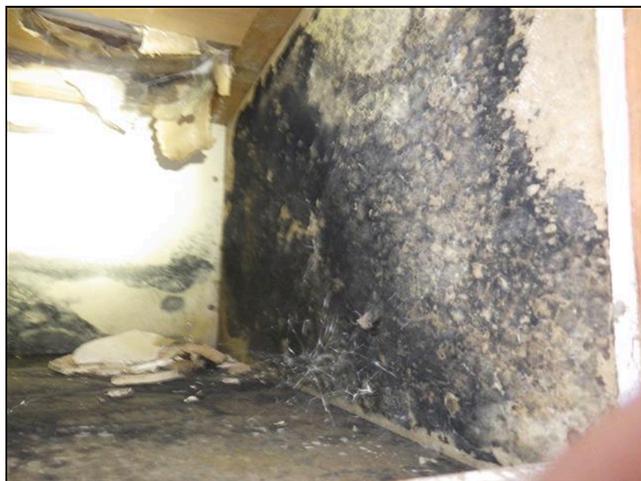
19.2 Item 1(Picture)

(2) Signs of fungi growth is present in under the bench of the shower of the master bathroom. We did not inspect, test or determine if this growth is or is not a health hazard. The underlying cause is moisture. I recommend you contact a mold inspector or expert for investigation or correction if needed.

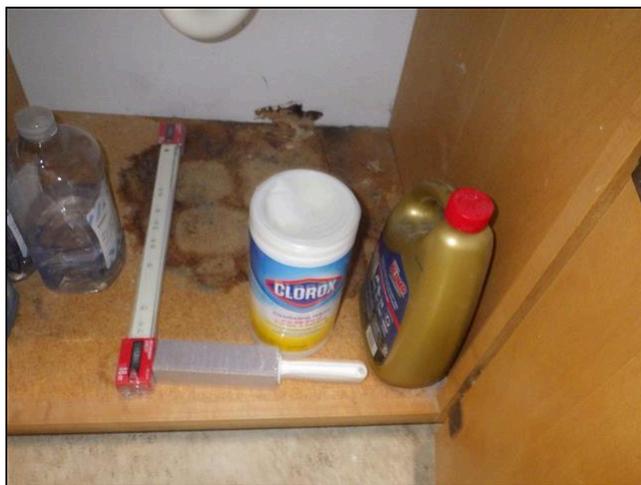
19.6 Item 1(Picture)

The sink base in master shows evidence from a previous leak but appeared dry at this time. I recommend upgrading this component when feasible.

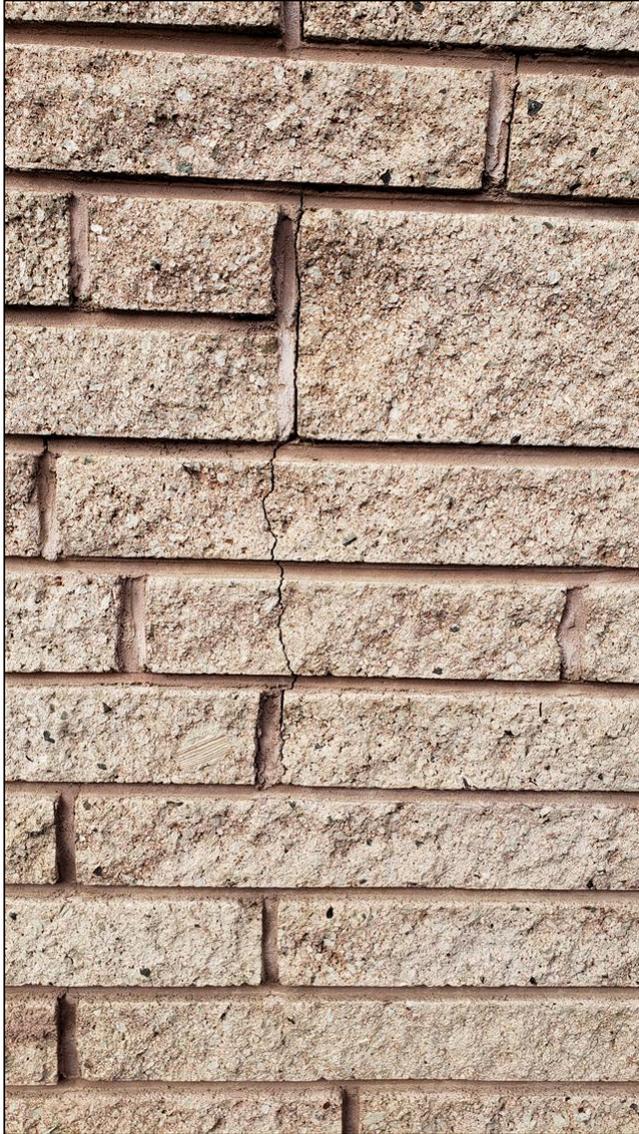
4.5 Item 6(Picture)

(4) Extensive cracking noted in the chimney structure. This crack a to be related to settlement. The suggestion inadequate Foundation below the chimney. Unable to locate a footing underneath the chimney. Recommend further investigation by a licensed and qualified contractor to determine the full scope of necessary repairs.
